DEPARTMENT OF TRANSPORTATION

Contract #: 04-0120F4Cty: SF/ALA Rte: 80 PM: 13.2/13.9File #: 99.28**WELDING INSPECTION REPORT****Resident Engineer:** Casey, William**Address:** 333 Burma Road**City:** Oakland, CA 94607**Report No:** WIR-027225**Date Inspected:** 22-Feb-2012**Project Name:** SAS Superstructure**OSM Arrival Time:** 700**Prime Contractor:** American Bridge/Fluor Enterprises, a JV**OSM Departure Time:** 1530**Contractor:** L & M Industrial Fabricators**Location:** Tangent, Oregon**CWI Name:** Tom Dreyer**CWI Present:** Yes No**Inspected CWI report:** Yes No N/A**Rod Oven in Use:** Yes No N/A**Electrode to specification:** Yes No N/A**Weld Procedures Followed:** Yes No N/A**Qualified Welders:** Yes No N/A**Verified Joint Fit-up:** Yes No N/A**Approved Drawings:** Yes No N/A**Approved WPS:** Yes No N/A**Delayed / Cancelled:** Yes No N/A**Bridge No:** 34-0006**Component:** Tower Chimney Parapet**Summary of Items Observed:**

CCO: 196 - Description: Construct parapet walls at the Tower Heads

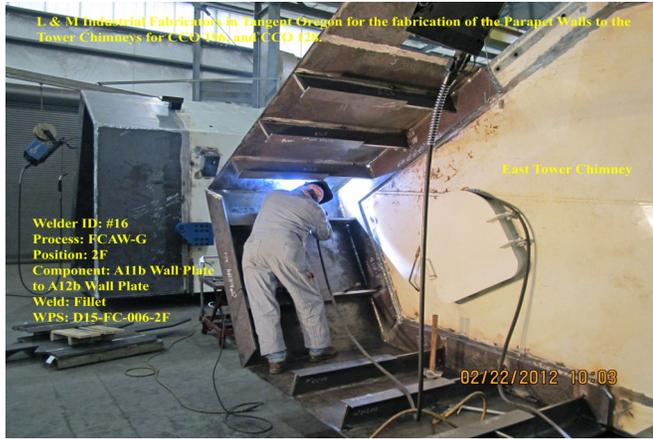
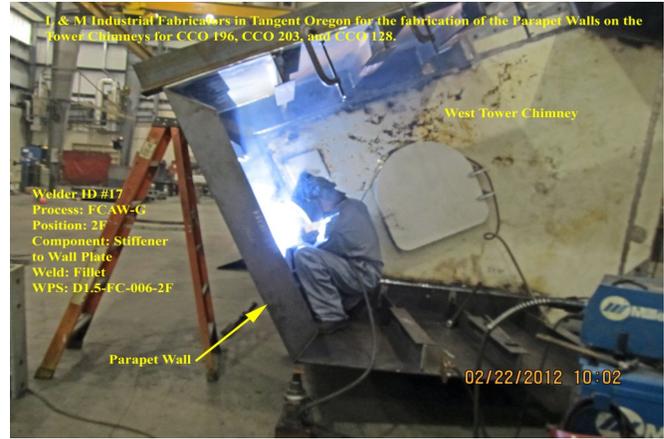
This QA Inspector randomly observed L & M welder Bradford Schroyer (Welder ID #16) performing the fillet weld operation per the Flux Cored Arc Welding (FCAW-G) gas shielding process in the (2F) horizontal position connecting stiffener plate- (A11e) and stiffener plate- (A11f) to wall plate- (A11b) and the (3F) vertical position connecting stiffener plate- (A11e) and stiffener plate- (A11f) to base plate- (A11a) and to top plate- (A11d) of the East Tower Head Chimney parapet wall. This QA Inspector observed QC Inspector Tom Dreyer verify prior to the start of the fillet weld operation, that the minimum preheat temperature as per the approved WPS was established and afterwards; verified that the welding parameters (Amps, Volts and Travel Speed) were in accordance with WPS-D1.5-FC-006-2F using Hobart Excel Arc E71T-1 (.052") diameter electrode.

The welding operation was completed at this location and the workmanship appeared to be in general compliance with the contract specifications.

This QA Inspector randomly observed L & M welder Jake Schuld (Welder ID #17) performing the fillet weld operation per the Flux Cored Arc Welding (FCAW-G) gas shielding process in the (2F) horizontal position connecting stiffener plate- (A11e) and stiffener plate- (A11f) to wall plate- (A11b) and the (3F) vertical position connecting stiffener plate- (A11e) and stiffener plate- (A11f) to base plate- (A11a) and to top plate- (A11d) of the West Tower Head Chimney parapet wall. This QA Inspector observed QC Inspector Tom Dreyer verify prior to the start of the fillet weld operation, that the minimum preheat temperature as per the approved WPS was established and afterwards; verified that the welding parameters (Amps, Volts and Travel Speed) were in accordance with WPS-D1.5-FC-006-2F using Hobart Excel Arc E71T-1 (.052") diameter electrode.
