DEPARTMENT OF TRANSPORTATION

Quality Assurance and Source Inspection

Contract #: 04-0120F4Cty: SF/ALA Rte: 80 PM: 13.2/13.9File #: 1.28**WELDING INSPECTION REPORT****Resident Engineer:** Casey, William**Address:** 333 Burma Road**City:** Oakland, CA 94607**Report No:** WIR-027228**Date Inspected:** 21-Feb-2012**Project Name:** SAS Superstructure**OSM Arrival Time:** 700**Prime Contractor:** American Bridge/Fluor Enterprises, a JV**OSM Departure Time:** 1730**Contractor:** American Bridge/Fluor Enterprises, a JV**Location:** Job Site**CWI Name:** Steve Jensen**CWI Present:** Yes No**Inspected CWI report:** Yes No N/A**Rod Oven in Use:** Yes No N/A**Electrode to specification:** Yes No N/A**Weld Procedures Followed:** Yes No N/A**Qualified Welders:** Yes No N/A**Verified Joint Fit-up:** Yes No N/A**Approved Drawings:** Yes No N/A**Approved WPS:** Yes No N/A**Delayed / Cancelled:** Yes No N/A**Bridge No:** 34-0006**Component:** SAS OBG**Summary of Items Observed:**

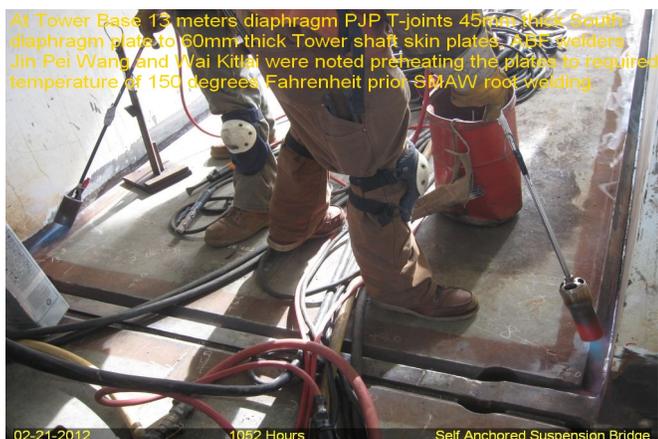
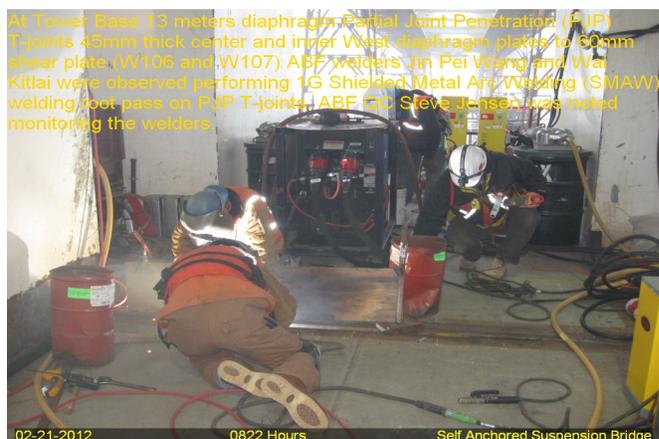
At Tower Base 13 meters diaphragm weld joint number W106, ABF welder Jin Pei Wang was observed continuing to perform 1G Shielded Metal Arc Welding (SMAW) welding root pass on the 45mm thick center diaphragm plate to 60mm shear plate Partial Joint Penetration (PJP) T-joint. The 45mm diaphragm has a 45 degrees bevel with an average root opening of 3.3mm, with partial backing bar. The alignment for weld number W106 was noted 0mm minimum to +10mm maximum. This misalignment which was previously brought to the attention of the ABF QC, and a remedial solution has been put forward by QC through Mr. Jim Bowers and awaiting approval according to QC. The welder was noted using 3/16" diameter E7018H4R implementing Welding Procedure Specification (WPS) ABF-WPS-D15-1160 with measured working current of 232 amps. Prior welding, the welder has preheated the plates to required preheat temperature of more than 150 degrees Fahrenheit using a propylene gas torch. During welding, ABF QC Steve Jensen was noted monitoring the welder. After the completion of the weld joint W106, the welder has moved to weld joint location W125 between the 60mm thick tower plate and 45mm thick South diaphragm plate. This weld joint has an average root opening of 6.8mm and has C-channel underneath the weld joint that is supporting the diaphragm plate and could serve as backing bar for the joint. The welder performed root welding using the same procedure mentioned above. This weld joint was also completed and the welder has again moved to another weld joint location W109. The 45mm outer West diaphragm plate has a 45 degrees bevel with an average root opening of 3.1mm, with partial backing bar. The alignment for weld number W109 was noted -8.5mm minimum to -12mm maximum. The welder has also welded

At Tower Base 13 meters diaphragm weld joint number W107, ABF welder Wai Kitlai was observed continuing to perform 1G Shielded Metal Arc Welding (SMAW) welding root pass on the 45mm thick inner West diaphragm plate to 60mm shear plate PJP T-joint. The 45mm diaphragm has a 45 degrees bevel with an average root opening of 14mm, with backing bar. The alignment for weld number W107 was noted -6mm minimum to +7mm maximum. This misalignment which was previously brought to the attention of the ABF QC, and a remedial solution has been put forward by QC through Mr. Jim Bowers and awaiting approval according to QC. The welder was noted using 3/16" diameter E7018H4R implementing Welding Procedure Specification (WPS) ABF-WPS-D15-1050A with measured working current of 216 amps. Prior welding, the welder has preheated the plates to required preheat temperature of more than 150 degrees Fahrenheit using a propylene gas torch. During welding, ABF QC Steve Jensen was noted monitoring the welder. After the completion of the weld joint W107, the welder has moved to weld joint location W126 between the 60mm thick tower skin plate and 45mm thick South diaphragm plate. This weld joint has an average root opening of 10mm and has C-channel underneath the weld joint that is supporting the diaphragm plate and could serve as backing bar for the joint. The welder performed root welding using the same procedure mentioned above. This weld joint was also completed and the welder has again moved to another weld joint location W108 between the 45mm inner West diaphragm plate to 60mm tower skin plate. The diaphragm has a 45 degrees bevel with an average root opening of 12mm, with backing bar. The alignment for weld number W108 was noted -5mm minimum to +11.5mm maximum. The welder has also welded the root pass but partially completed only. Welding of the remaining unwelded length of the joint should continue tomorrow.

At Tower Base 9 meters diaphragm, fit up/tack welding of drop in plates at outer West diaphragm was noted. ABF welder Luo Xiao Hua was observed performing tack welding the 45mm drop ins to 60mm thick shear plate using Shielded Metal Arc Welding (SMAW) with 1/8" diameter E7018H4R electrode. The plates were preheated to required temperature of 150 degrees Fahrenheit using propylene gas torch prior welding. During the tack welding, ABF QC Steve Jensen was noted monitoring the parameters of the welder. At the end of the shift, fit up/tack welding of two out of four drop ins for the outer West diaphragm was completed.

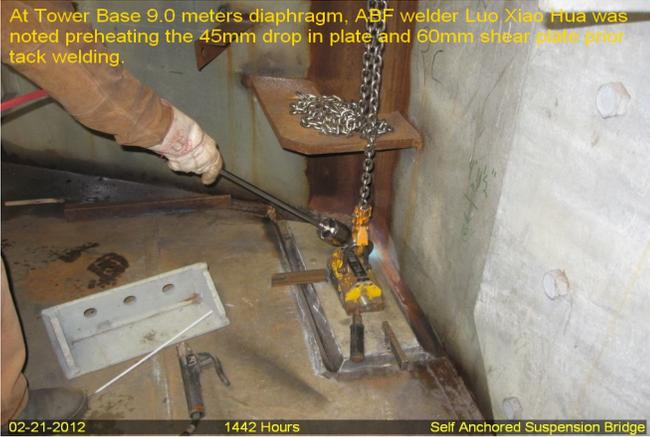
At Tower Base 9.0 meters diaphragm, ABF welder Luo Xiao Hua was noted preheating the 45mm drop in plate and 60mm shear plate prior tack welding.
