Contract #: 04-0120F4Cty: SF/ALA Rte: 80 PM: 13.2/13.9File #: 1.28**WELDING INSPECTION REPORT****Resident Engineer:** Casey, William**Address:** 333 Burma Road**City:** Oakland, CA 94607**Report No:** WIR-027239**Date Inspected:** 23-Feb-2012**Project Name:** SAS Superstructure**OSM Arrival Time:** 700**Prime Contractor:** American Bridge/Fluor Enterprises, a JV**OSM Departure Time:** 1730**Contractor:** American Bridge/Fluor Enterprises, a JV**Location:** Jobsite**CWI Name:** As noted below**CWI Present:** Yes No**Inspected CWI report:** Yes No N/A**Rod Oven in Use:** Yes No N/A**Electrode to specification:** Yes No N/A**Weld Procedures Followed:** Yes No N/A**Qualified Welders:** Yes No N/A**Verified Joint Fit-up:** Yes No N/A**Approved Drawings:** Yes No N/A**Approved WPS:** Yes No N/A**Delayed / Cancelled:** Yes No N/A**Bridge No:** 34-0006**Component:** SAS OBG**Summary of Items Observed:**

8E PP71 E2 Deck Access Hole (Exterior)

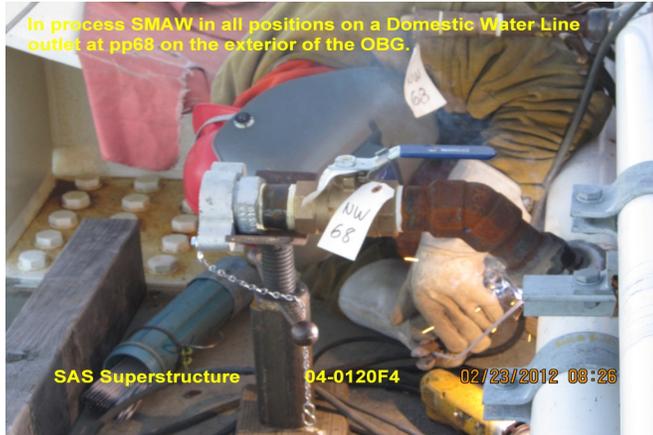
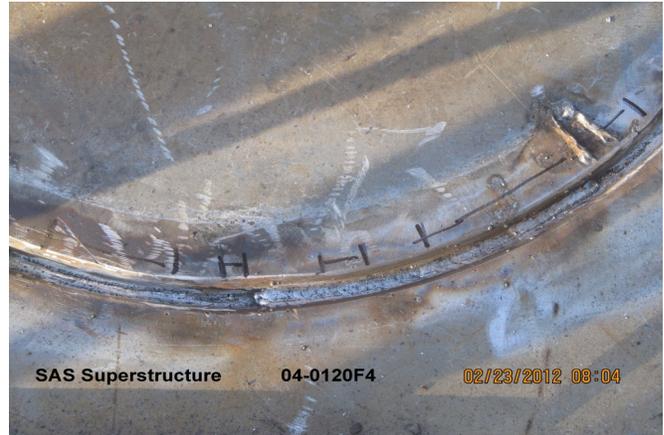
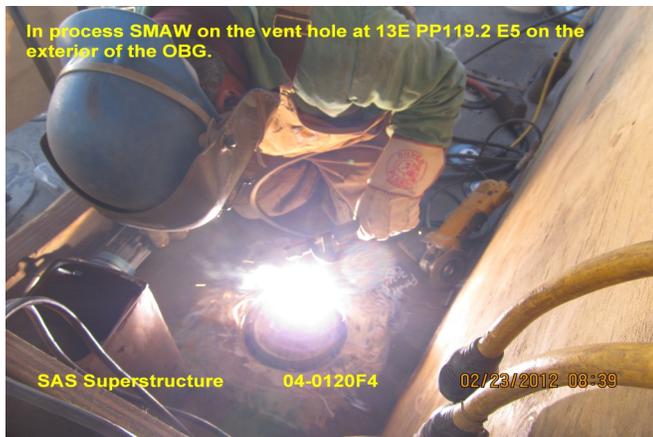
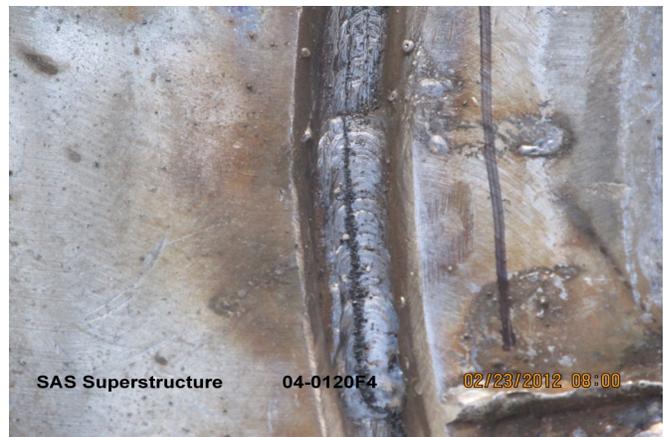
This QA Inspector noted that at the end of the shift on 2/22/2012, ABF welder Jason Collins (ID 8128) had completed the root pass implementing the Shielded Metal Arc Welding (SMAW) process pertaining to ABF-WPS-D1.5- 1010-Revision 1 on the deck access hole located at 8E PP71 E2 on the exterior of the OBG. This QA Inspector noted that the work appeared to be in general conformance with the contract documents. On this date at the beginning of the shift, this QA Inspector noted that a linear indication was present along the weld at the east end radius of the DAH joint. (See photos below). A TL-15 was generated on this date.

This QA Inspector randomly observed ABF welding personnel utilize a small disc grinder to remove the outer surface of the root pass down to smooth shiny metal. QC Inspector Chuck Storer was observed performing a Magnetic Particle (MT) inspection to test the soundness of the metal. It was noted that Mr. Storer found no rejectable indications. This QA Inspector randomly observed ABF welder Jason Collins perform the Flux Core Arc Welding with Gas (FCAW-G) process employing a Bug-O with a magnetic base in the 1G flat position on the radius of the B-U3-GF joint. The QC Inspector was observed monitoring the welding and the parameters to ensure compliance with ABF-WPS-D1.5-3010-1. The parameters at this location were recorded as: (A=229/V=23.7/TS=325/HI=1.0). This QA Inspector made subsequent observations throughout the shift to monitor quality and
