DEPARTMENT OF TRANSPORTATION

Quality Assurance and Source Inspection

Contract #: 04-0120F4Cty: SF/ALA Rte: 80 PM: 13.2/13.9File #: 1.28**WELDING INSPECTION REPORT****Resident Engineer:** Casey, William**Address:** 333 Burma Road**City:** Oakland, CA 94607**Report No:** WIR-027246**Date Inspected:** 27-Feb-2012**Project Name:** SAS Superstructure**OSM Arrival Time:** 700**Prime Contractor:** American Bridge/Fluor Enterprises, a JV**OSM Departure Time:** 1730**Contractor:** American Bridge/Fluor Enterprises, a JV**Location:** Job Site

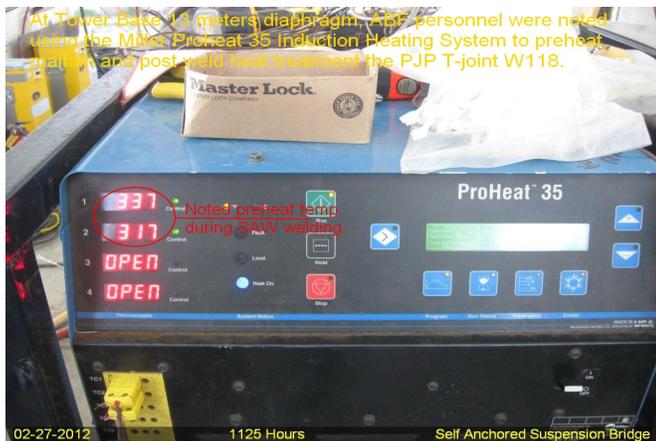
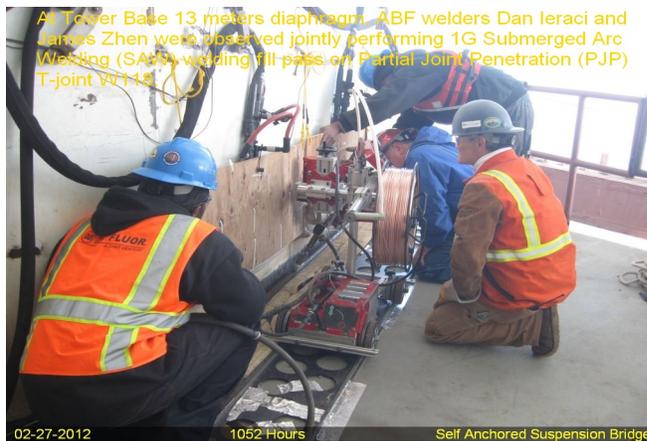
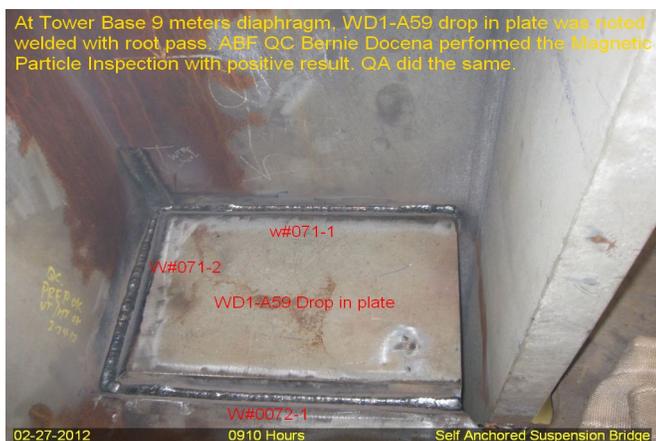
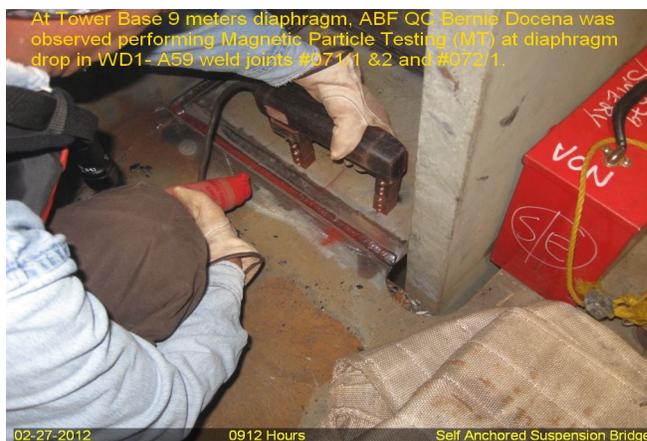
At Tower Base 13 meter external diaphragm, weld joint number W118, QA randomly observed ABF certified welder James Zhen ID #6001 and Dan Ieraci ID #3232 continuing to perform 1G (flat position) Submerged Arc Welding (SAW) on the Partial Joint Penetration (PJP) T- joint between the 45mm thick outer East diaphragm plate and 45mm thick Tower North Shaft skin plate 'B'. The welders were utilizing F7A6-EM12K-H8, 3.2mm electrode with corresponding Esab OK Flux 10.62 flux and implementing Caltrans approved Welding Procedure Specification (WPS) ABF-WPS-D15-4062-1. The joint being welded has a 45 degree bevel groove T- joint that was previously root pass welded using SMAW and tested by ABF QC and QA using Magnetic Particle Testing (MT). No relevant indications were observed. The plates were preheated to more than 225 °F using Miller Proheat 35 Induction Heating System with one heater blanket located on top of each plate prior welding and moving it to the side and lifting the other during welding. ABF/QC Harry Scharein was noted monitoring the welding parameters of the welder with measured working current of 560 amperes, 31.5 volts with travel speed of 375 mm per minute and calculated heat input of 2.8 Kjoules/mm. QA noted the welding parameters, the workmanship and appearance of the completed fill passes appeared to be satisfactory. At the end of the shift, SAW cover pass welding was completed. The preheat of more than 225 degrees Fahrenheit was held for three more hours after welding as required.

1. Outer West diaphragm drop in plate WD1-057 weld joint #064, ABF welder Wai Kitlai was observed continuing to perform welding on the PJP splice butt joint of 45mm drop in plate to 45mm thick diaphragm plate per Field Welding Schedule FWT29. The welder was noted welding at 1G utilizing a dual shield Flux Cored Arc Welding (FCAW-G) with E71T-1M, 1/16" diameter wire electrode and implementing Caltrans approved Welding Procedure Specification (WPS) ABF-WPS-D15-3160-1. The plates were preheated and maintained to required 225°F temperature using Miller Proheat 35 Induction Heating System. During the shift, cover pass FCAW welding on the W#064 was completed and the welder has held the same preheat of more than 225°F for three hours as required for the post weld heat treatment (PWHT).

2. Inner West diaphragm drop in plate WD1-A50 weld joint #067/#068, ABF welder Wai Kitlai was observed perform root pass welding on the PJP T-joint between the 45mm drop in plate and shear/tower skin plates and splice butt joint on drop in plate to diaphragm plate. After the welding completion of the root pass, ABF QC Bernie Docena was observed performing MT on the root welded T-joints and butt joint with positive result. This QA also performed random MT on the same welded root pass with noted same result. The welder resumed FCAW-G welding fill pass until the end of the shift without able to complete. The welder has held the same preheat of more than 225°F for three hours as required after welding.

3. Inner West diaphragm drop in plate WD1-A59 weld joint #071/#072, ABF welder Jin Pei Wang was observed perform root pass welding on the PJP T-joint between the 45mm drop in plate and shear/tower skin plates and splice butt joint on drop in plate to diaphragm plate. The welder was noted welding in the 1G position utilizing dual shield Flux Cored Arc Welding (FCAW-G) with E71T-1M, 1/16" diameter wire electrode and implementing Caltrans approved Welding Procedure Specification (WPS) ABF-WPS-D15-3160-1. The plates were preheated and maintained to required 225°F temperature using Miller Proheat 35 Induction Heating System. After the welding completion of the root pass, ABF QC Bernie Docena was observed performing MT on the root welded T-joints and butt joint. No relevant indications were observed. This QA also performed random MT on the same welded root pass with noted same results. The welder resumed FCAW-G welding fill pass to cover pass until the end of the shift where the welder has completed the three weld joints. The welder performed the post weld heat treatment (PWHT) using the same heating machine and held it for three hours as required.

4. Center diaphragm drop in plates WD1-A49, ABF welder Luo Xioa Hua was observed performing fit up/tack welding on the two drop in plates to shear plates and diaphragm plate. The welder was noted using Shielded Metal Arc Welding (SMAW) with 1/8" diameter E7018H4R electrode.
