Contract #: 04-0120F4Cty: SF/ALA Rte: 80 PM: 13.2/13.9File #: 1.28**WELDING INSPECTION REPORT**

Report No: WIR-027256
Date Inspected: 29-Feb-2012

Project Name: SAS Superstructure
Prime Contractor: American Bridge/Fluor Enterprises, a JV
Contractor: American Bridge/Fluor Enterprises, a JV

On this date, Quality Assurance Inspector (QAI) Kenneth Riley was present at the San Francisco Oakland Bay Bridge job site at Yerba Buena Island to observe erection and welding activities for the San Francisco Oakland Bay Bridge (SFOBB) project. This Quality Assurance Inspector (QAI) observed the following work performed by American Bridge/Fluor Enterprises (AB/F) personnel at the locations noted below:

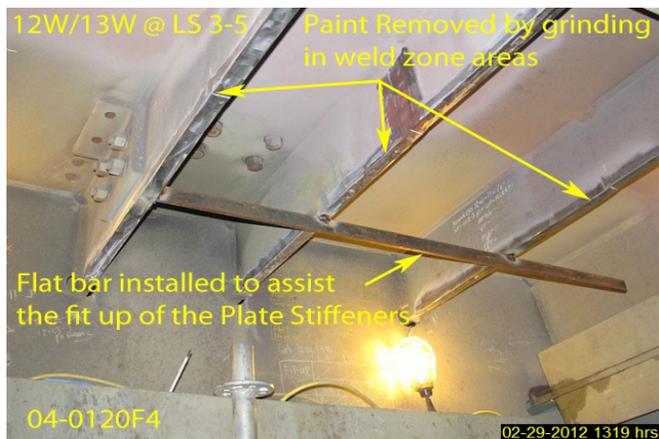
Plate Stiffeners

This QAI observed the contractor preparing plate stiffeners to be installed at 12W/13W @ LS 3-5. The material being prepped is Gr 485 plate stiffeners (ID X3847D-H & J and X4879D-H & J) the dimensions of the plate stiffeners are 18mm x 125 & 130mm x 1500mm Gr 485W. This QAI was informed by QC that a WPS was sent through on WQCP addendum 37; this QAI contacted the SMR Mr. Bahjat Dagher who verified the addendum to the WQCP and confirmed that ABF-WPS-D15-1162-4 had been approved by the department. This QAI spoke with the field lead QC and informed him that the WPS was approved and that no Non-Conformance Report (TL-15) would be generated. This QAI observed welder's Rory Hogan and Jeremy Dolman preparing the area at 12W/13W @ LS 3-5, for the plate stiffeners, the welders are using a section of flat bar to hold the plates in place while they perform the fit up and welding process. At this time the paint was being removed using a grinder on the LS stiffeners and Plate stiffeners where they would receive the Partial Joint Penetration weld (PJP). The location will be heated to a temperature of 100 degrees Celsius by thermocouples'. The welding position for this location will be in the overhead 4G position. The QC for this location is Salvador Merino who was observed as documenting the fit up progress.
