Contract #: 04-0120F4Cty: SF/ALA Rte: 80 PM: 13.2/13.9File #: 1.28**WELDING INSPECTION REPORT**

Report No: WIR-027315
Date Inspected: 03-Mar-2012

Project Name: SAS Superstructure
Prime Contractor: American Bridge/Fluor Enterprises, a JV
Contractor: American Bridge/Fluor Enterprises, a JV

1) 13M Diaphragm Welding

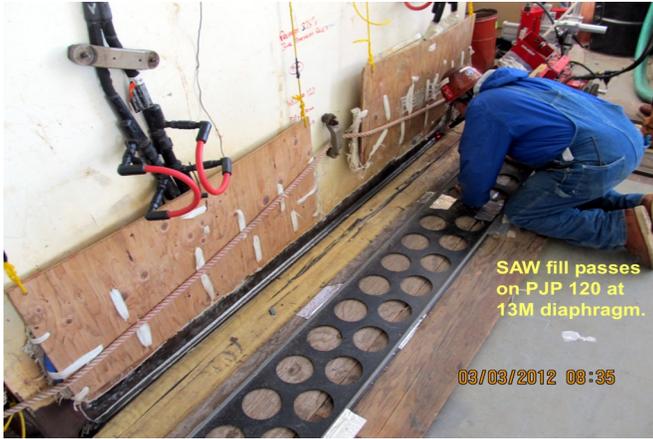
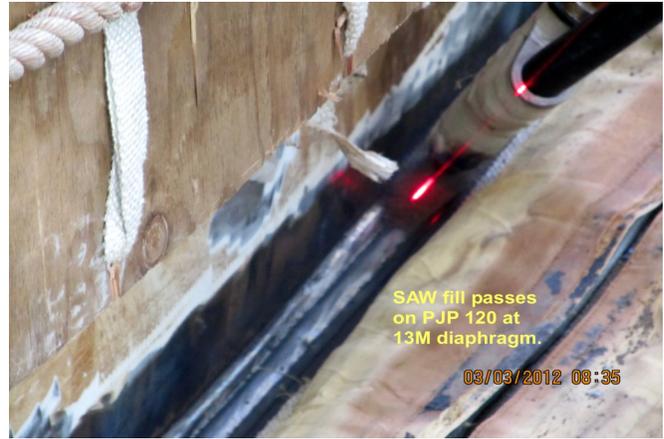
The QAI observed ABF personnel making a partial joint penetration (PJP) weld at the 13M diaphragm to the North tower shaft (weld #120). The QAI noted that ABF foreman / welder Dan Ieraci, ID 3232, is operating the Submerged Arc Welding (SAW) machine. The QAI noted that the Quality Control Inspector (QCI) Fred Von Hoff is monitoring this welding. At the start of shift, the QAI noted that the weld had previously been fit up and the root was welded. The QAI spoke with the QCI and was informed that there have been difficulties maintaining the preheat temperature and the weld has just gotten to the required 325°F. The QAI verified that the preheat temperature was conforming to the welding procedure specification (WPS) ABF-WPS-D15-4062-1. As the welding progressed, the QCI informed the QAI that the welding parameters were conforming to the WPS. The QAI made random observations of the work in progress during this shift. The QAI noted that fill and cover passes were being made. The QAI observed that the weld has incomplete ends and the QAI was informed that the ends will not be welded at this time. The QAI noted that after the center portion of the weld was completed, it was given 3 hours of post weld heating at 325°F. See the attached photos.
