**DEPARTMENT OF TRANSPORTATION**

Contract #: 04-0120F4Cty: SF/ALA Rte: 80 PM: 13.2/13.9File #: 1.28**WELDING INSPECTION REPORT****Resident Engineer:** Casey, William**Address:** 333 Burma Road**City:** Oakland, CA 94607**Report No:** WIR-027354**Date Inspected:** 21-Mar-2012**Project Name:** SAS Superstructure**OSM Arrival Time:** 800**Prime Contractor:** American Bridge/Fluor Enterprises, a JV**OSM Departure Time:** 1730**Contractor:** American Bridge/Fluor Enterprises, a JV**Location:** job site**CWI Name:** See below**CWI Present:** Yes No**Inspected CWI report:** Yes No N/A**Rod Oven in Use:** Yes No N/A**Electrode to specification:** Yes No N/A**Weld Procedures Followed:** Yes No N/A**Qualified Welders:** Yes No N/A**Verified Joint Fit-up:** Yes No N/A**Approved Drawings:** Yes No N/A**Approved WPS:** Yes No N/A**Delayed / Cancelled:** Yes No N/A**Bridge No:** 34-0006**Component:** OBG**Summary of Items Observed:**

**LSA 12E/13E-@LS5/LS6**

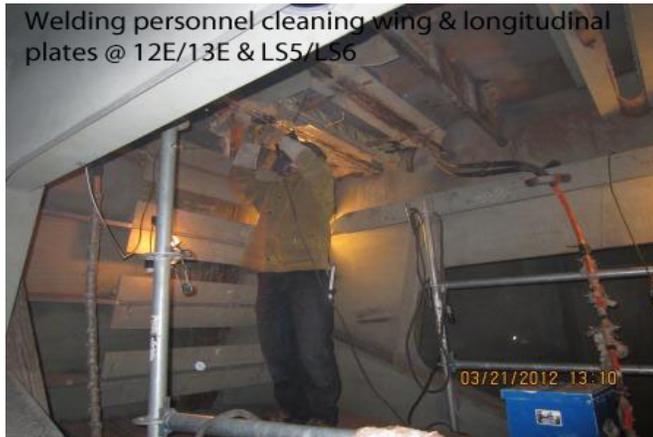
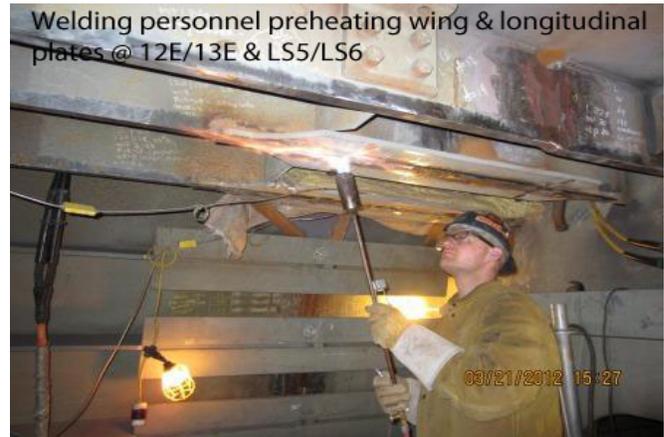
The QA Inspector observed welder Jeremy Dolman welding on the 18mm Wing Plate to the 35mm stiffener plate located on 12E/13E at LS5/LS6. The QA Inspector performed a random verification of the welding parameters at this location and were observed and noted at 130 amperes for Partial Joint Penetration (PJP) weld passes per Welding Procedure Specification (WPS) ABF-WPS-D15-1162-4. The QA Inspector verified the pre-heat temperature met the minimum requirement of 225 degrees Fahrenheit, but did not exceed the maximum allowable interpass temperature. The welder was observed using the proper cleaning procedures with slag hammers and wire brushes. The QA Inspector observed QC Inspector John Pagliero frequently monitoring the work in progress to ensure compliance with the contract specifications.

All work appears to be in general compliance with the contract documents.
