DEPARTMENT OF TRANSPORTATION

Quality Assurance and Source Inspection

Contract #: 04-0120F4Cty: SF/ALA Rte: 80 PM: 13.2/13.9File #: 1.28**WELDING INSPECTION REPORT****Resident Engineer:** Casey, William**Address:** 333 Burma Road**City:** Oakland, CA 94607**Report No:** WIR-027390**Date Inspected:** 29-Mar-2012**Project Name:** SAS Superstructure**OSM Arrival Time:** 700**Prime Contractor:** American Bridge/Fluor Enterprises, a JV**OSM Departure Time:** 1730**Contractor:** American Bridge/Fluor Enterprises, a JV**Location:** Job Site**CWI Name:** Bernie Docena**CWI Present:** Yes No**Inspected CWI report:** Yes No N/A**Rod Oven in Use:** Yes No N/A**Electrode to specification:** Yes No N/A**Weld Procedures Followed:** Yes No N/A**Qualified Welders:** Yes No N/A**Verified Joint Fit-up:** Yes No N/A**Approved Drawings:** Yes No N/A**Approved WPS:** Yes No N/A**Delayed / Cancelled:** Yes No N/A**Bridge No:** 34-0006**Component:** SAS Tower**Summary of Items Observed:**

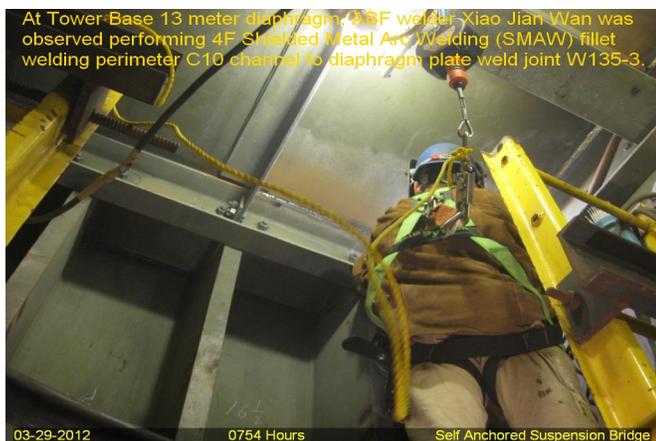
At Tower Base 13 meter North external diaphragm, this QA Inspector randomly observed ABF personnel Xiao Jian Wan continuing to perform 4F (overhead position) fillet production welding on the perimeter C10 channel to 45mm thick diaphragm plate fillet weld joint 135-3. The welder was noted welding 6mm fillet between one side of the channel top flange and diaphragm plate per detail 1 of the ZPMC drawing number FW3. The welder was using the 1/8" diameter E7018H4R electrode and implementing Caltrans approved Welding Procedure Specification (WPS) ABF-WPS-D15-F1200A. This QA Inspector observed ABF personnel using propylene gas torch to preheat the plates being welded prior welding. This QA Inspector observed QC Inspector Bernie Docena using a Fluke infra red temperature gauge to verify the preheat temperature of more than 150°F. This QA Inspector performed a verification of the welding parameters and observed 125 amperes on the 1/8" diameter electrode. The welding appeared to comply with Welding Procedure Specification (WPS) ABF-WPS-F1200A. At the end of the shift, SMAW fillet welding was completed.

At Tower Base 13 meter North external diaphragm, this QA Inspector randomly observed ABF personnel Luo Xiao Hua continuing to perform 4F (overhead position) fillet production welding on the perimeter C10 channel to 45mm thick diaphragm plate fillet weld joint 135-1 & 4. The welder was noted welding 6mm fillet between one side of the channel top flange and diaphragm plate per detail 1 of the ZPMC drawing number FW3. The welder was using the 1/8" diameter E7018H4R electrode and implementing Caltrans approved Welding Procedure

At Tower Base 13 meter North external diaphragm, this QA Inspector randomly observed ABF personnel Han Wen Yu perform 4F (overhead position) fillet production welding on the perimeter C10 channel to 45mm thick diaphragm plate fillet weld joint 135-2. The welder was noted welding 6mm fillet between one side of the channel top flange and diaphragm plate per detail 1 of the ZPMC drawing number FW3. The welder was using the 1/8" diameter E7018H4R electrode and implementing Caltrans approved Welding Procedure Specification (WPS) ABF-WPS-D15-F1200A. This QA Inspector observed ABF personnel using propylene gas torch to preheat the plates being welded prior welding. This QA Inspector observed QC Inspector Bernie Docena using a Fluke infra red temperature gauge to verify the preheat temperature of more than 150°F. This QA Inspector performed a verification of the welding parameters and observed 130 amperes on the 1/8" diameter electrode. The welding appeared to comply with Welding Procedure Specification (WPS) ABF-WPS-F1200A. At the end of the shift, SMAW fillet welding was still continuing and should remain tomorrow.

At Tower Base shear plate above 9 meter between inner East and outer East external diaphragms, this QA Inspector randomly observed ABF personnel Jin Pei Wang perform fit up and tack welding on the 18 1/2" diameter X 60mm thick doubler plate below the 9 meter diaphragm per ZPMC approved field drawing ED1-A29 A/B. The welder was noted tack welding the doubler plate to the 60 mm thick shear plate using Shielded Metal Arc Welding (SMAW) with 1/8" diameter E7018H4R electrode and implementing Caltrans approved Welding Procedure Specification (WPS) ABF-WPS-D15-F1200A. The doubler plate being welded was marked as weld joint A29 P1127 below 9M diaphragm. This QA Inspector observed ABF personnel using propylene gas torch to preheat the plates to more than 150°F prior welding. This QA Inspector observed QC Inspector Bernie Docena using a Fluke infra red temperature gauge to verify the preheat temperature of more than 150°F and measured the welding parameters to 130 amperes. After the completion of the fit up/tack welding, ABF QC has verified the fit up alignment and found it acceptable. This QA randomly verified the same fit up with noted same result. The welder performed the production welding using the same SMAW process with 5/32" diameter E7018H4R electrode until the end of the shift wherein the welder was not able to complete the 10mm fillet all around on both sides of the doubler plate.

At Tower Base 9 meter external diaphragm, this QA Inspector randomly observed ABF personnel Jin Pei Wang perform 2F (horizontal position) fillet production welding on the 25mm thick fit lug to the 45mm thick 9-meter outer East external diaphragm plate on one side and to the 65mm thick vertical stiffener plate on the other side. The welder was using the dual shielded Flux Cored Arc Welding (FCAW-G) with E71T-1M, 1/16" diameter wire electrode and implementing Caltrans approved Welding Procedure Specification (WPS) ABF-WPS-D15-F3200-2. This QA Inspector observed ABF personnel using propylene gas torch to preheat the plates being welded prior welding. This QA Inspector observed QC Inspector Bernie Docena using a Fluke infra red temperature gauge to verify the preheat temperature of more than 325°F. This QA Inspector performed a verification of the welding parameters and observed 273 amperes and 23.5 volts. The welding appeared to comply with Welding Procedure Specification (WPS) ABF-WPS-D15-F3200-2. During the shift, the welder has completed the 22mm fillet weld on

At Tower Base 9 meter external diaphragm, this QA Inspector randomly observed ABF personnel Wai Kitlai perform 2F (horizontal position) fillet production welding on the 25mm thick fit lug to the 45mm thick 9-meter outer East external diaphragm plate on one side and to the 65mm thick vertical stiffener plate on the other side. The welder was using the dual shielded Flux Cored Arc Welding (FCAW-G) with E71T-1M, 1/16" diameter wire electrode and implementing Caltrans approved Welding Procedure Specification (WPS) ABF-WPS-D15-F3200-2. This QA Inspector observed ABF personnel using propylene gas torch to preheat the plates being welded prior welding. This QA Inspector observed QC Inspector Bernie Docena using a Fluke infra red temperature gauge to verify the preheat temperature of more than 325°F. This QA Inspector performed a verification of the welding parameters and observed 286 amperes and 23.6 volts. The welding appeared to comply with Welding Procedure Specification (WPS) ABF-WPS-D15-F3200-2. During the shift, the welder has completed the 22mm fillet weld on two sides of the four (4) fit lugs marked W091-30 to W091-33.
