Contract #: 04-0120F4Cty: SF/ALA Rte: 80 PM: 13.2/13.9File #: 1x.28**WELDING INSPECTION REPORT****Resident Engineer:** Casey, William**Address:** 333 Burma Road**City:** Oakland, CA 94607**Report No:** WIR-027454**Date Inspected:** 13-Apr-2012**Project Name:** SAS Superstructure**OSM Arrival Time:** 700**Prime Contractor:** American Bridge/Fluor Enterprises, a JV**OSM Departure Time:** 1530**Contractor:** American Bridge/Fluor Enterprises, a JV**Location:** On Site**CWI Name:** Sal Marino**CWI Present:** Yes No**Inspected CWI report:** Yes No N/A**Rod Oven in Use:** Yes No N/A**Electrode to specification:** Yes No N/A**Weld Procedures Followed:** Yes No N/A**Qualified Welders:** Yes No N/A**Verified Joint Fit-up:** Yes No N/A**Approved Drawings:** Yes No N/A**Approved WPS:** Yes No N/A**Delayed / Cancelled:** Yes No N/A**Bridge No:** 34-0006**Component:** Bike Path Panel on Skyway Portion**Summary of Items Observed:**

CCO: 193 - Description: Modify the existing bikepath panels at the expansion joints of the Skyway portion of the SFOBB East Span Seismic Safety Program.

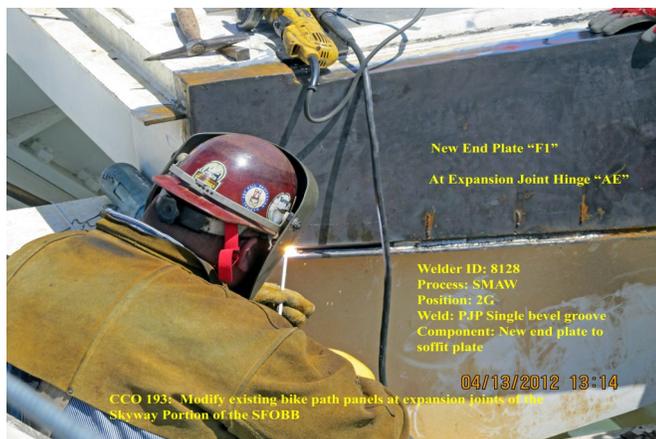
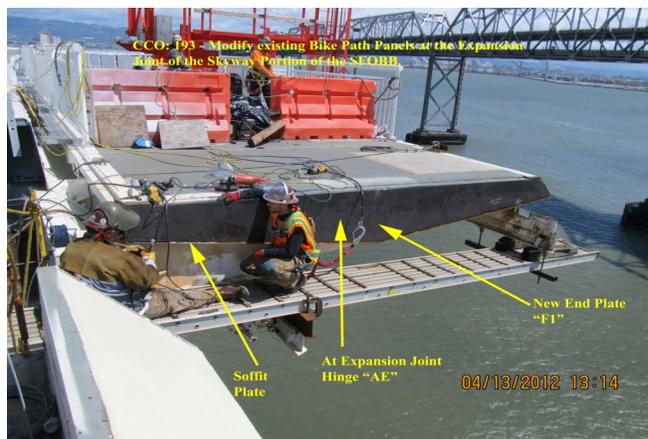
The root, fill, and cover pass weld operation connecting the new end plate "F1" to the existing bike path box panel's soffit plate was in-process at the end of this QA Inspector's shift.

At the Expansion Joint Hinge "AE", this QA Inspector previously observed ABF personnel cut back the existing bike path box panels' top, side, stiffener, and diaphragm plates for a distance of (616) mm using an oxyacetylene cutting torch on a track system and the existing bike path box panels' soffit plate for a distance of (600) mm on the existing bottom soffit plate of the bike path panel.

The cut back distances were detailed on ABF Submittal number 2549R2 ABN-404 sheet 4 of 6.
