DEPARTMENT OF TRANSPORTATION

Contract #: 04-0120F4Cty: SF/ALA Rte: 80 PM: 13.2/13.9File #: 1.28**WELDING INSPECTION REPORT****Resident Engineer:** Casey, William**Address:** 333 Burma Road**City:** Oakland, CA 94607**Report No:** WIR-027467**Date Inspected:** 20-Apr-2012**Project Name:** SAS Superstructure**OSM Arrival Time:** 700**Prime Contractor:** American Bridge/Fluor Enterprises, a JV**OSM Departure Time:** 1730**Contractor:** American Bridge/Fluor Enterprises, a JV**Location:** Job Site

WELDING INSPECTION REPORT

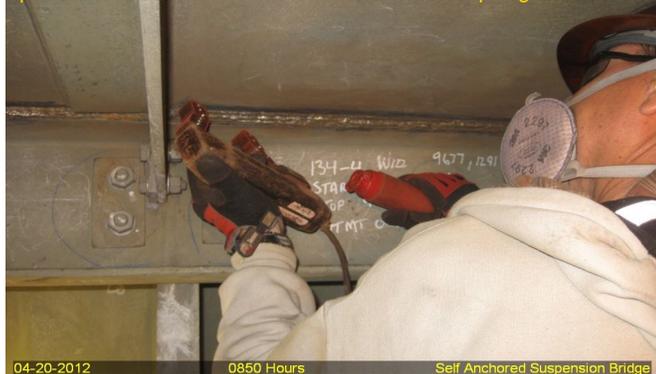
At Tower Base 13 meter diaphragm, ABF QC William Sherwood was observed performing Magnetic Particle Testing (MT) on fillet welded perimeter C10 channel to the bottom side of the diaphragm.

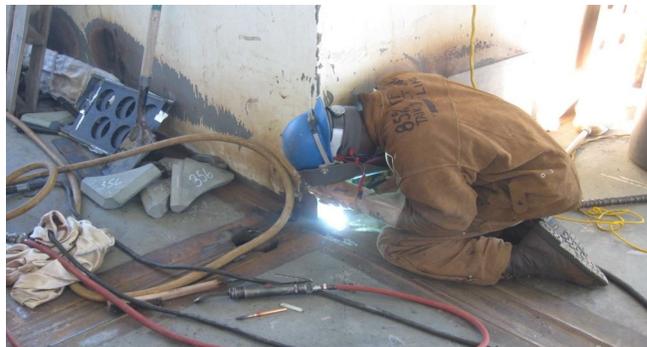
At Tower Base 13 meter diaphragm, ABF personnel Devan Murphy was noted continuing to perform carbon arc gouging on the ends/termination of the welded PJP T-joints W104, W105 and W120.

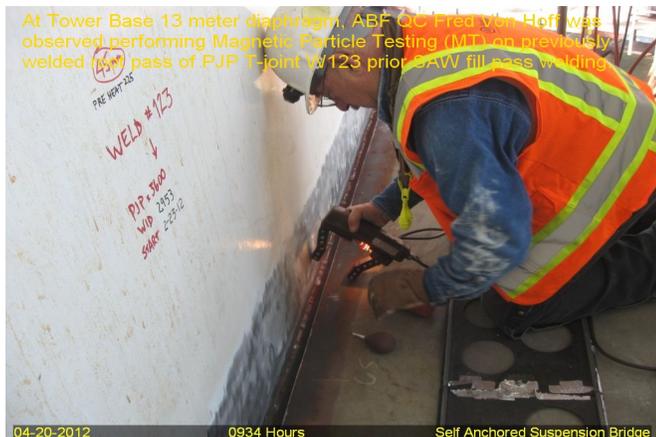
At Tower Base 13 meter diaphragm, ABF QC Fred Van Hoff was observed performing Magnetic Particle Testing (MT) on previously welded (PJP) pass of PJP T-joint W123 prior to SAW fill pass welding.

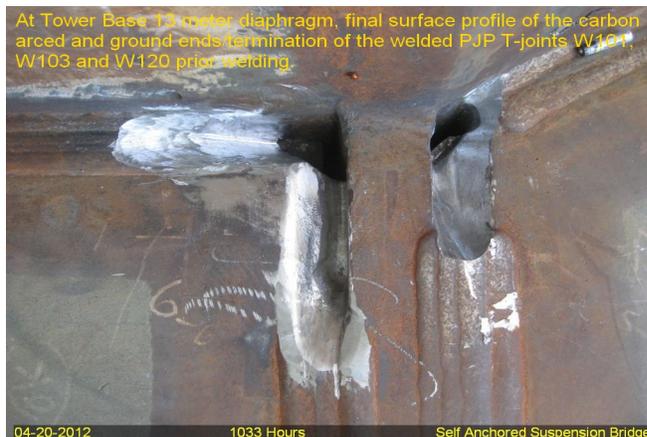
At Tower Base 13 meter diaphragm, final surface profile of the carbon arced and ground ends/termination of the welded PJP T-joints W104, W103 and W120 prior welding.
