Contract #: 04-0120F4Cty: SF/ALA Rte: 80 PM: 13.2/13.9File #: 1x.28**WELDING INSPECTION REPORT****Resident Engineer:** Casey, William**Address:** 333 Burma Road**City:** Oakland, CA 94607**Report No:** WIR-027522**Date Inspected:** 30-Apr-2012**Project Name:** SAS Superstructure**OSM Arrival Time:** 1300**Prime Contractor:** American Bridge/Fluor Enterprises, a JV**OSM Departure Time:** 1730**Contractor:** American Bridge/Fluor Enterprises, a JV**Location:** On Site**CWI Name:** Bernie Docena**CWI Present:** Yes No**Inspected CWI report:** Yes No N/A**Rod Oven in Use:** Yes No N/A**Electrode to specification:** Yes No N/A**Weld Procedures Followed:** Yes No N/A**Qualified Welders:** Yes No N/A**Verified Joint Fit-up:** Yes No N/A**Approved Drawings:** Yes No N/A**Approved WPS:** Yes No N/A**Delayed / Cancelled:** Yes No N/A**Bridge No:** 34-0006**Component:** SAS OBG Components**Summary of Items Observed:**

Segment 13E Grid Line E2.8 Deck Plate Drop-in Section Longitudinal Field Weld Splice

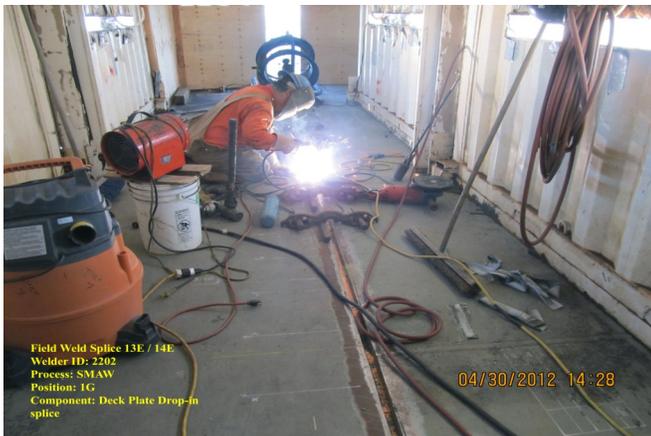
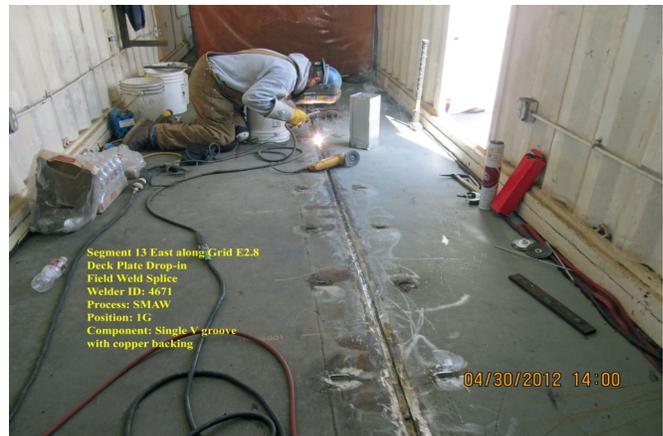
This QA Inspector observed ABF Welder Mike Jimenez (Welder ID 4671) performing the root pass weld operation per the Shielded Metal Arc Welding (SMAW) process in the (1G) flat position on the (top side) of the Deck Plate Drop-in Section Longitudinal Field Weld Splice on Segment 13E along Grid Line E2.8.

This QA Inspector observed ABF welder Salvador Sandoval (Welder ID 2202) performing the root pass weld operation per the Shielded Metal Arc Welding (SMAW) process in the (1G) flat position on the (top side) of the Deck Plate Drop-in Section Transverse Field Weld Splice on Segment 13E/14E.

This QA Inspector observed ABF Welder Steve Davis (Welder ID 7889) performing the root pass weld operation per the Shielded Metal Arc Welding (SMAW) process in the (1G) flat position on the (top side) of the Deck Plate Drop-in Section Transverse Field Weld Splice on Segment 13E along PP 122.2.
