**Report No:** WIR-027523  
**Date Inspected:** 30-Apr-2012

**Project Name:** SAS Superstructure  
**Prime Contractor:** American Bridge/Fluor Enterprises, a JV  
**Contractor:** American Bridge/Fluor Enterprises, a JV

## 13W PP120/PP124.7 Grid Line W2.0/W2.8 Deck Plate Drop-in Sections

# WELDING INSPECTION REPORT

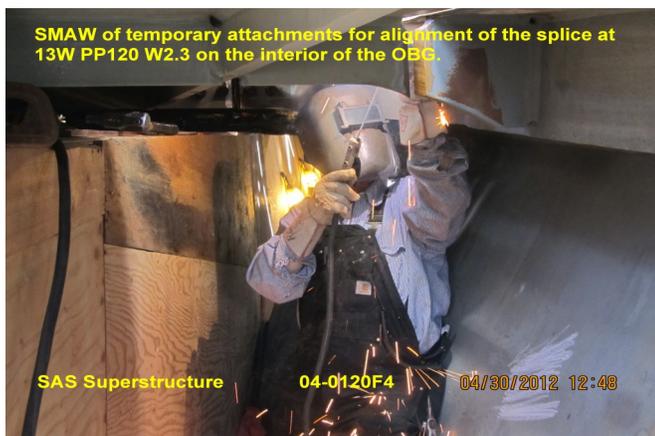
This QA Inspector made random observations of the fit-up operations of Drop in Panel SA3013A on the west OBG at 13W PP119.7-122.2. ABF Welding personnel were observed pre-heating the deck and this QA Inspector verified the pre-heat utilizing a 150° Tempilstik. ABF welder Rick Clayborn (ID 2773) was observed performing the fillet weld operation as pertaining to the Shielded Metal Arc Welding (SMAW) process to attach blank nuts and key plates along the W2.3 line. QC Inspector William Sherwood was present to monitor the welding as it pertained to ABF-WPS-D1.5-F1200A. Mr. Sherwood was observed measuring the planar offset by employing a Bridge Cam Gauge in order to locate alignment points at W2.1 line. On a subsequent observation, alignment work was being performed on A0 to A2.1. The welder was observed welding transverse to the roll of the steel as pertaining to submittal 1361 Revision 3. At periodic intervals, this QA Inspector observed the welder attaching blank nuts and key plates along W2.8 line in locations identified by the QC Inspector. This QA Inspector observed ABF Welder Todd Jackson (ID 4639) performing the fillet weld operation per the SMAW process in the (4F) overhead position to attach the U-Bars to the underside of the deck plate on Segment 13W. The work being performed was to augment the installation of the non-fusible copper backing bar prior to welding the complete-joint penetration (CJP) single V groove butt-joint between the Deck Plate section and Deck Plate Drop-in section at longitudinal field weld splice along Grid W2.8. On a subsequent observation, this QA Inspector

observed the welder performing the fillet weld operation per the SMAW process in the (2F) horizontal position attaching the blank nuts to the deck plate on line segment PPW 122.2 for installation of the key plates to adjust the longitudinal weld splice planar offset between the Deck Plate section and Deck Plate Drop-in section at transverse field weld splice 13W/14W on PP125, longitudinal field weld splice along Grid A2.1 and Grid W2.2. This QA Inspector observed QC Inspector William Sherwood verify prior to the start of the fillet weld operation, that the minimum preheat temperature as per the approved WPS was established; and afterward's verified that the welding parameters (Amps and Travel Speed) were in accordance with WPS F1200A using E7018 3.2mm diameter electrodes. Welder Todd Jackson was continuing performing the fillet weld operation per the SMAW process in the (4F) overhead position to attach the U-Bars to the underside of the deck plate on Segment 13W. The work being performed was to augment the installation of the non-fusible copper backing bar prior to welding the complete-joint penetration (CJP) single V groove butt-joint between the Deck Plate section and Deck Plate Drop-in section at longitudinal field weld splice along Grid W2.5. This QA Inspector made subsequent observations throughout the shift to monitor quality and noted that the work is in progress and appeared to be in general conformance with the contract documents.
