**DEPARTMENT OF TRANSPORTATION**

Contract #: 04-0120F4Cty: SF/ALA Rte: 80 PM: 13.2/13.9File #: 1x.28**WELDING INSPECTION REPORT****Resident Engineer:** Casey, William**Address:** 333 Burma Road**City:** Oakland, CA 94607**Report No:** WIR-027550**Date Inspected:** 03-May-2012**Project Name:** SAS Superstructure**OSM Arrival Time:** 700**Prime Contractor:** American Bridge/Fluor Enterprises, a JV**OSM Departure Time:** 1730**Contractor:** American Bridge/Fluor Enterprises, a JV**Location:** On Site**CWI Name:** Tony Sherwood**CWI Present:** Yes No**Inspected CWI report:** Yes No N/A**Rod Oven in Use:** Yes No N/A**Electrode to specification:** Yes No N/A**Weld Procedures Followed:** Yes No N/A**Qualified Welders:** Yes No N/A**Verified Joint Fit-up:** Yes No N/A**Approved Drawings:** Yes No N/A**Approved WPS:** Yes No N/A**Delayed / Cancelled:** Yes No N/A**Bridge No:** 34-0006**Component:** SAS OBG Components**Summary of Items Observed:**

### Segment 13E PP122.2 Deck Plate Drop-in Section Transverse Field Weld Splice - (8600 mm)

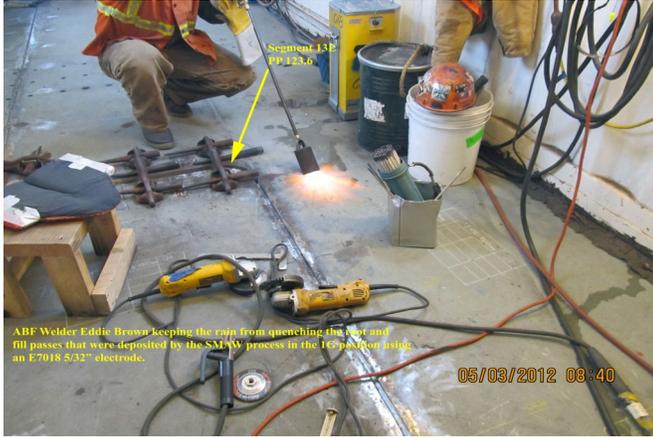
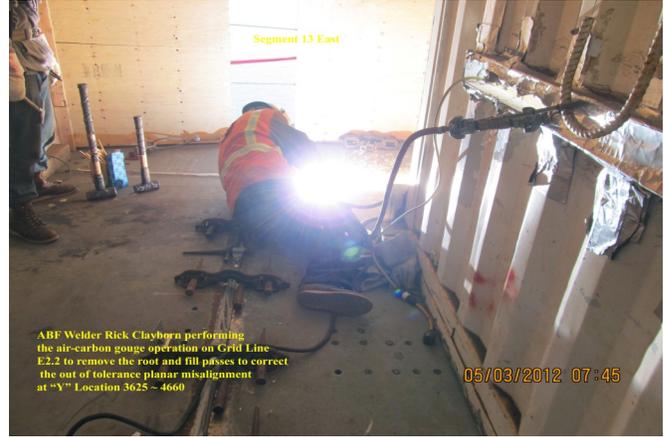
This QA Inspector observed ABF Welder Rick Clayborn (Welder ID 2773) removing the root and fill passes previously deposited by the air-carbon-arc method to adjust the out of tolerance planar mis-alignment between the deck plate and the deck plate drop-in section at (5) five locations. The "Y" locations and length of excavations performed were on Segment 13 East are as follows:

At all (5) five of the locations mentioned above the Engineer was not notified before the excavation of the root and fill passes at the above locations commenced. This QA Inspector notified Lead Inspector Danny Reyes of the work being performed to correct the planar misalignment at these locations and provided the "Y" locations and the total length of the excavations to be incorporated into a weld map and submitted to QA Task Leader Bill Levell and SMR Bajat Dagher for review and disposition.
