Contract #: 04-0120F4Cty: SF/ALA Rte: 80 PM: 13.2/13.9File #: 1.28**WELDING INSPECTION REPORT****Resident Engineer:** Casey, William**Address:** 333 Burma Road**City:** Oakland, CA 94607**Report No:** WIR-027565**Date Inspected:** 02-May-2012**Project Name:** SAS Superstructure**OSM Arrival Time:** 700**Prime Contractor:** American Bridge/Fluor Enterprises, a JV**OSM Departure Time:** 1730**Contractor:** American Bridge/Fluor Enterprises, a JV**Location:** Job site**CWI Name:** Bernard Docena**CWI Present:** Yes No**Inspected CWI report:** Yes No N/A**Rod Oven in Use:** Yes No N/A**Electrode to specification:** Yes No N/A**Weld Procedures Followed:** Yes No N/A**Qualified Welders:** Yes No N/A**Verified Joint Fit-up:** Yes No N/A**Approved Drawings:** Yes No N/A**Approved WPS:** Yes No N/A**Delayed / Cancelled:** Yes No N/A**Bridge No:** 34-0006**Component:** Tower**Summary of Items Observed:**

A). Outer East Tower Base-Bearing Plate Assembly

B). Outer West Tower Base-Bearing Plate Assembly

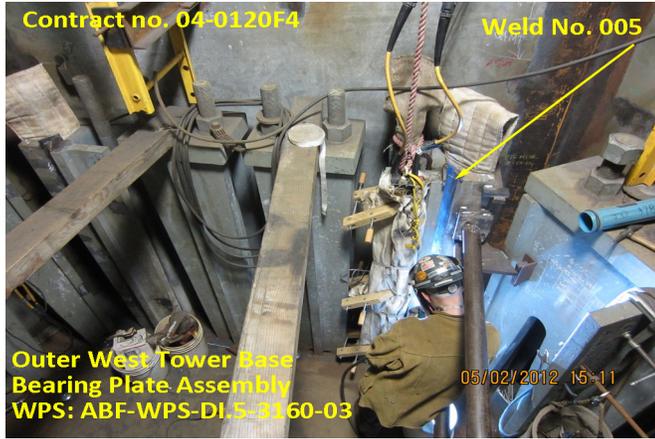
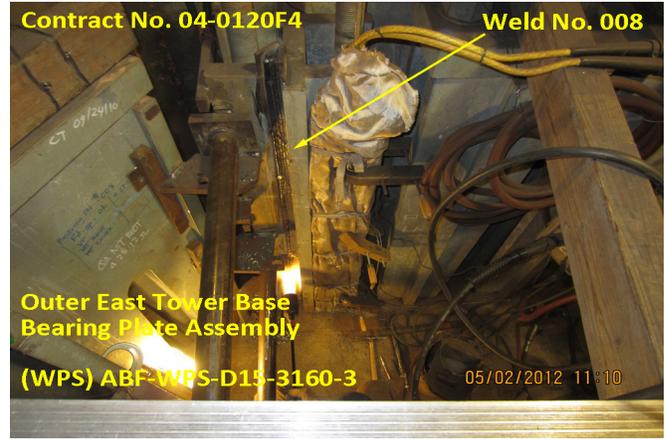
This QAI observed that welder Richard Garcia was welding the Bearing Plate Assembly, Weld No. 008. This QAI observed these parameters as defined in Welding Procedure Specification (WPS) ABF-WPS-D15-3160-3. The QC inspector Bernard Docena verified the fit up for this location and found it to be acceptable, this information was relayed to the QAI. The welder then continued pre-heat throughout the area during welding using a propane type weed burner and heat rack at 110 degrees Celsius (225 degrees F) which was verified using a tempstik and infrared gun by the QC. The welder was using the Flux Cored Arc Welding (FCAW) electrode E71T-1M/T-9M for the Partial Joint Penetration (PJP) weld in the vertical (3G) position with 1.6 mm wire. The welding parameters were verified as 252 amps, 23.5volts and 1.12 k/j Heat index. The welder utilized a power grinder and power wire wheel for the inter-pass cleaning. The QC inspector for this location was Bernard Docena and was observed verifying and documenting the welding parameters for this location, along with overseeing the welding operations. At the time METS observation was performed. No issues were noted by the QAI.

The welder was grinding the starts and stops between weld layers to a bright metal. The location was still in process at the end of this QAI's shift.

This QAI observed that welder Jeremy Dolman was welding the Bearing Plate Assembly, Weld No. 005. This QAI observed these parameters as defined in Welding Procedure Specification (WPS) ABF-WPS-D15-3160-3. The QC inspector Bernard Docena verified the fit up for this location and found it to be acceptable, this information was relayed to the QAI. The welder then continued pre-heat throughout the area during welding using a propane type weed burner and heat rack at 110 degrees Celsius (225 degrees F) which was verified using a tempstik and infrared gun by the QC. The welder was using the Flux Cored Arc Welding (FCAW) electrode E71T-1M/T-9M for the Partial Joint Penetration (PJP) weld in the vertical (3G) position with 1.6 mm wire. The welding parameters were verified as 248 amps, 23.0volts and 1.11 k/j Heat index. The welder utilized a power grinder and power wire wheel for the inter-pass cleaning. The QC inspector for this location was Bernard Docena and was observed verifying and documenting the welding parameters for this location, along with overseeing the welding operations. At the time METS observation was performed. No issues were noted by the QAI.
