Quality Assurance and Source Inspection

Contract #: 04-0120F4Cty: SF/ALA Rte: 80 PM: 13.2/13.9File #: 1.28**WELDING INSPECTION REPORT****Resident Engineer:** Casey, William**Address:** 333 Burma Road**City:** Oakland, CA 94607**Report No:** WIR-027568**Date Inspected:** 08-May-2012**Project Name:** SAS Superstructure**OSM Arrival Time:** 700**Prime Contractor:** American Bridge/Fluor Enterprises, a JV**OSM Departure Time:** 1730**Contractor:** American Bridge/Fluor Enterprises, a JV**Location:** Job Site

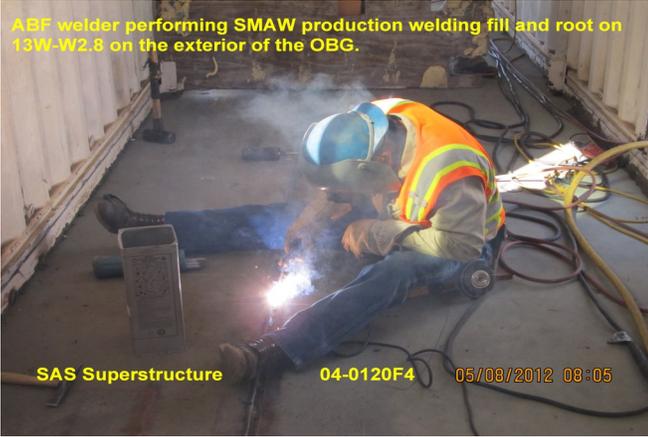
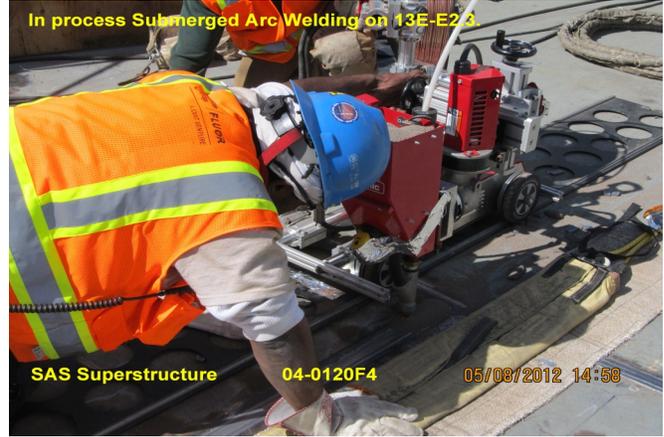
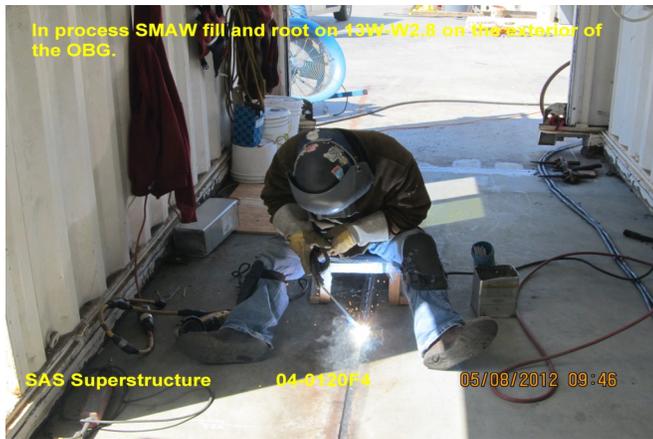
This QA Inspector randomly observed ABF welder Steve Davis (ID 7889) pre-heat the Complete Joint Penetration (CJP) joint along 13W-W2.8 at y+12000mm and ABF welder Khit Lounechaney (ID 4985) pre-heat the joint along y+100mm. QC Inspector Sal Merino verified the correct temperature as per the approved WPS and afterward's verified that the welding parameters (Amps and Travel Speed) were in accordance with ABF-WPS-D1. 5-1040C-CU using E7018 4.0mm diameter electrodes drawing amperage of 180 for Mr. Davis and 226 amperes with 4.8mm electrodes for Mr. Lounechaney. This QA Inspector observed the welders performing the Shielded Metal Arc Welding (SMAW) process in the 1G flat positions continuing root and fill welding at y+12000mm to y+6000mm and y+100mm to y+6000mm respectively. The welders were observed cleaning the start/stop edges of the work utilizing small disc grinders to smooth and blend the transitions and compressed air to clear the debris. On a subsequent observation, the welders were noted as continuing the production welding and between passes the QC Inspector verified the welding parameters and surface temperatures utilizing a Fluke 337 clamp meter to measure the electrical welding parameters and Tempilstik Heat Indicators for verifying the preheat and inter-pass temperatures. This QA Inspector noted that the electrodes were stored in electrically heated, thermostatically controlled oven after removal from the sealed containers. The exposure limits of the electrodes appeared to comply with the minimum storage oven temperature of 120 degrees Celsius as per the contract documents. At

approximately the middle of the shift, this QA Inspector observed that Mr. Davis had completed approximately 10mm of fill from y+100mm to y+600mm and had relocated to 13W-W2.0 line at y+100mm. The welder was observed pre-heating the joint and upon verification by QC, commenced the SMAW process in the 1G flat position. On a subsequent observation, the welders were observed continuing the production root and fill welding and this QA Inspector noted that no issues had arisen. This QA Inspector made subsequent observations to monitor quality and noted that the work at 13W-W2.8 and 13W-W2.0 was in progress and appeared to be in general conformance with the contract documents.

This QA Inspector observed ABF welder Mike Jimenez (ID 4671) performing the root and fill pass weld operation per the SMAW process in the 1G flat position on the (top side) of the Deck Plate Drop-in Section on Segment 13W along PP121.6 at y+2175mm, ABF welder Edward Brown (ID 9331) and ABF welder Jacob Stafford (ID 8020) performing the root and fill pass weld operation per the SMAW process in the 1G flat position on the (top side) of the Deck Plate Drop-in Section on Segment 13E along A.0 at y+1400mm, and ABF welder Salvador Sandoval (ID 2202) performing SMAW in the 1G flat position at 13E-A2.1. This QA Inspector observed QC Inspector William Sherwood verify prior to the start of the root and fill pass weld operation, that the minimum preheat temperature as per the approved WPS was established; and afterward's verified that the welding parameters (Amps and Travel Speed) were in accordance with WPS D1.5-1040C-CU Revision 0 using E7018 3.2mm diameter electrodes. This QA Inspector noted that for the three (3) welders that the 3.2mm electrodes were stored in electrically heated, thermostatically controlled oven after removal from the sealed containers. The exposure limits of the electrodes appeared to comply with the minimum storage oven temperature of 120 degrees Celsius as per the contract documents. The welding parameters and surface temperatures were verified by the QC inspector's utilizing a Fluke 337 clamp meter to measure the electrical welding parameters and Tempilstik Heat Indicators for verifying the preheat and inter-pass temperatures. This QA Inspector observed ABF welder Kenneth Chappell (ID 3833) performing Submerged Arc Welding (SAW) utilizing a Lincoln track mounted wire feeder at 13E-E2.3. It was also noted that the remote oven for the ESAB EN 760 Flux was in the on position with the dial set at 250° F. ABF welding Superintendent Dan Ieraci provided a remote temperature gauge to verify the flux temperature inside of the oven. This QA Inspector verified that the F7A2-EM12KH8 electrode spool was compliant with ABF-WPS-D1.5-4042B-Revision 1. QC Inspector William Sherwood measured the parameters for amperage, volts, travel speed and the heat input as the welder adjusted the controls on the Lincoln track mounted wire feeder. This QA Inspector made subsequent observations to monitor quality and noted that the production work by the welders was in progress and appeared to be in general conformance with the contract documents.
