Contract #: 04-0120F4Cty: SF/ALA Rte: 80 PM: 13.2/13.9File #: 1.28**WELDING INSPECTION REPORT****Resident Engineer:** Casey, William**Address:** 333 Burma Road**City:** Oakland, CA 94607**Report No:** WIR-027569**Date Inspected:** 09-May-2012**Project Name:** SAS Superstructure**OSM Arrival Time:** 700**Prime Contractor:** American Bridge/Fluor Enterprises, a JV**OSM Departure Time:** 1730**Contractor:** American Bridge/Fluor Enterprises, a JV**Location:** Job Site

Bridge No: 34-0006**Summary of Items Observed:**

WELDING INSPECTION REPORT

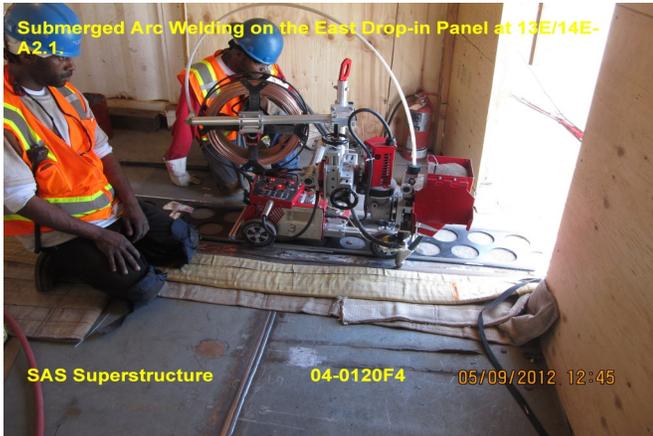
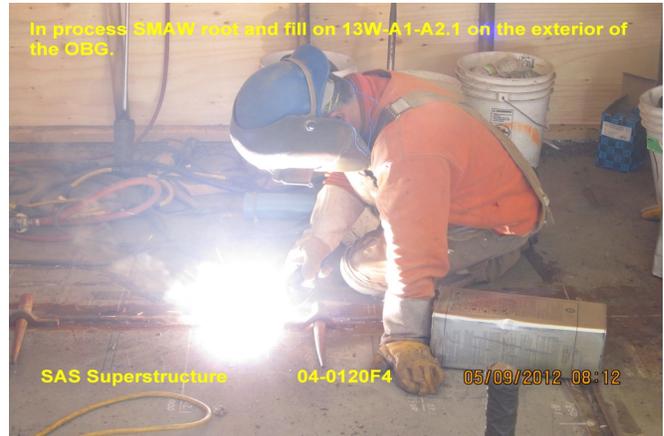
utilizing E7018-H4R electrodes on the modification plates for the suspender brackets at 11E PP104. The work required a 12mm fillet in the 4F and 2F with a 22mm fillet in the 3F vertical positions. QC Inspector William Sherwood was present to monitor the welding and the parameters as they pertained to ABF-WPS-D1.5-F1200A. This QA Inspector made subsequent observations throughout the shift to monitor quality and noted that the work at this location had been completed on this date and appeared to be in general conformance with the contract documents.
