**DEPARTMENT OF TRANSPORTATION**

Contract #: 04-0120F4Cty: SF/ALA Rte: 80 PM: 13.2/13.9File #: 1.28**WELDING INSPECTION REPORT****Resident Engineer:** Casey, William**Address:** 333 Burma Road**City:** Oakland, CA 94607**Report No:** WIR-027588**Date Inspected:** 10-May-2012**Project Name:** SAS Superstructure**OSM Arrival Time:** 700**Prime Contractor:** American Bridge/Fluor Enterprises, a JV**OSM Departure Time:** 1730**Contractor:** American Bridge/Fluor Enterprises, a JV**Location:** Job Site

**Bridge No:** 34-0006**Component:** SAS Tower**Summary of Items Observed:**

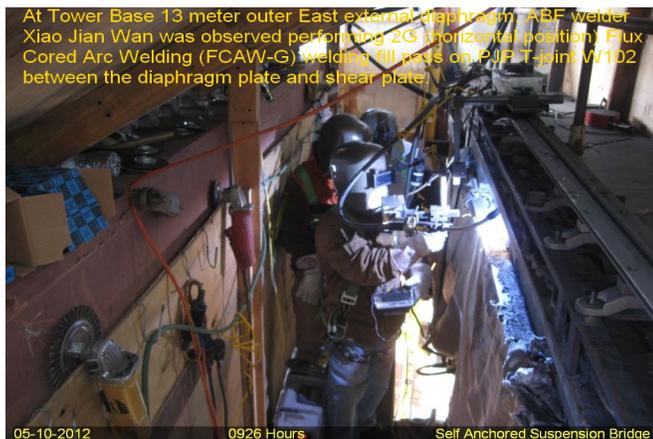
At Tower Base 13 meter outer East external diaphragm, QA randomly observed ABF/JV qualified welder Xiao Jian Wan continuing to perform Partial Joint Penetration (PJP) T-joint welding fill pass on 80mm thick shear plate to 45mm thick diaphragm plate weld joint #W102. The welder was observed welding in the 2G (horizontal) position utilizing a dual shield Flux Cored Arc Welding (FCAW-G) with E71T-1M, 1/16" diameter wire electrode and implementing Caltrans approved Welding Procedure Specification (WPS) ABF-WPS-D15-3160-1. The welder was using a track mounted welder holder assembly that was remotely controlled. The PJP T-joint was preheated to greater than 325 degrees Fahrenheit using Miller Proheat 35 Induction Heating System with the heater blankets located on top of the plate prior welding. During welding, ABF Quality Control (QC) Fred Von Hoff was noted monitoring the welding parameters of the welder. Measured welding parameters during welding were 240 amperes, 23.5 volts and 325mm travel speed. Calculated heat input was 1.04 Kjoules/mm which appears in compliance to the contract requirements. At the end of the shift, FCAW-G fill pass welding was still continuing and should remain tomorrow. The welder held the preheat using the same Miller Proheat 35 Heating System for three hours after welding as required.

At Tower Base 9 meter outer East external diaphragm, this QA Inspector randomly observed ABF personnel Richard Garcia continuing to perform 4F (overhead position) fillet production welding on the C10 channel to 45mm thick diaphragm plate fillet weld joint W098. The welder was noted welding 6mm fillet between one side

of the channel top flange and diaphragm plate per detail 1 of the ZPMC drawing number FW3. The welder was using the 1/8" diameter E7018H4R electrode and implementing Caltrans approved Welding Procedure Specification (WPS) ABF-WPS-D15-F1200A. This QA Inspector observed ABF personnel using propylene gas torch to preheat the plates being welded prior welding. This QA Inspector observed QC Inspector Bernie Docena using a Fluke infra red temperature gauge to verify the preheat temperature of more than 150°F. This QA Inspector performed a verification of the welding parameters and observed 130 amperes on the 3.2mm diameter electrode. The welding appeared to comply with Welding Procedure Specification (WPS) ABF-WPS-F1200A. At the end of the shift, the welder has completed the 6mm fillet weld on outer East diaphragm.
