**DEPARTMENT OF TRANSPORTATION**

Contract #: 04-0120F4Cty: SF/ALA Rte: 80 PM: 13.2/13.9File #: 1.28**WELDING INSPECTION REPORT****Resident Engineer:** Casey, William**Address:** 333 Burma Road**City:** Oakland, CA 94607**Report No:** WIR-027642**Date Inspected:** 22-May-2012**Project Name:** SAS Superstructure**OSM Arrival Time:** 700**Prime Contractor:** American Bridge/Fluor Enterprises, a JV**OSM Departure Time:** 1730**Contractor:** American Bridge/Fluor Enterprises, a JV**Location:** Job Site**CWI Name:** As noted below.**CWI Present:** Yes No**Inspected CWI report:** Yes No N/A**Rod Oven in Use:** Yes No N/A**Electrode to specification:** Yes No N/A**Weld Procedures Followed:** Yes No N/A**Qualified Welders:** Yes No N/A**Verified Joint Fit-up:** Yes No N/A**Approved Drawings:** Yes No N/A**Approved WPS:** Yes No N/A**Delayed / Cancelled:** Yes No N/A**Bridge No:** 34-0006**Component:** Tower Component**Summary of Items Observed:**

**Tower**

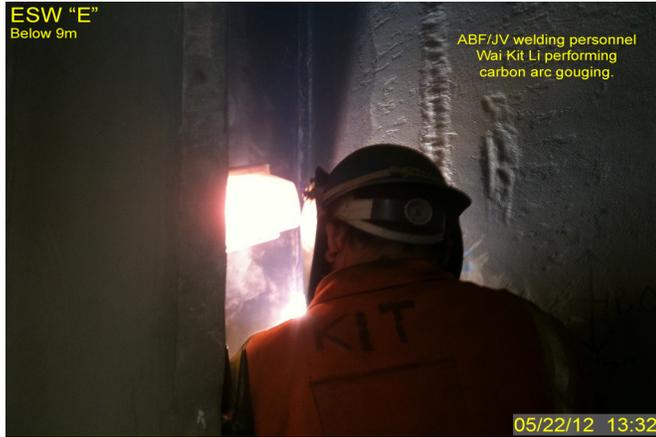
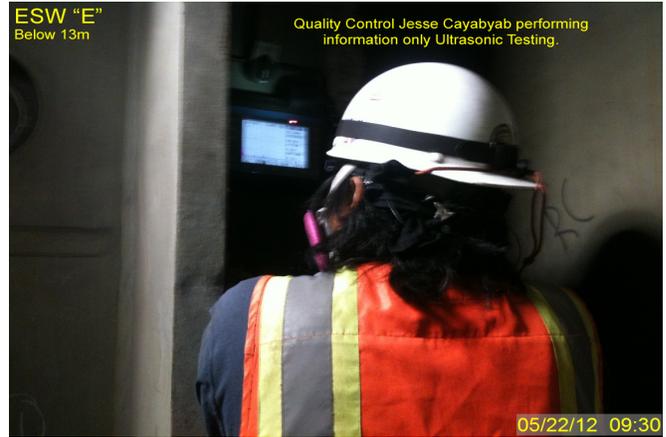
This QA observed, at random intervals, ABF/JV qualified welder Richard Garcia #5892 performing Shielded Metal Arc Welding (SMAW) with 3.2mm diameter E7018H4R electrode and implementing Caltrans approved Welding Procedure Specification (WPS) ABF-WPS-D15-1160. The joint being welded was Weld #W007 at Tower Shear Base Assembly designated as ED1-829.

This QA randomly observed ABF/JV welding personnel performing excavation of welds previously Ultrasonic Testing (UT) rejected. Excavations are currently in process, QC has not performed Magnetic Particle Testing (MT) at this time.

Electroslag Welds (ESW) "E" and "M" are currently being excavated.
