**DEPARTMENT OF TRANSPORTATION**

Contract #: 04-0120F4Cty: SF/ALA Rte: 80 PM: 13.2/13.9File #: 1.28**WELDING INSPECTION REPORT****Resident Engineer:** Casey, William**Address:** 333 Burma Road**City:** Oakland, CA 94607**Report No:** WIR-027651**Date Inspected:** 24-May-2012**Project Name:** SAS Superstructure**OSM Arrival Time:** 700**Prime Contractor:** American Bridge/Fluor Enterprises, a JV**OSM Departure Time:** 1730**Contractor:** American Bridge/Fluor Enterprises, a JV**Location:** Job Site**CWI Name:** Andrew Keach**CWI Present:** Yes No**Inspected CWI report:** Yes No N/A**Rod Oven in Use:** Yes No N/A**Electrode to specification:** Yes No N/A**Weld Procedures Followed:** Yes No N/A**Qualified Welders:** Yes No N/A**Verified Joint Fit-up:** Yes No N/A**Approved Drawings:** Yes No N/A**Approved WPS:** Yes No N/A**Delayed / Cancelled:** Yes No N/A**Bridge No:** 34-0006**Component:** SAS Tower**Summary of Items Observed:**

Caltrans Office of Structural Material (OSM) Quality Assurance Inspector (QAI) Joselito Lizardo was present at the Self Anchored Suspension (SAS) job site as requested to perform observations on the welding of components for the San Francisco Oakland Bay

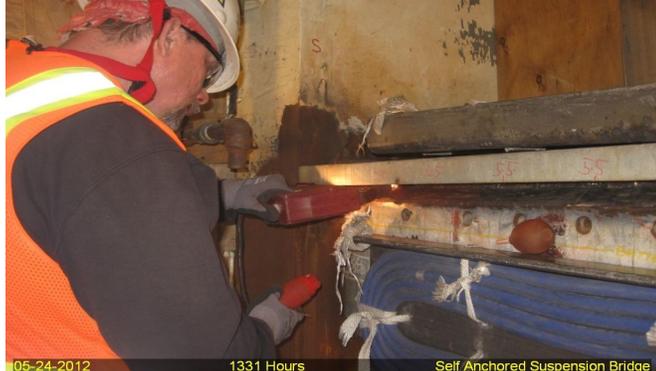
05-24-2012 1331 Hours Self Anchored Suspension Bridge

At Tower Base 13 meter South external diaphragm, ABF QC Andrew Keach was observed performing Magnetic Particle Testing (MT) on welded root pass of the diaphragm to shear plate PJP T-joint W111.

At Tower Base 13 meter outer West external diaphragm, ABF welder Xiao Jian Wan was observed perform buttering on the one side of the PJP T-joint W111 due to excessive root gap as previously reported. The welder was noted buttering where the maximum measured root opening was measured 6.0mm. The welder was noted buttering at overhead position using Shielded Metal Arc Welding (SMAW) with 3.2mm diameter E7018H4R electrode implementing Caltrans approved Welding Procedure Specification (WPS) ABF-WPS-D15- F1200A. The diaphragm plate being buttered was noted preheated to more than 150°F using propylene gas torch. During the shift, buttering on the PJP T-joint W111 was completed. After the buttering completion, ABF QC Andrew was observed performing Visual Test (VT) and Magnetic Particle Testing (MT) and found no relevant indication during the test. This QA also performed MT verification on the same buttering and noted same result.

After the completion of MT, the same welder resumed welding the root pass of the PJP T-joint mentioned above. The welder was noted using the same process but implemented Caltrans approved Welding Procedure Specification (WPS) ABF-WPS-D15-1160. The same QC also monitored the welding parameters during root pass welding. ABF QC Andrew Keach performed the VT/MT after the completion of the root pass and found no relevant indication during the test. This QA performed the same MT verification and noted same result.

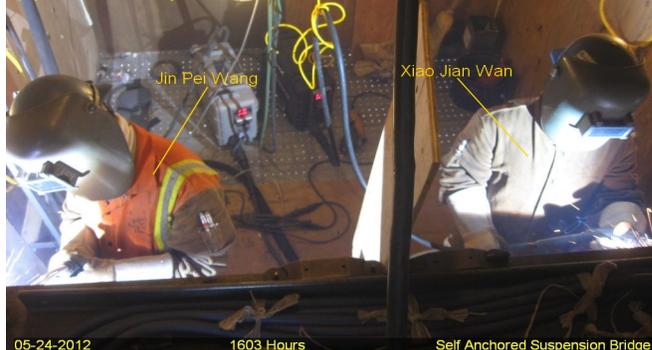
05-24-2012 1603 Hours Self Anchored Suspension Bridge

At Tower Base 13 meter South external diaphragm, ABF welders Xiao Jian Wan and Jin Pei Wang were observed performing side by side 2G (horizontal) position Flux Cored Arc Welding (FCAW-G) welding fill pass on PJP T-joint W111.

This QA noted two ABF welders performed the manual Flux Cored Arc Welding (FCAW-G) welding fill pass on PJP T-joint W111 after the completion of the MT. ABF welders Xiao Jian Wan and Jin Pei Wang were noted 2G (horizontal) position welding side by side using dual shield Flux Cored Arc Welding (FCAW-G) with E71T-1M, 1/16" diameter wire electrode and implementing Caltrans approved Welding Procedure Specification (WPS) ABF-WPS-D15-3160-1. The diaphragm plate and shear plate being welded were noted preheated to more than 225°F using Miller Proheat 35 Induction Heating System. During welding, ABF Quality Control (QC) Andrew Keach was noted monitoring the welding parameters of the welders. Measured welding parameters during welding were 250 amperes, 23.4 volts and 330mm travel speed and 256 amperes, 24.0 volts and 330mm travel speed respectively for Xiao Jian Wan and Jin Pei Wang. At the end of the shift, fill pass welding was still continuing for both welders and should remain tomorrow.

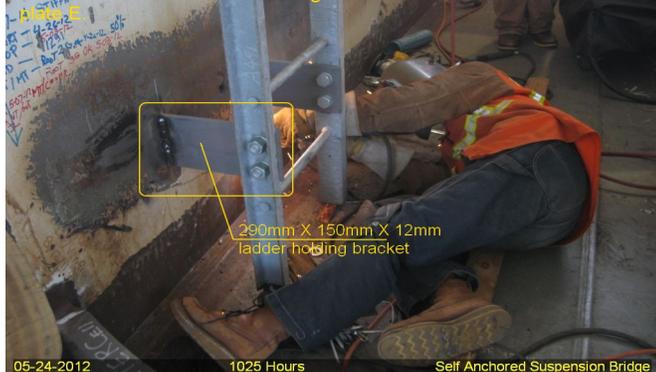
05-24-2012 1025 Hours Self Anchored Suspension Bridge

At Tower Base 13 meter, ABF welder Jin Pei Wang was observed performing 2F (vertical) position fillet welding 290mm long X 150mm wide X 12mm thick ladder holding bracket to Tower East Shaft skin

At Tower Base shear plate above 9 meter between inner West and center external diaphragms, this QA Inspector randomly observed ABF personnel Jin Pei Wang perform 3F (vertical) position fillet welding on the 290mm long X 150mm wide 12mm thick ladder holding bracket. The welder was noted fillet welding the bracket plate to the 60

mm thick Tower shaft 'E' skin plate E using Shielded Metal Arc Welding (SMAW) with 3.2mm diameter E7018H4R electrode and implementing Caltrans approved Welding Procedure Specification (WPS) ABF-WPS-D15-F1200A. This QA Inspector observed ABF personnel using propylene gas torch to preheat the plates to more than 150°F prior welding. This QA Inspector observed QC Inspector Andrew Keach using a Fluke infra red temperature gauge to verify the preheat temperature of more than 150°F and measured the welding parameters to 124 amperes. At the end of the shift, 10mm fillet welded on both sides of the four (4) holding brackets were completed.
