Contract #: 04-0120F4Cty: SF/ALA Rte: 80 PM: 13.2/13.9File #: 1.28**WELDING INSPECTION REPORT**

Report No: WIR-027750
Date Inspected: 10-Jun-2012

Project Name: SAS Superstructure
Prime Contractor: American Bridge/Fluor Enterprises, a JV
Contractor: American Bridge/Fluor Enterprises, a JV

OBG E13 Drop-In Panels (SPCM)

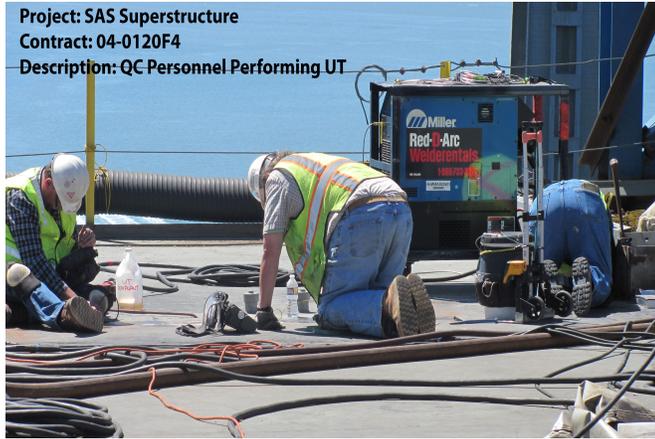
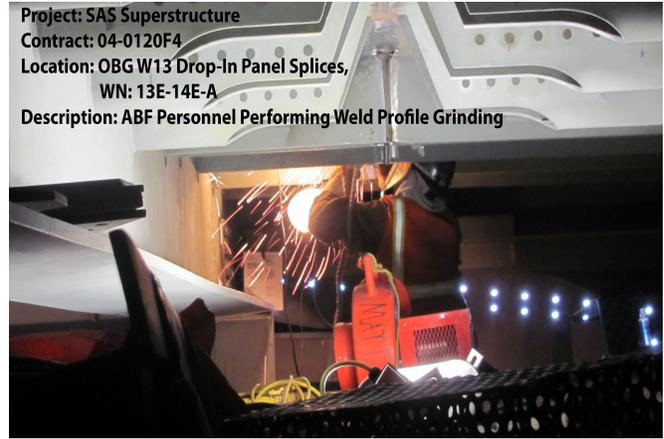
The digital photographs on page two (2) of this report illustrate the some of the work observed by this QA inspector during this shift.
