**DEPARTMENT OF TRANSPORTATION**

Contract #: 04-0120F4Cty: SF/ALA Rte: 80 PM: 13.2/13.9File #: 1.28**WELDING INSPECTION REPORT****Resident Engineer:** Casey, William**Address:** 333 Burma Road**City:** Oakland, CA 94607**Report No:** WIR-027795**Date Inspected:** 18-Jun-2012**Project Name:** SAS Superstructure**OSM Arrival Time:** 700**Prime Contractor:** American Bridge/Fluor Enterprises, a JV**OSM Departure Time:** 1730**Contractor:** American Bridge/Fluor Enterprises, a JV**Location:** Job Site**CWI Name:** William Sherwood**CWI Present:** Yes No**Inspected CWI report:** Yes No N/A**Rod Oven in Use:** Yes No N/A**Electrode to specification:** Yes No N/A**Weld Procedures Followed:** Yes No N/A**Qualified Welders:** Yes No N/A**Verified Joint Fit-up:** Yes No N/A**Approved Drawings:** Yes No N/A**Approved WPS:** Yes No N/A**Delayed / Cancelled:** Yes No N/A**Bridge No:** 34-0006**Component:** SAS Tower**Summary of Items Observed:**

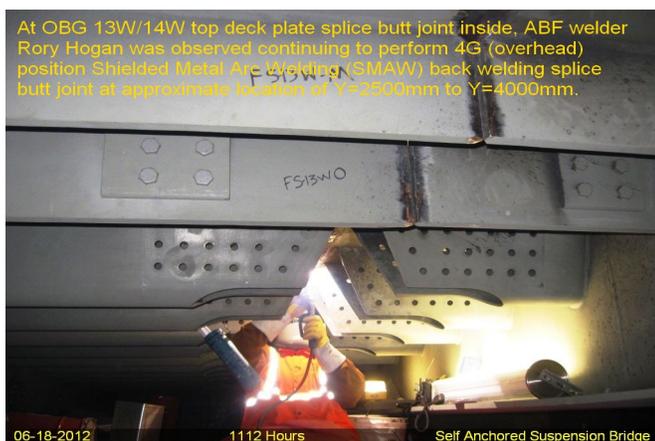
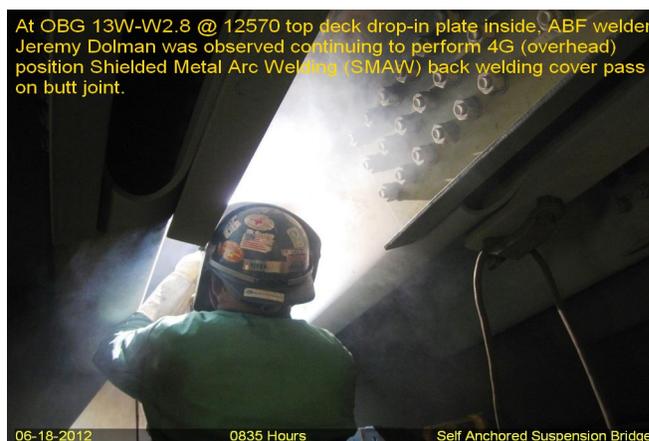
At OBG 13W-W2.8 @ 12570 approximately between Y=5000mm to Y=6000mm top deck drop-in plate inside, QA randomly observed ABF certified welder Jeremy Dolman continuing to perform 4G (overhead position) Shielded Metal Arc Welding (SMAW) back welding cover pass on the CJP SPCM splice butt joint. The welder was utilizing 3.2mm diameter E7018H4R electrode implementing Caltrans approved Welding Procedure Specification (WPS) ABF-WPS-D15-1040C-CU. The joint being welded had a single V-groove butt joint with copper plate backing bar that was originally welded from the top using a combination of SMAW and Submerged Arc Welding (SAW) then removed the copper backing plate using carbon air arc gouging and ground smooth. The plates were preheated to more than 150 degree Fahrenheit using Miller Proheat 35 Induction Heating System prior welding. Welding parameters were monitored by ABF/QC William Sherwood. QA noted the working welding parameters of 126 amperes on the 3.2mm diameter E7018H4R electrode. The workmanship and appearance of the completed cover pass deemed satisfactory. During the shift, cover pass back welding on area mentioned above was completed and the welder performed the flush grinding of the back welded cover of 13W-W2.8 from panel point PP123 to PP123.5. After the completion of the flush grinding on weld area just mentioned, the welder has moved farther to same weld location but between panel point PP123.5 to PP124 with approximate Y=6800mm to Y=9200mm. The welder performed the same back welding on the OBG drop-in plate butt joint using the same process and implementing the same WPS until the end of the shift.

At OBG 13W/14W top deck splice butt joint inside approximately between Y=2500mm to Y=4000mm, QA randomly observed ABF certified welder Rory Hogan continuing to perform 4G (overhead position) Shielded Metal Arc Welding (SMAW) back welding cover pass on the CJP SPCM splice butt joint. The welder was utilizing 3.2mm diameter E7018H4R electrode implementing Caltrans approved Welding Procedure Specification (WPS) ABF-WPS-D15-1040C-CU. The joint being welded had a single V-groove butt joint with copper plate backing bar that was originally welded from the top using a combination of SMAW and Submerged Arc Welding (SAW) then removed the copper backing plate using carbon air arc gouging and ground smooth. The plates were preheated to more than 150 degree Fahrenheit using Miller Proheat 35 Induction Heating System prior welding. Welding parameters were monitored by ABF/QC William Sherwood. QA noted the working welding parameters of 128 amperes on the 3.2mm diameter E7018H4R electrode. The workmanship and appearance of the completed cover pass deemed satisfactory. During the shift, cover pass back welding on area mentioned above was totally completed.

At OBG various locations along grid line W2.4 and W2.5 of the West bound lane, ABF foreman Rick Clayborn was noted performing fit up and tack welding of OBG floor beam web and flange splice connections. The welder was noted tack welding at various positions using SMAW with 3.2mm diameter E7018H4R electrode implementing Caltrans approved Welding Procedure Specification (WPS) ABF-WPS-D15-F1200A . The following were noted fitted and tack welded;

1. 13W-PP121-W2.4
2. 13W-PP121.5-W2.5
3. 13W-PP122-W2.5
