Quality Assurance and Source Inspection

Contract #: 04-0120F4Cty: SF/ALA Rte: 80 PM: 13.2/13.9File #: 99.28**WELDING INSPECTION REPORT****Resident Engineer:** Casey, William**Address:** 333 Burma Road**City:** Oakland, CA 94607**Report No:** WIR-027835**Date Inspected:** 18-Jun-2012**Project Name:** SAS Superstructure**OSM Arrival Time:** 600**Prime Contractor:** American Bridge/Fluor Enterprises, a JV**OSM Departure Time:** 1630**Contractor:** American Bridge Manufacturing**Location:** Reedsport, OR**CWI Name:** James Vanek**CWI Present:** Yes No**Inspected CWI report:** Yes No N/A**Rod Oven in Use:** Yes No N/A**Electrode to specification:** Yes No N/A**Weld Procedures Followed:** Yes No N/A**Qualified Welders:** Yes No N/A**Verified Joint Fit-up:** Yes No N/A**Approved Drawings:** Yes No N/A**Approved WPS:** Yes No N/A**Delayed / Cancelled:** Yes No N/A**Bridge No:** 34-0006**Component:** As Noted Below**Summary of Items Observed:**

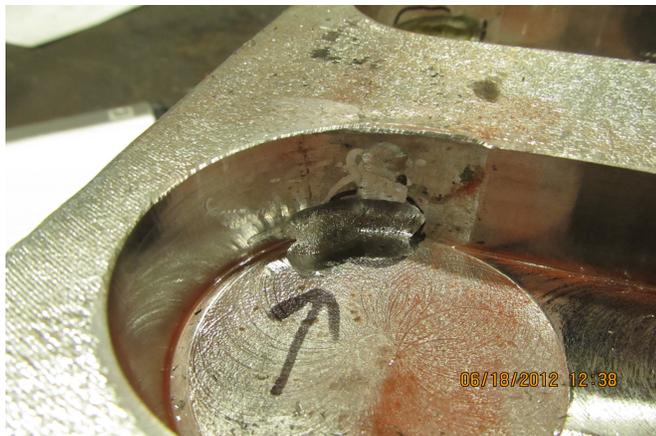
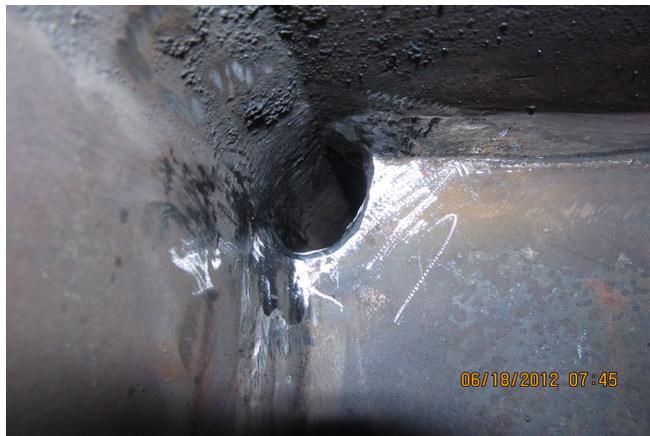
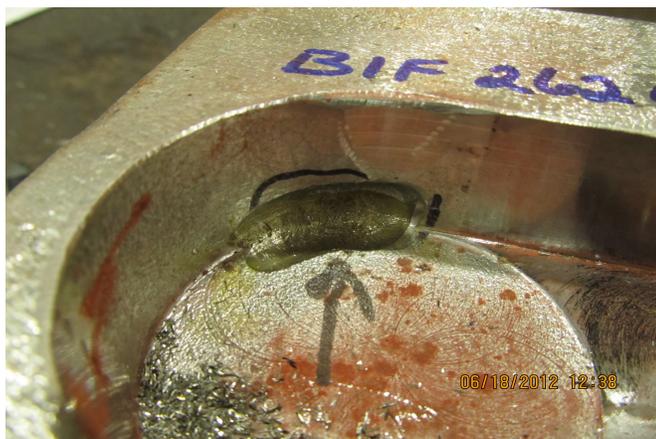
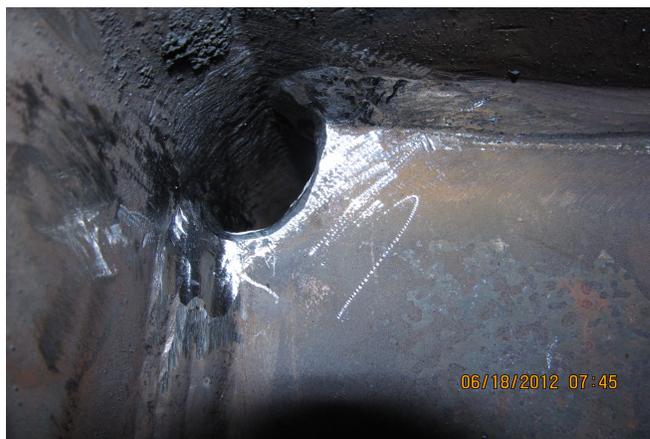
The QAI observed ABM welder Brian Moore (ID# B) welding fillet (seal) welds on added stiffeners 1 and 2 (reference sheet X451-12B) in accordance with Request For Information (RFI) ABF-RFI-002872R00 "Option No. 2" on Suspender Brackets 108W, 108E, 110W and 110E. The QAI observed the welder placing welds in the 2F position with Flux Cored Arc Welding with 100% CO₂ Gas Shielding (FCAW-G) utilizing 1.4mm E71T-1C wire electrode. The QAI checked welding parameters (235 DC Amps and 27.5 DC Volts) and appear to be in compliance with Welding Procedure Specifications (WPS) ABM-SAS-06. Quality Control Inspector (QCI) James Vanek was observed monitoring the welding parameters. During subsequent observations it was noted that the welder was using a power die grinder to profile the weld at weld to a smooth finish, and was cleaning between weld passes with power wire wheel brushes. Welding was in process to the end of the shift.

The QAI noted that ABM personnel were in process of excavation procedures on Split Collars noted with casting discontinuities exposed on the machined surfaces after slotting that require repair in accordance with Special Provisions, Section 10-1.60. The QAI noted that ABM personnel excavated to a maximum of a 13mm depth using

die grinders. Work was in process to the end of the shift. Work is done in accordance with ABM's client American Bridge / Flour directions.
