**DEPARTMENT OF TRANSPORTATION**

Contract #: 04-0120F4Cty: SF/ALA Rte: 80 PM: 13.2/13.9File #: 1.28**WELDING INSPECTION REPORT****Resident Engineer:** Casey, William**Address:** 333 Burma Road**City:** Oakland, CA 94607**Report No:** WIR-027883**Date Inspected:** 01-Jul-2012**Project Name:** SAS Superstructure**OSM Arrival Time:** 700**Prime Contractor:** American Bridge/Fluor Enterprises, a JV**OSM Departure Time:** 1530**Contractor:** American Bridge/Fluor Enterprises, a JV**Location:** Job Site

# WELDING INSPECTION REPORT

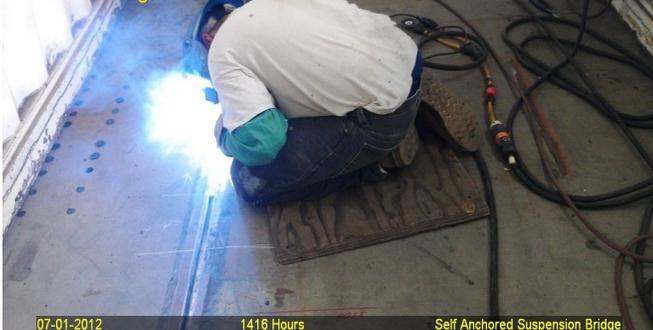
07-01-2012 1416 Hours Self Anchored Suspension Bridge

At OBG 12W-W2.1 top deck corner drop-in plate assembly, ABF welder Richard Garcia was observed performing 2F (horizontal) position Flux Cored Arc Welding (FCAW-G) seal welding the 20mm top deck plate to steel backing bar.

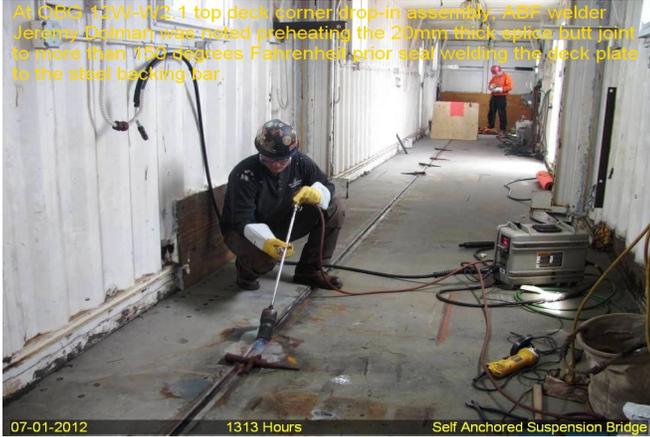
At CBB-12V-W-2.1 top deck corner drop-in assembly, ABF welder Jeremy Dolman was noted preheating the 20mm thick splice butt joint to more than 450 degrees Fahrenheit prior to seal welding the deck plate to the steel backing bar.

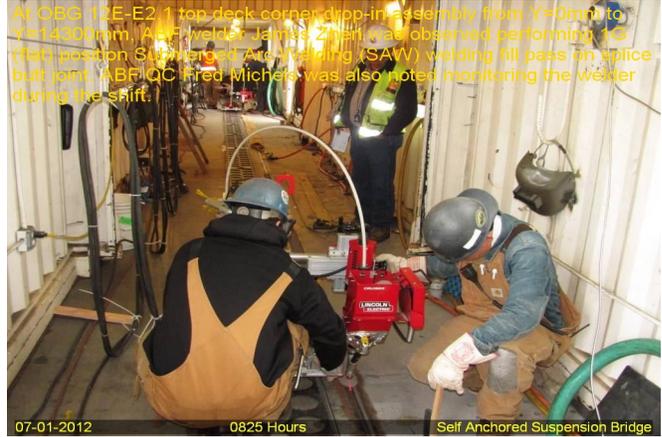
At CBB-12E-E2.1 top deck corner drop-in assembly from Y=0mm to Y=14300mm, ABF welder James Zheri, as observed performing 1G (flat position) Submerged Arc Welding (SAW) welding fill pass on splice butt joint. ABF QC Fred Michels was also noted monitoring the welder during the shift.
