Contract #: 04-0120F4Cty: SF/ALA Rte: 80 PM: 13.2/13.9File #: 1.28**WELDING INSPECTION REPORT**

**Report No:** WIR-027983  
**Date Inspected:** 16-Jul-2012

**Project Name:** SAS Superstructure  
**Prime Contractor:** American Bridge/Fluor Enterprises, a JV  
**Contractor:** American Bridge/Fluor Enterprises, a JV

<b>CWI Name:</b>	Bernie Docena	<b>CWI Present:</b>	Yes	No
<b>Inspected CWI report:</b>	Yes No N/A	<b>Rod Oven in Use:</b>	Yes	No N/A
<b>Electrode to specification:</b>	Yes No N/A	<b>Weld Procedures Followed:</b>	Yes	No N/A
<b>Qualified Welders:</b>	Yes No N/A	<b>Verified Joint Fit-up:</b>	Yes	No N/A
<b>Approved Drawings:</b>	Yes No N/A	<b>Approved WPS:</b>	Yes	No N/A
		<b>Delayed / Cancelled:</b>	Yes	No N/A
<b>Bridge No:</b>	34-0006	<b>Component:</b>	SAS Tower

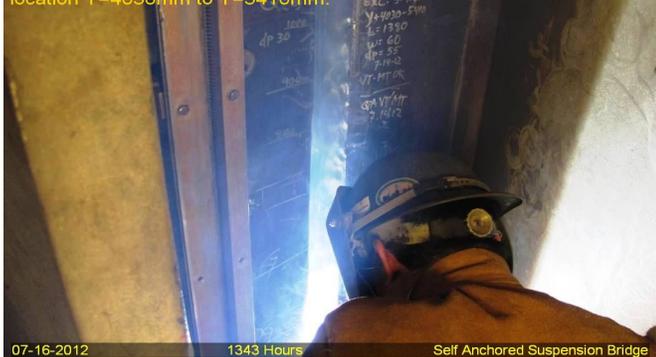
07-16-2012 1343 Hours Self Anchored Suspension Bridge

At Tower Base Electro Slag Weld (ESW) location 'Q' face B (E-043), ABF welder James Zhen was observed performing 3G (vertical) position Flux Cored Arc Welding (FCAW-G) welding repair on welded ESW at location Y=4030mm to Y=5410mm.

At Tower Base Electro Slag Weld (ESW) location 'Q' face B (E-043), QA randomly observed ABF/JV qualified welder James Zhen perform CJP groove welding repair. The repair excavation being welded has Caltrans approval per Request for Weld Repair (RWR) #201206-083. The welder was observed perform automatic welding in the 3G (vertical) position utilizing a Bug –o track mounted dual shield Flux Cored Arc Welding (FCAW-G) with E71T-1M, 1/16" diameter wire electrode and implementing Caltrans approved Welding Procedure Specification (WPS) ABF-WPS-D15-3000-3 Repair. The repair excavation was preheated and continuously maintained to more than 350 degree Fahrenheit using Miller Proheat 35 Induction Heating System prior/during welding. The ESW repair being welded is located at ESW 'Q' face B, from Y=4030mm to Y=5410mm having dimensions of 1380mm long X 60mm wide X 55mm deep. During the shift, ABF QC Bernie Docena was noted monitoring the welder with measured working current of 265 amperes, 22.5 volts with travel speed of 200mm per minute and calculated heat input of 1.7Kjoules per mm. At the end of the shift, 3G FCAW-G repair welding at location mentioned above was still continuing and the welder held the same preheat of 350°F on the excavation repair for three hours after welding as required.

Location	Weld No.	Y-dim.	Length	Width	Depth	Remarks
1. 'Q'	E-043	4030mm	1380mm	60mm	55mm	In progress.

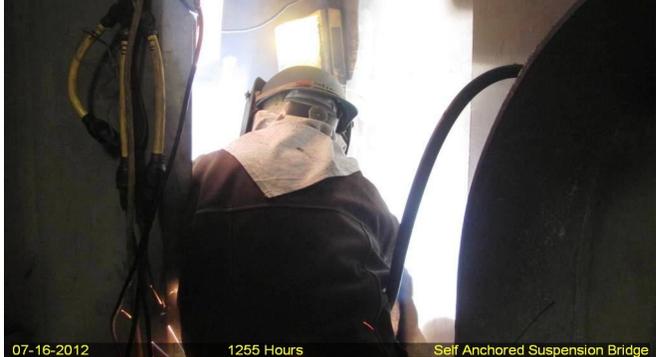
07-16-2012 1255 Hours Self Anchored Suspension Bridge

At Tower Base Electro Slag Weld (ESW) location 'Q' face B (E-043), ABF welder Lou Xiao Hua was noted continuing to excavate UT detected defects on welded ESW at Y=6160mm.

At Tower Base Electro Slag Weld (ESW), this QA observed ABF welder Lou Xiao Hua (who took over from Han Wen Yu) continuing to perform repair excavation at location 'Q' face B (E-043) Y=6160mm due to Ultrasonic Testing (UT) detected defect. The repair excavation is being undertaken per Caltrans approved Request for Weld Repair RWR #201206-084. The welder was noted using carbon air arc gouging followed by grinding using a die grinder. The excavation was alternately gouged and ground then Magnetic Particle Testing (MT) tested by ABF QC Bernie Docena and this QA. The following excavation events were noted during the repair excavation;

ESW location	Y-dim	Depth of excavation	Noted defect
1. 'Q' (B)	6160mm	32mm	2-5mm long linear indication noted.
2. 'Q' (B)	6160mm	>32mm	Excavation in progress.

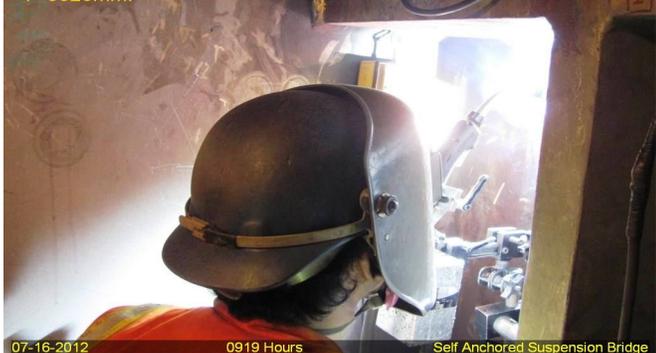
07-16-2012 0919 Hours Self Anchored Suspension Bridge

At Tower Base Electro Slag Weld (ESW) location 'P' face B (N-043), ABF welder Wai Kitlai was observed performing 3G (vertical) position Flux Cored Arc Welding (FCAW-G) welding repair on welded ESW at Y=5020mm.

At Tower Base Electro Slag Weld (ESW) location 'P' face B (N-043), QA randomly observed ABF/JV qualified welder Wai Kitlai continuing to perform CJP groove welding repair. The repair excavation being welded has Caltrans approval per Request for Weld Repair (RWR) #201206-074. The welder was observed perform automatic welding in the 3G (vertical) position utilizing a Bug -o track mounted dual shield Flux Cored Arc Welding (FCAW-G) with E71T-1M, 1/16" diameter wire electrode and implementing Caltrans approved Welding Procedure Specification (WPS) ABF-WPS-D15-3000-3 Repair. The repair excavation was preheated and continuously maintained to more than 350 degree Fahrenheit using Miller Proheat 35 Induction Heating System prior/during welding. The ESW repair being welded is located at ESW 'P' face B, from Y=5020mm to Y=5350mm having dimensions of 330mm long X 55mm wide X 52mm deep. During the shift, ABF QC Bernie Docena was noted monitoring the welder with measured working current of 270 amperes, 22.6 volts with travel speed of 220mm per minute and calculated heat input of 1.66Kjoules per mm. At the end of the shift, 3G FCAW-G repair welding at location mentioned above was still continuing and the welder held the same preheat of 350°F on the excavation repair for three hours after welding as required.

Location	Weld No.	Y-dim.	Length	Width	Depth	Remarks
1. 'P'	N-043	5060mm	330mm	55mm	52mm	Completed.
2. 'P'	N-043	4080/4250mm	800mm	70mm	55mm	In progress.
