**DEPARTMENT OF TRANSPORTATION**

Contract #: 04-0120F4Cty: SF/ALA Rte: 80 PM: 13.2/13.9File #: 1.28**WELDING INSPECTION REPORT**

**Report No:** WIR-028000  
**Date Inspected:** 18-Jul-2012

**Project Name:** SAS Superstructure  
**Prime Contractor:** American Bridge/Fluor Enterprises, a JV  
**Contractor:** American Bridge/Fluor Enterprises, a JV

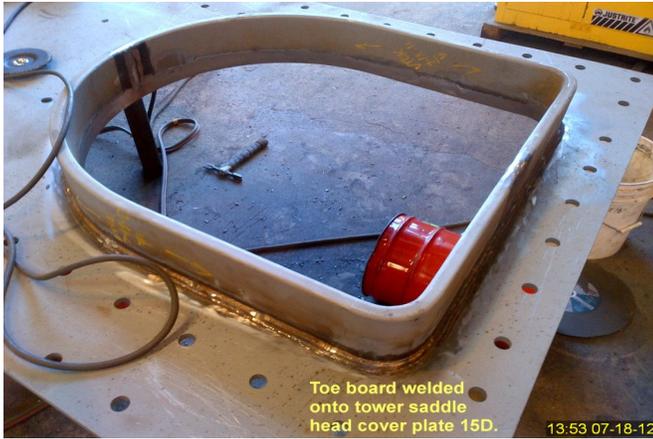
The QAI made several attempts to witness welding of welding at Pier 7. The QAI noted that a toe board is being welded onto the tower saddle head plate 15d, per Request For Information (RFI) 2899R0. The QAI noted that this work began yesterday and was not completed. At 7am, the QAI was informed that the welder has been tasked with other duties and it will be several hours before welding resumes. The QAI returned at 2pm and noted that the welding appeared to be completed. The QAI noted that the QCI Fred Michels was tasked with monitoring this work and he was on standby this morning. The QAI observed VTOK marked on the parts and conducted a visual examination of the welds. The welds appeared to be visually conforming to the contract requirements. The QAI was later informed that MT will be performed after the 24 hour requirement. See the attached photo.

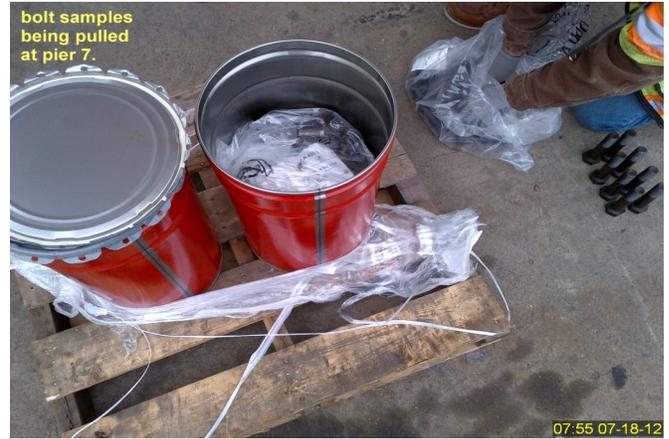
The QAI was requested to sample fastener assemblies that have been delivered to the pier 7 staging area. The QAI met with Caltrans Transportation Engineer Bob Brignano and selected a representative sample of the fasteners. The QAI reviewed the supporting documentation for the fasteners. The QAI noted that these fasteners are intended for use with West Jacking Saddle Frame. The QAI completed a TL-102 sampling form with lot number B212-071-12. The QAI noted that these fasteners will be field released upon acceptable verification testing. See the attached photo.
