**DEPARTMENT OF TRANSPORTATION**

Contract #: 04-0120F4Cty: SF/ALA Rte: 80 PM: 13.2/13.9File #: 1.28**WELDING INSPECTION REPORT****Resident Engineer:** Casey, William**Address:** 333 Burma Road**City:** Oakland, CA 94607**Report No:** WIR-028010**Date Inspected:** 18-Jul-2012**Project Name:** SAS Superstructure**OSM Arrival Time:** 700**Prime Contractor:** American Bridge/Fluor Enterprises, a JV**OSM Departure Time:** 1930**Contractor:** American Bridge/Fluor Enterprises, a JV**Location:** jobsite**CWI Name:** William Sherwood**CWI Present:** Yes No**Inspected CWI report:** Yes No N/A**Rod Oven in Use:** Yes No N/A**Electrode to specification:** Yes No N/A**Weld Procedures Followed:** Yes No N/A**Qualified Welders:** Yes No N/A**Verified Joint Fit-up:** Yes No N/A**Approved Drawings:** Yes No N/A**Approved WPS:** Yes No N/A**Delayed / Cancelled:** Yes No N/A**Bridge No:** 34-0006**Component:** OBG**Summary of Items Observed:**

**13W/14W OBG Drop-In**

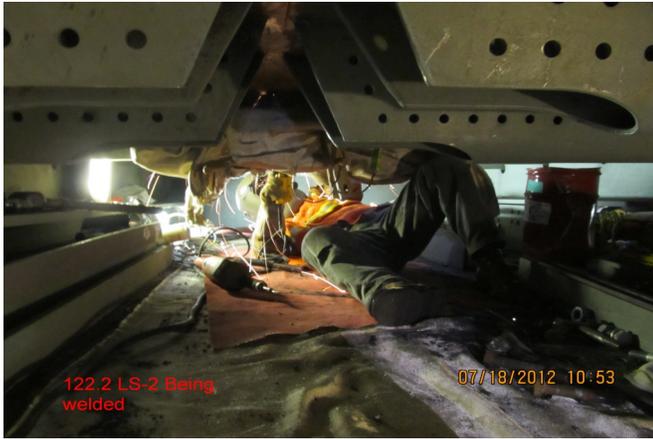
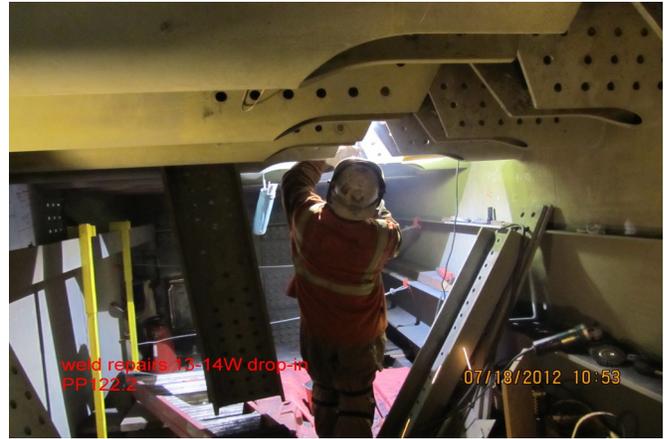
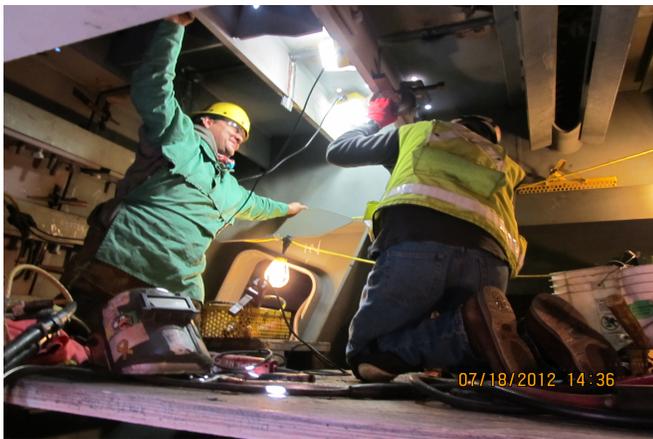
This QAI observed Rick Clayborn excavating utilizing Carbon Arc Gouging from bottom of Deck Splice Weld 13W-PP122.2 at the following locations:

This QAI observed Tran Chau welding the above listed repair excavations utilizing the Shield Metal Arc Welding to the parameters set forth in the approved Welding Procedure Specification. During welding operations a 350F preheat was being maintained using induction heating blankets. At the conclusion of welding operations post heat was initiated at 450F for four hours.

QAI witnessed the welding of stiffener splice 122.2 LS-3 by welder Jeremy Doleman (ID#5042) utilizing the Shield Metal Arc Welding Process in the 3G position using E9018 consumable electrodes. The QC recorded and this QAI verified that the weld metal was being deposited to the parameters of the applicable Welding Procedure Specification. Welder Doleman was observed using the stringer method and good workmanship practices in regard to interpass cleaning.
