Contract #: 04-0120F4Cty: SF/ALA Rte: 80 PM: 13.2/13.9File #: 1.28**WELDING INSPECTION REPORT**

Report No: WIR-028016
Date Inspected: 19-Jul-2012

Project Name: SAS Superstructure
Prime Contractor: American Bridge/Fluor Enterprises, a JV
Contractor: American Bridge/Fluor Enterprises, a JV

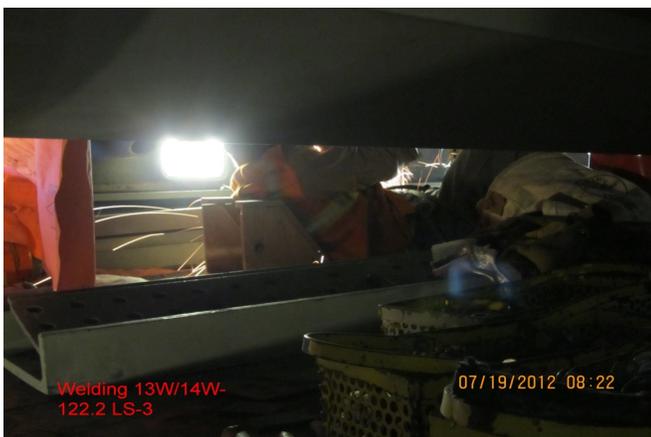
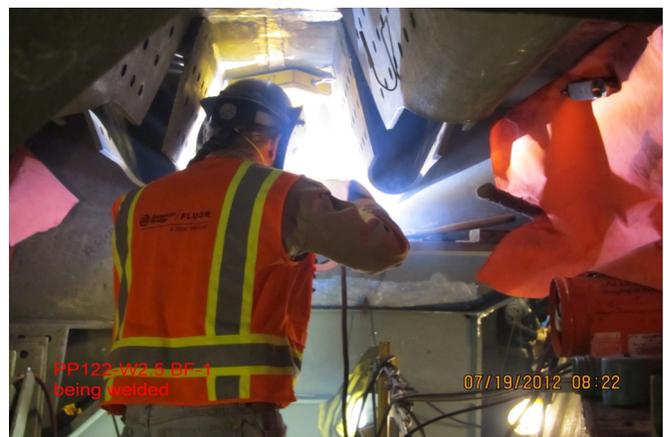
This QAI observed Welder Mike Jiminez using a rosebud torch to preheat stiffener splice 12W-13W LS-3 to a QC recorded, QA verified temperature of 200F. Preheat temperature was measured using a Tempil Stick. This QAI noted QC William Sherwood recording preheat temperature whenever there was a stop in work.

QAI witnessed the welding of stiffener splice 12W-13W LS-3 by welder Mike Jiminez utilizing the Shield Metal Arc Welding Process in the 3G position using E9018 consumable electrodes. The QC recorded and this QAI verified that the weld metal was being deposited to the parameters of the applicable Welding Procedure Specification. Welder Jiminez was observed using the stringer method and good workmanship practices in regard to interpass cleaning.
