Contract #: 04-0120F4Cty: SF/ALA Rte: 80 PM: 13.2/13.9File #: 1.28**WELDING INSPECTION REPORT**

**Report No:** WIR-028025  
**Date Inspected:** 22-Jul-2012

**Project Name:** SAS Superstructure  
**Prime Contractor:** American Bridge/Fluor Enterprises, a JV  
**Contractor:** American Bridge/Fluor Enterprises, a JV

<b>CWI Name:</b>	As noted below	<b>CWI Present:</b>	Yes	No
<b>Inspected CWI report:</b>	Yes No N/A	<b>Rod Oven in Use:</b>	Yes No N/A	
<b>Electrode to specification:</b>	Yes No N/A	<b>Weld Procedures Followed:</b>	Yes No N/A	
<b>Qualified Welders:</b>	Yes No N/A	<b>Verified Joint Fit-up:</b>	Yes No N/A	
<b>Approved Drawings:</b>	Yes No N/A	<b>Approved WPS:</b>	Yes No N/A	
		<b>Delayed / Cancelled:</b>	Yes No N/A	
<b>Bridge No:</b>	34-0006	<b>Component:</b>	SAS OBG

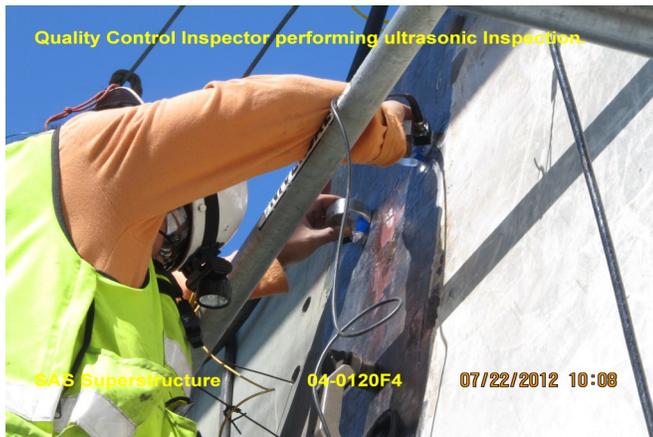
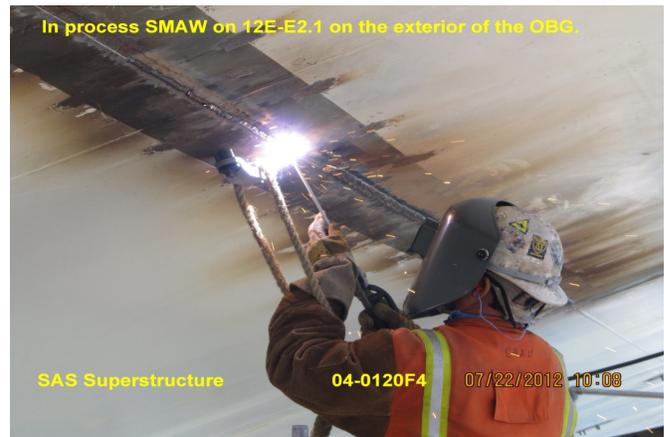
This QA Inspector randomly observed the ongoing Carbon Arc Cutting (CAC) process of the backing bar and the back-gouging from the root side of the joint at 12E-E2.1 on the interior of the OBG. ABF/JV qualified welder Wen Han Yu #6317 was observed continuing the process throughout the shift employing scaffolding to access the locations for cutting and gouging. This QA Inspector observed the welder utilizing the appropriate respiratory apparatus and noted that the work at this location was in progress and appeared to be in general conformance with the contract specifications.

This QA Inspector randomly observed QC Inspector Jesse Cayabyab at 13E PP122.2 at y+3010mm performing Ultrasonic Testing (UT). The QC Inspector was observed scanning from each side of the weld and the scanning pattern as described in D1.5 6.24. The QC Inspectors were noted as identifying a class A rejectable indication 15mm in length at 14mm deep. This QA Inspector noted that the work at these locations is ongoing and appeared to be in general conformance with the contract documents and SE-UT-D1.5-CT-100-Revision 4.
