DEPARTMENT OF TRANSPORTATION

Quality Assurance and Source Inspection

Contract #: 04-0120F4Cty: SF/ALA Rte: 80 PM: 13.2/13.9File #: 1.28**WELDING INSPECTION REPORT****Resident Engineer:** Casey, William**Address:** 333 Burma Road**City:** Oakland, CA 94607**Report No:** WIR-028187**Date Inspected:** 15-Aug-2012**Project Name:** SAS Superstructure**OSM Arrival Time:** 700**Prime Contractor:** American Bridge/Fluor Enterprises, a JV**OSM Departure Time:** 1900**Contractor:** American Bridge/Fluor Enterprises, a JV**Location:** jobsite

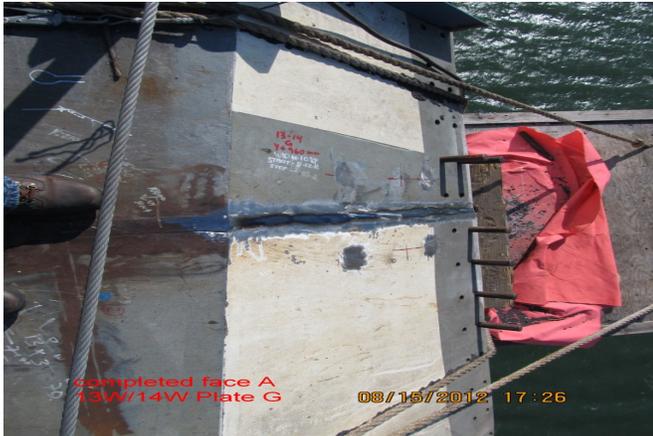
Due to the contractor choosing to weld prior to getting engineer approval for the poor fit up an Incident Report was issued on the above-mentioned welded splice. At the time of this report the joint exhibited a 3mm to 5mm offset with a maximum root opening of 20mm.

The QA inspector from observed the in process Shield Metal Arc Welding being performed by ABF welding personnel Jim Quan Huang (9340) on 13W/14W Plate G vertical splice. The welder spent the shift depositing the fill passes with approximately 100% being completed at the end of the shift. QC inspector Fred Michels was noted

to be present in order to monitor the progress and ensure the welding was within the established Welding Procedure Specification (WPS) noted as ABF-WPS-D15-1040-C and supporting Procedure Qualification Records (PQR). Prior to initiating the welding at this location the QC inspector observed the preheat temperature, using a Raytek non-contact Thermometer, was sufficient and compliant to the above-mentioned WPS. Using a Tempil Stick, (temperature indicating crayon)the preheat and interpass temperature was then verified by this QA inspector to be greater than 150F and the parameters, using a Fluke brand Tong style meter, was verified to be 160 amps. See digital photo included in the body of this report for general information.

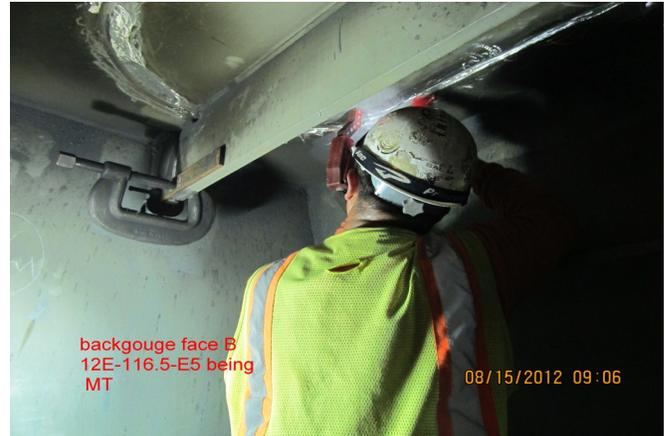
Back gouging 12E-PP116.5-E5 Deck Access Hole Face B

The QA inspector intermittently observed the in process Shield Metal Arc Welding being performed by ABF welding personnel Roby Smith on Face B of Deck Access Hole 12E-116.5-E5. The welder spent the shift depositing the root passes and fill passes with approximately 80% being completed at the end of the shift. QC inspector Chris Concha was noted to be present in order to monitor the progress and ensure the welding was within the established Welding Procedure Specification (WPS) noted as ABF-WPS-D15-1110-A and supporting Procedure Qualification Records (PQR). Prior to initiating the welding at this location the QC inspector observed the preheat temperature, using a Raytek non-contact Thermometer, was sufficient and compliant to the above-mentioned WPS. Using a Tempil Stick, (temperature indicating crayon)the preheat and interpass temperature was then verified by this QA inspector to be greater than 150F and the parameters, using a Fluke brand Tong style meter, was verified to be 150 amps. See digital photo included in the body of this report for general information.

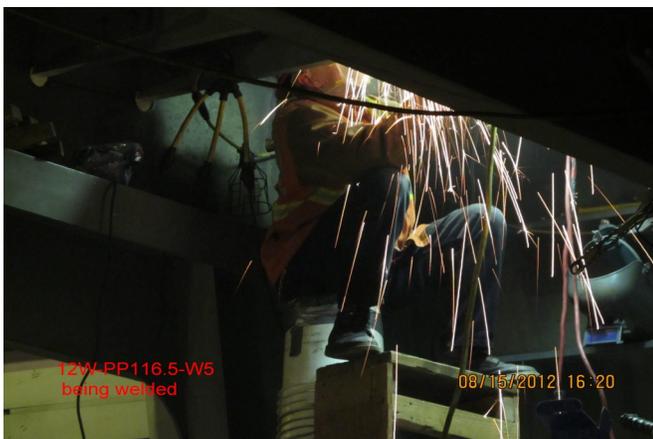
Welding 12W-PP116.5-W5 Deck Access Hole Face B

The QA inspector intermittently observed the in process Shield Metal Arc Welding being performed by ABF welding personnel Roby Smith on Face B of Deck Access Hole 12W-116.5-W5. The welder spent the shift depositing the root passes and fill passes with approximately 80% being completed at the end of the shift. QC inspector Chris Concha was noted to be present in order to monitor the progress and ensure the welding was within the established Welding Procedure Specification (WPS) noted as ABF-WPS-D15-1110-A and supporting Procedure Qualification Records (PQR). Prior to initiating the welding at this location the QC inspector observed the preheat temperature, using a Raytek non-contact Thermometer, was sufficient and compliant to the above-mentioned WPS. Using a Tempil Stick, (temperature indicating crayon)the preheat and interpass temperature was then verified by this QA inspector to be greater than 150F and the parameters, using a Fluke brand Tong style meter, was verified to be 160 amps. See digital photo included in the body of this report for general information.
