Contract #: 04-0120F4Cty: SF/ALA Rte: 80 PM: 13.2/13.9File #: 99.28**WELDING INSPECTION REPORT****Resident Engineer:** Casey, William**Address:** 333 Burma Road**City:** Oakland, CA 94607**Report No:** WIR-028213**Date Inspected:** 15-Aug-2012**Project Name:** SAS Superstructure**OSM Arrival Time:** 1100**Prime Contractor:** American Bridge/Fluor Enterprises, a JV**OSM Departure Time:** 2130**Contractor:** American Bridge**Location:** Reedsport, OR**CWI Name:** Harry Woodworth**CWI Present:** Yes No**Inspected CWI report:** Yes No N/A**Rod Oven in Use:** Yes No N/A**Electrode to specification:** Yes No N/A**Weld Procedures Followed:** Yes No N/A**Qualified Welders:** Yes No N/A**Verified Joint Fit-up:** Yes No N/A**Approved Drawings:** Yes No N/A**Approved WPS:** Yes No N/A**Delayed / Cancelled:** Yes No N/A**Bridge No:** 34-0006**Component:** Jacking Saddle Shim Block**Summary of Items Observed:**

# WELDING INSPECTION REPORT

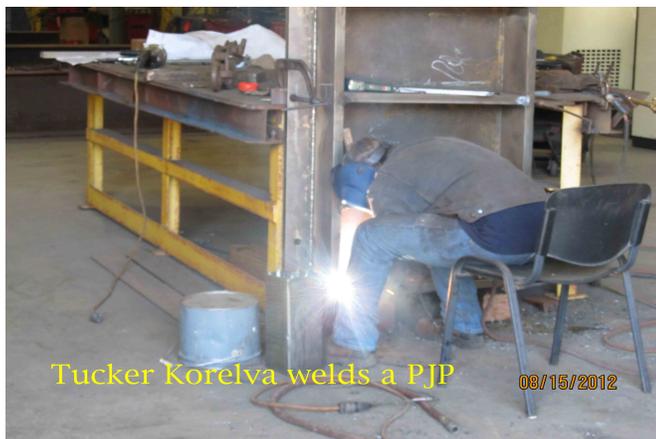
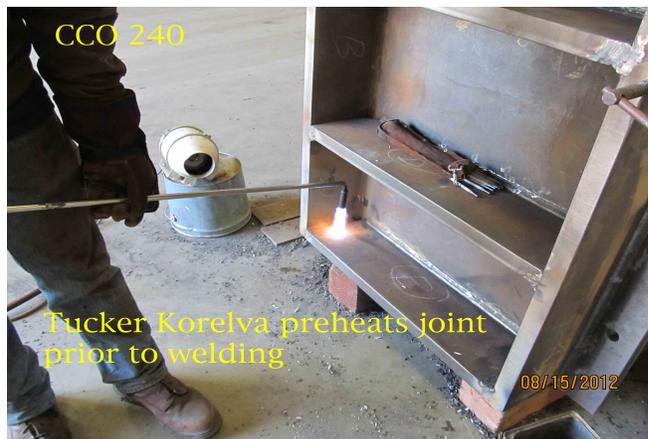
During the second work shift, this Quality Assurance Inspector (QAI) observed Quality Control Inspector (QCI), Harry Woodworth, of American Bridge (AB) Manufacturing continued to monitor the welding of Jacking Saddle Shim Block, 90% completed, from previous two days of work. This Jacking Saddle Shim Block has been welding during first work shift by AB personnel. A welder, Tucker Koreiva, of AB continued welding on the shim block from first work shift. Tucker Koreiva performed a Partial Joint Penetration (PJP) on a 1-1/2" to 1-1/2" plate of A709 HPS 70W (485W) steel material per approved drawing in accordance to Welding Procedure Specification (WPS) ABM-SMAW. Shielded Metal Arc Welding (SMAW) process was utilized with E9018M-H4R 5/32" diameter electrode as the filler metal. This QAI noted electrodes were stored in a heated oven and were not exposed to atmosphere for more than one hour. Also noted Tucker Koreiva preheated the joint prior to welding. This QAI verified joint fit-up and verified preheat temperature with Extech min-infrared thermometer Model 42500. This QAI verified amperage, 165 amps, during welding using Amprobe Model ACDC-100. These instruments were noted to be within calibration due date.

This QAI performed visual observation and randomly verified weld size using a fillet weld gauge at on the shim block upon welding completion. This QAI noted weld size seemed to meet approved drawing and meet weld profile.
