**DEPARTMENT OF TRANSPORTATION**

Contract #: 04-0120F4Cty: SF/ALA Rte: 80 PM: 13.2/13.9File #: 1.28**WELDING INSPECTION REPORT****Resident Engineer:** Casey, William**Address:** 333 Burma Road**City:** Oakland, CA 94607**Report No:** WIR-028236**Date Inspected:** 17-Aug-2012**Project Name:** SAS Superstructure**OSM Arrival Time:** 700**Prime Contractor:** American Bridge/Fluor Enterprises, a JV**OSM Departure Time:** 1900**Contractor:** American Bridge/Fluor Enterprises, a JV**Location:** jobsite

**Bridge No:** 34-0006**Component:** OBG**Summary of Items Observed:**

# WELDING INSPECTION REPORT

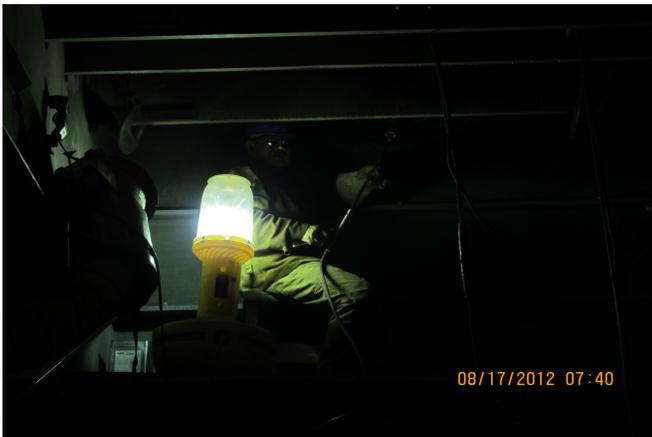
Welding 12W-PP116.5-W5 Deck Access Hole Face B

The QA inspector at random observed the in process Shield Metal Arc Welding being performed by ABF welding personnel Roby Smith on Face B of Deck Access Hole 12W-116.5-W5. The welder spent the shift depositing the root passes and fill passes with approximately 100% being completed at the end of the shift. QC inspector Chris Concha was noted to be present in order to monitor the progress and ensure the welding was within the established Welding Procedure Specification (WPS) noted as ABF-WPS-D15-1110-A and supporting Procedure Qualification Records (PQR). Prior to initiating the welding at this location the QC inspector observed the preheat temperature, using a Raytek non-contact Thermometer, was sufficient and compliant to the above-mentioned WPS. Using a Tempil Stick, (temperature indicating crayon) the preheat and interpass temperature was then verified by this QA inspector to be greater than 150F and the parameters, using a Fluke brand Tong style meter, was verified to be 151 amps. See digital photo included in the body of this report for general information.
