DEPARTMENT OF TRANSPORTATION

Contract #: 04-0120F4Cty: SF/ALA Rte: 80 PM: 13.2/13.9File #: 99.28**WELDING INSPECTION REPORT****Resident Engineer:** Casey, William**Address:** 333 Burma Road**City:** Oakland, CA 94607**Report No:** WIR-028349**Date Inspected:** 14-Aug-2012**Project Name:** SAS Superstructure**OSM Arrival Time:** 1100**Prime Contractor:** American Bridge/Fluor Enterprises, a JV**OSM Departure Time:** 2130**Contractor:** American Bridge**Location:** Reedsport, OR**CWI Name:** Harry Woodworth**CWI Present:** Yes No**Inspected CWI report:** Yes No N/A**Rod Oven in Use:** Yes No N/A**Electrode to specification:** Yes No N/A**Weld Procedures Followed:** Yes No N/A**Qualified Welders:** Yes No N/A**Verified Joint Fit-up:** Yes No N/A**Approved Drawings:** Yes No N/A**Approved WPS:** Yes No N/A**Delayed / Cancelled:** Yes No N/A**Bridge No:** 34-0006**Component:** Jacking Saddle Shim Block**Summary of Items Observed:**

WELDING INSPECTION REPORT

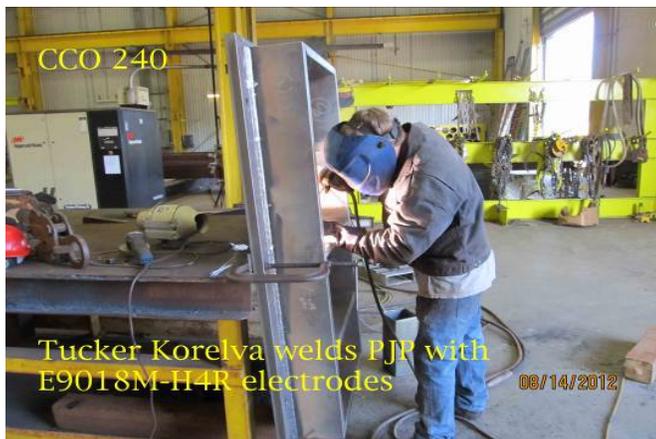
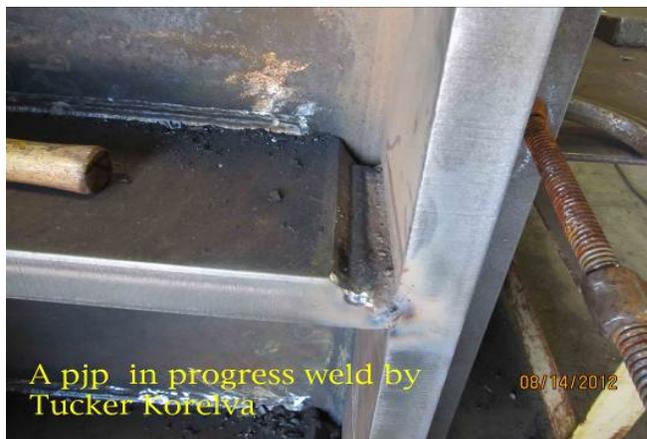
This QAI observed that ABM was continuing the welding operations on the shim block by welder Tucker Koreiva from the first shift welders. It was observed that the welder was using the Shielded Metal Arc Welding (SMAW) for the Partial Joint Penetration (PJP) welds on A709 HPS 70W (485W). The material thickness being welded was 1-1/2" to 1-1/2" with electrode E9018M-H4R, and a 5/32" diameter. The welding Procedure Specification (WPS) being used by the welder was, ABM-SMAW. This QAI observed that the QCI was using Amp probe Model ACDC-100 to verify the welding parameters and appeared to be within the WPS range of 165 amps. Prior to the start of the welding process the welder preheated the material to 150°F which was verified by the QCI using an Extech mini-infrared thermometer Model 42500. It was relayed to this QAI that the welder was informed of the atmospheric requirements for this electrode of no more than one (1) hour of exposure. This QAI also noted that the QCI was monitoring the inter-pass temperatures for both weld joints that were in process. The welder was alternating between two (2) weld joints. At the time of the observation the in process welding appeared to be within general compliance of the contract documents.

Item	Weld Identification	Applicable WPS	CWI Name	Amperage	Voltage	TravelSpeed	Preheat Temp	Remarks
1	SMAW: fillet and pjp	ABM-SAS-023	Harry Woodworth	174	N/A	19 ipm	150 F	QA random observed in process welding
