DEPARTMENT OF TRANSPORTATION

Contract #: 04-0120F4Cty: SF/ALA Rte: 80 PM: 13.2/13.9File #: 1.28**WELDING INSPECTION REPORT****Resident Engineer:** Casey, William**Address:** 333 Burma Road**City:** Oakland, CA 94607**Report No:** WIR-028375**Date Inspected:** 12-Sep-2012**Project Name:** SAS Superstructure**OSM Arrival Time:** 700**Prime Contractor:** American Bridge/Fluor Enterprises, a JV**OSM Departure Time:** 1930**Contractor:** American Bridge/Fluor Enterprises, a JV**Location:** Job Site**CWI Name:** See below.**CWI Present:** Yes No**Inspected CWI report:** Yes No N/A**Rod Oven in Use:** Yes No N/A**Electrode to specification:** Yes No N/A**Weld Procedures Followed:** Yes No N/A**Qualified Welders:** Yes No N/A**Verified Joint Fit-up:** Yes No N/A**Approved Drawings:** Yes No N/A**Approved WPS:** Yes No N/A**Delayed / Cancelled:** Yes No N/A**Bridge No:** 34-0006**Component:** OBG**Summary of Items Observed:**

OBG 12W

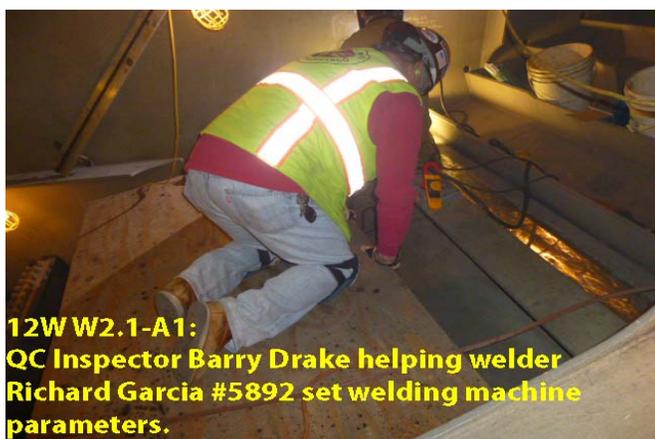
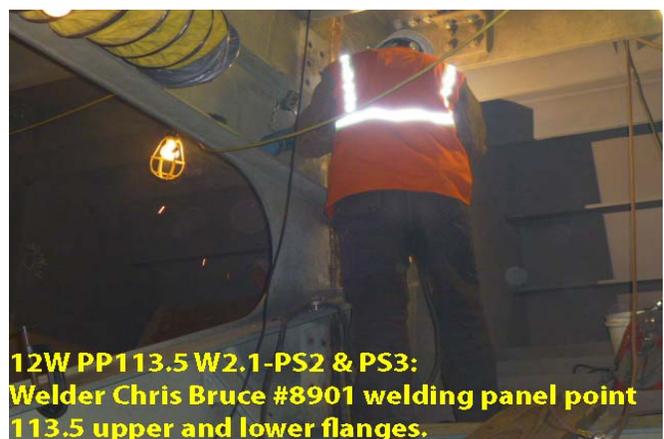
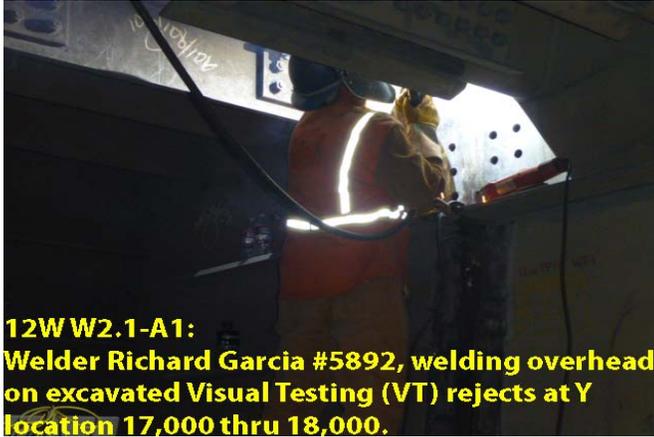
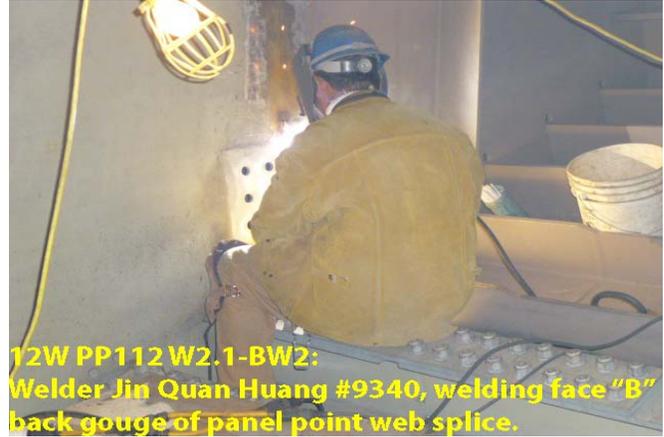
Welder Chris Bruce was observed welding on welds 12W PP113.5 W2.1-BW1 (3G, CJP), 12W PP113.5 W2.1-BW2 (3G, CJP), 12W PP113.5 W2.1-PS2 (1G/4G, CJP) and 12W PP113.5 W2.1-PS3 (1G/4G, CJP). The welder was observed utilizing Caltrans approved Welding Procedure Specification's (WPS) ABF-WPS-D15-1030; preheating to the specified temperature prior to welding. Welding parameters observed were as per Welding Procedure Specification's (WPS) noted above and appears to be in order.

Welder Jin Quan Huang was observed welding on welds 12W PP112 W2.1-BW2 (3G, CJP). The welder was observed utilizing Caltrans approved Welding Procedure Specification's (WPS) ABF-WPS-D15-1030; preheating to the specified temperature of over 150 degrees prior to welding. Welding parameters observed were as per Welding Procedure Specification's (WPS) noted above and appears to be in order.

Welder Richard Garcia was observed welding overhead on weld 12W W2.1-A1(1G/4G, CJP). The welder was observed utilizing Caltrans approved Welding Procedure Specification's (WPS) ABF-WPS-D15-3110-4 and preheating to 200 degrees prior to welding. Welding parameters observed were as per Welding Procedure Specification's (WPS) noted above and appears to be in order. The areas welded by the welder were visual porosity noted previously after grinding. Porosity was excavated to cumulative length of 2300mm long x 8mm deep. Total weld length is 31,000mm. As discussed on 12-08-15 with lead Danny Reyes, weld was still in process and no Request for Weld Repair or RWR was required.

This QA observed no rejectable indications at the time of testing. This QA Inspector generated an MT report on this date. The completed and accepted work observed at this location appeared to be in compliance with the contract specifications.
