**DEPARTMENT OF TRANSPORTATION**

Contract #: 04-0120F4Cty: SF/ALA Rte: 80 PM: 13.2/13.9File #: 1.28**WELDING INSPECTION REPORT****Resident Engineer:** Casey, William**Address:** 333 Burma Road**City:** Oakland, CA 94607**Report No:** WIR-028407**Date Inspected:** 13-Sep-2012**Project Name:** SAS Superstructure**OSM Arrival Time:** 700**Prime Contractor:** American Bridge/Fluor Enterprises, a JV**OSM Departure Time:** 1930**Contractor:** American Bridge/Fluor Enterprises, a JV**Location:** Job Site**CWI Name:** Salvador Merino**CWI Present:** Yes No**Inspected CWI report:** Yes No N/A**Rod Oven in Use:** Yes No N/A**Electrode to specification:** Yes No N/A**Weld Procedures Followed:** Yes No N/A**Qualified Welders:** Yes No N/A**Verified Joint Fit-up:** Yes No N/A**Approved Drawings:** Yes No N/A**Approved WPS:** Yes No N/A**Delayed / Cancelled:** Yes No N/A**Bridge No:** 34-0006**Component:** SAS OBG**Summary of Items Observed:**

# WELDING INSPECTION REPORT

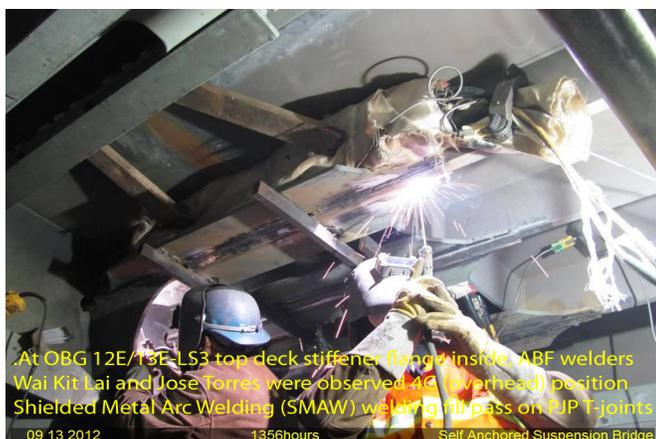
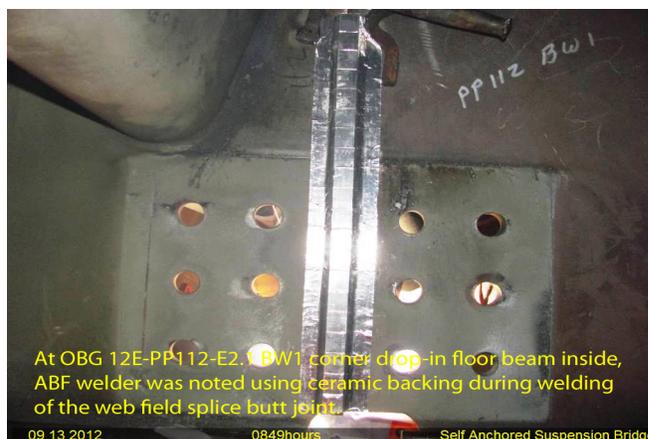
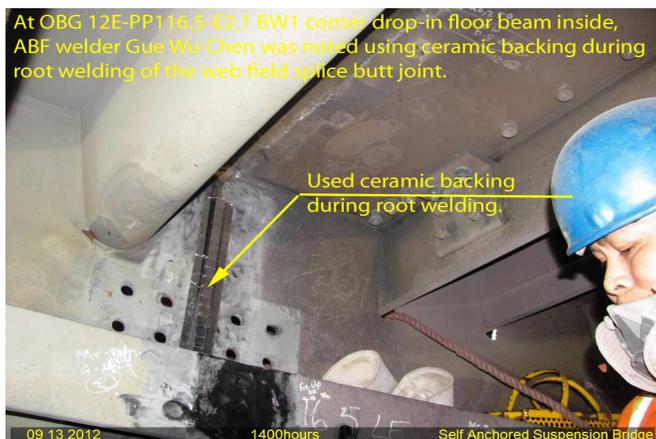
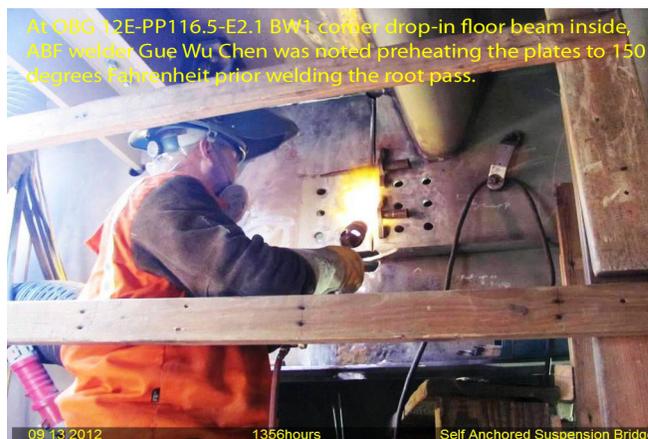
At OBG 12E/13E-LS3 deck stiffener flange inside, QA randomly observed ABF/JV qualified welders Wai Kit Lai and Jose Torres continuing to perform production PJP groove welding fill pass to cover pass on the 485W deck stiffener flange T-joint. The welders were observed perform manual welding in the 4G (overhead) position utilizing a Shielded Metal Arc Welding (SMAW) with 3.2mm diameter E9018H4R electrode and implementing Caltrans approved Welding Procedure Specification (WPS) ABF-WPS-D15-1162-4 rev. 0. The stiffener flange plate has a 45 degree bevel groove that is being welded PJP T-joint to the 485W longitudinal stiffener. The plates were preheated to more than 200 degree Fahrenheit using Miller Proheat 35 Induction Heating System. During welding, ABF Quality Control (QC) Salvador Merino was noted monitoring the welding parameters of the welder with measured working current of 128 and 134 amperes respectively on the welders mentioned. At the end of the shift, cover pass welding was completed on the two wing plates and the welders held the same preheat of >200 degree Fahrenheit for three hours after welding as required.

At OBG 12E-PP116.5-E2.1-BW1 corner drop-in floor beam, QA randomly observed ABF certified welder Gue Wu Chen continuing to perform 3G (vertical position) Shielded Metal Arc Welding (SMAW) welding fill pass on the CJP web splice butt joint. The welder was utilizing 3.2mm diameter E7018H4R on the root pass implementing Caltrans approved Welding Procedure Specification (WPS) ABF-WPS-D15-1040A-CU Rev. 0. The joint being welded has a single V-groove butt joint with ceramic backing that will be removed and back gouged then back

welded. Prior welding, ABF QC Salvador Merino was noted checking the fit up alignment and found it acceptable. This QA performed the fit up verification and noted same result. The plates were preheated to more than 150 degree Fahrenheit using propylene gas torch prior welding. Welding parameters were monitored by ABF/QC Salvador Merino. QA noted the welding working parameter of 124 amperes on the 3.2 diameter E7018H4R electrode. The workmanship and appearance of the completed root pass deemed satisfactory. At the end of the shift, fill pass welding on web splice butt joint mentioned above was still continuing and should remain tomorrow.

At OBG 12W-PP112-W2.1-BW1 corner drop-in floor beam, QA randomly observed ABF certified welder Jin Quan Huang continuing to perform 3G (vertical position) Shielded Metal Arc Welding (SMAW) welding fill pass on the CJP web splice butt joint. The welder was utilizing 3.2mm diameter E7018H4R on the fill pass implementing Caltrans approved Welding Procedure Specification (WPS) ABF-WPS-D15-1040A-CU Rev. 0. The joint being welded has a single V-groove butt joint with ceramic backing that will be removed and back gouged then back welded. The plates were preheated to more than 150 degree Fahrenheit using propylene gas torch prior welding. Welding parameters were monitored by ABF/QC Barry Drake. QA noted the welding working parameter of 128 amperes on the 3.2 diameter E7018H4R electrode. The workmanship and appearance of the completed fill pass deemed satisfactory. At the end of the shift, fill pass welding on web splice butt joint mentioned above was still continuing and should remain tomorrow.
