**DEPARTMENT OF TRANSPORTATION**

Contract #: 04-0120F4Cty: SF/ALA Rte: 80 PM: 13.2/13.9File #: 1.28**WELDING INSPECTION REPORT****Resident Engineer:** Casey, William**Address:** 333 Burma Road**City:** Oakland, CA 94607**Report No:** WIR-028408**Date Inspected:** 20-Sep-2012**Project Name:** SAS Superstructure**OSM Arrival Time:** 700**Prime Contractor:** American Bridge/Fluor Enterprises, a JV**OSM Departure Time:** 1930**Contractor:** American Bridge/Fluor Enterprises, a JV**Location:** Job Site**CWI Name:** See below.**CWI Present:** Yes No**Inspected CWI report:** Yes No N/A**Rod Oven in Use:** Yes No N/A**Electrode to specification:** Yes No N/A**Weld Procedures Followed:** Yes No N/A**Qualified Welders:** Yes No N/A**Verified Joint Fit-up:** Yes No N/A**Approved Drawings:** Yes No N/A**Approved WPS:** Yes No N/A**Delayed / Cancelled:** Yes No N/A**Bridge No:** 34-0006**Component:** OBG**Summary of Items Observed:**

**OBG 12W**

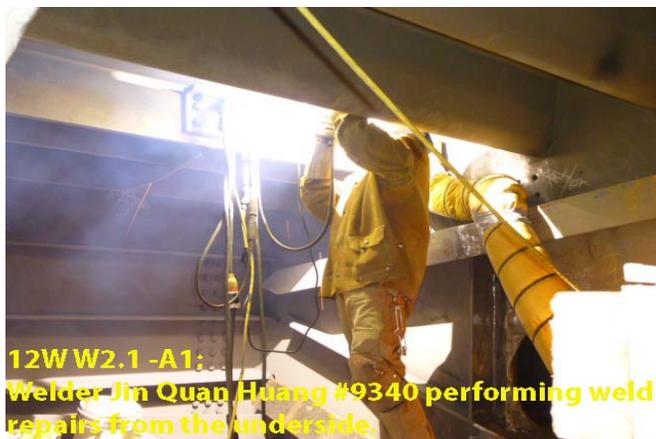
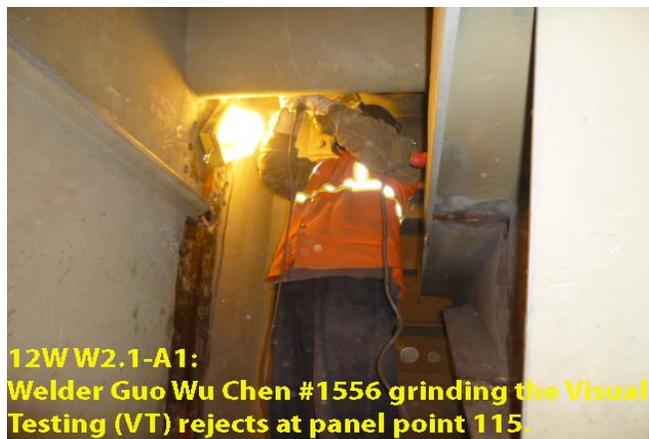
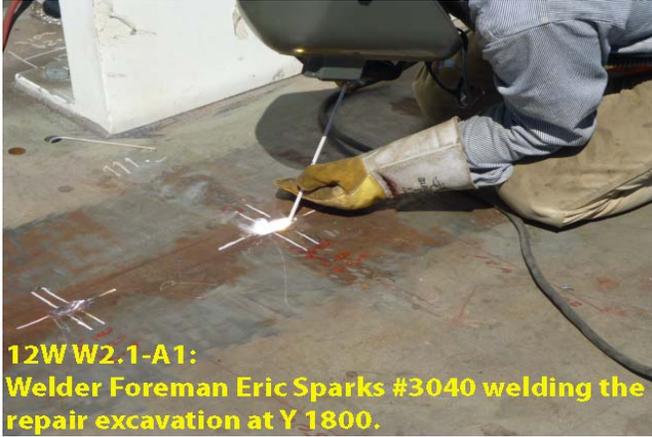
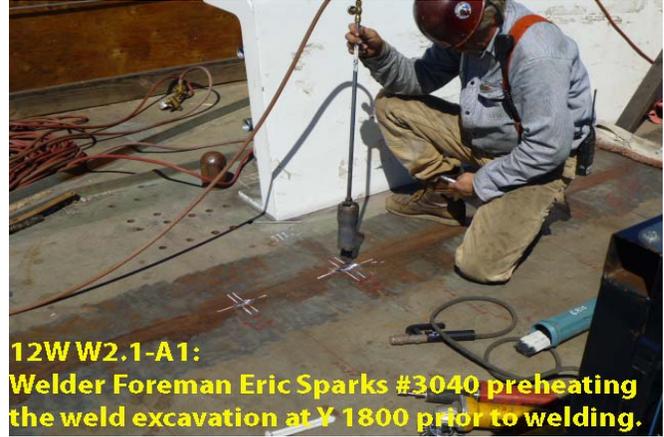
Welder Foreman Eric Sparks was observed performing welding repairs and grinding on weld 12W W2.1-A1 at Y locations 1420 and 1800. Both excavations were excavated to 12mm deep. The welder was then observed utilizing Caltrans approved Welding Procedure Specification's (WPS) ABF-WPS-D15-1001-R to fill the excavations up. The weld was preheated to 125 degrees Fahrenheit prior to welding. Welding parameters observed appears to be in compliance to the WPS noted above. The repaired areas were areas rejected by Ultrasonic Testing Shear Wave (UTSW). The Ultrasonic Testing Shear Wave (UTSW) inspection for the weld was in process during the weld repairs.

This QA randomly observed QC Inspector Andrew Keech performing Magnetic Particle Testing (MPT) and Ultrasonic Testing Shear Wave (UTSW) on weld 12W W2.1-A1. Also noted with him performing Ultrasonic Testing Shear Wave (UTSW) on the weld were QC Inspectors Harry Schein and Jesus Cayabyab QC Inspector Patrick Swain was observed working closely with welder Eric Sparks on repairing the rejects before being assigned elsewhere.
