DEPARTMENT OF TRANSPORTATION

Contract #: 04-0120F4Cty: SF/ALA Rte: 80 PM: 13.2/13.9File #: 1.28**WELDING INSPECTION REPORT****Resident Engineer:** Casey, William**Address:** 333 Burma Road**City:** Oakland, CA 94607**Report No:** WIR-028440**Date Inspected:** 14-Sep-2012**Project Name:** SAS Superstructure**OSM Arrival Time:** 700**Prime Contractor:** American Bridge/Fluor Enterprises, a JV**OSM Departure Time:** 1930**Contractor:** American Bridge/Fluor Enterprises, a JV**Location:** Job Site**CWI Name:** See below.**CWI Present:** Yes No**Inspected CWI report:** Yes No N/A**Rod Oven in Use:** Yes No N/A**Electrode to specification:** Yes No N/A**Weld Procedures Followed:** Yes No N/A**Qualified Welders:** Yes No N/A**Verified Joint Fit-up:** Yes No N/A**Approved Drawings:** Yes No N/A**Approved WPS:** Yes No N/A**Delayed / Cancelled:** Yes No N/A**Bridge No:** 34-0006**Component:** OBG**Summary of Items Observed:**

OBG 12W

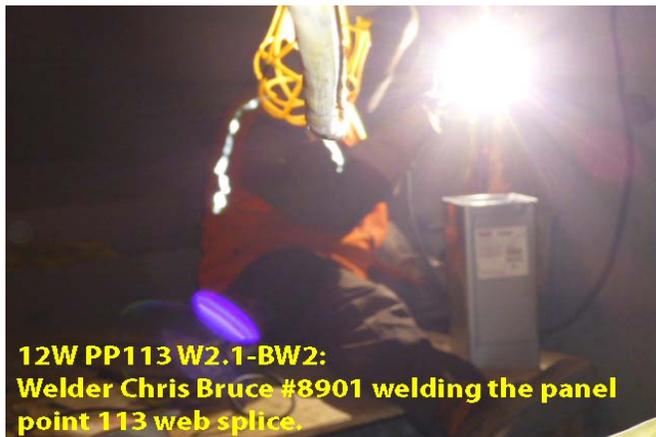
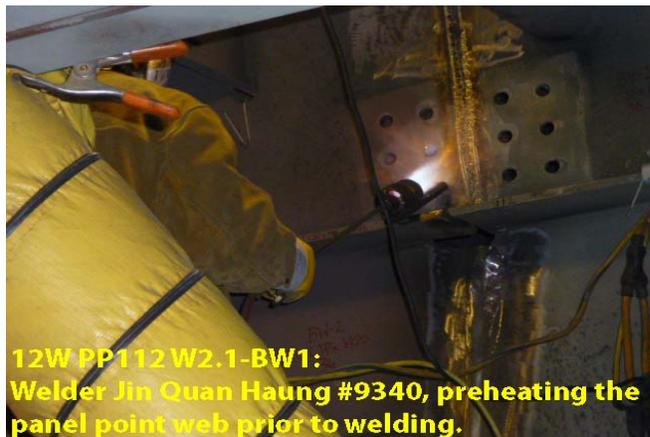
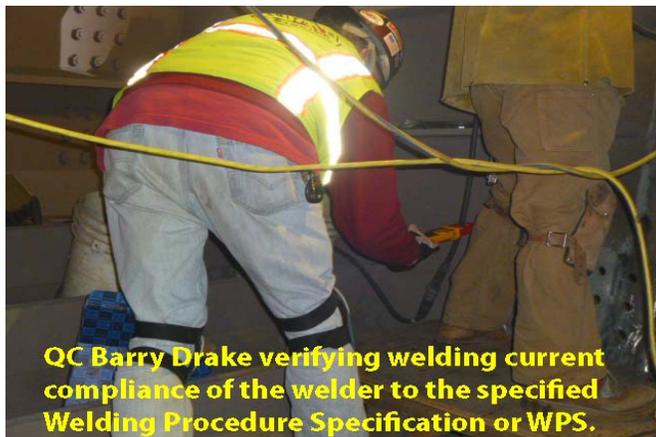
Welder Chris Bruce was observed welding on welds 12W PP113 W2.1-BW1 (3G, CJP) and 12W PP113 W2.1-BW2 (3G, CJP) The welder was observed utilizing Caltrans approved Welding Procedure Specification's (WPS) ABF-WPS-D15-1030; preheating to the specified temperature prior to welding. Welding parameters observed were as per Welding Procedure Specification's (WPS) noted above and appears to be in order.

Welder Jin Quan Huang was observed welding on welds 12W PP112 W2.1-BW2 (3G, CJP). The welder was observed utilizing Caltrans approved Welding Procedure Specification's (WPS) ABF-WPS-D15-1030; preheating to the specified temperature prior to welding. Welding parameters observed were as per Welding Procedure Specification's (WPS) noted above and appears to be in order.

Andrew Keech performing Ultrasonic Testing Shear Wave (UTSW) at panel point 12W PP114.5 W2.1. Inspector Keech was testing the various welds at the above mentioned location.

Unless otherwise noted, all work observed on this date appeared to generally comply with applicable contract documents.
