DEPARTMENT OF TRANSPORTATION

Quality Assurance and Source Inspection

Contract #: 04-0120F4Cty: SF/ALA Rte: 80 PM: 13.2/13.9File #: 1.28**WELDING INSPECTION REPORT****Resident Engineer:** Casey, William**Address:** 333 Burma Road**City:** Oakland, CA 94607**Report No:** WIR-028480**Date Inspected:** 27-Sep-2012**Project Name:** SAS Superstructure**OSM Arrival Time:** 700**Prime Contractor:** American Bridge/Fluor Enterprises, a JV**OSM Departure Time:** 1930**Contractor:** American Bridge/Fluor Enterprises, a JV**Location:** Job Site**CWI Name:** See below.**CWI Present:** Yes No**Inspected CWI report:** Yes No N/A**Rod Oven in Use:** Yes No N/A**Electrode to specification:** Yes No N/A**Weld Procedures Followed:** Yes No N/A**Qualified Welders:** Yes No N/A**Verified Joint Fit-up:** Yes No N/A**Approved Drawings:** Yes No N/A**Approved WPS:** Yes No N/A**Delayed / Cancelled:** Yes No N/A**Bridge No:** 34-0006**Component:** OBG**Summary of Items Observed:**

OBG 12W

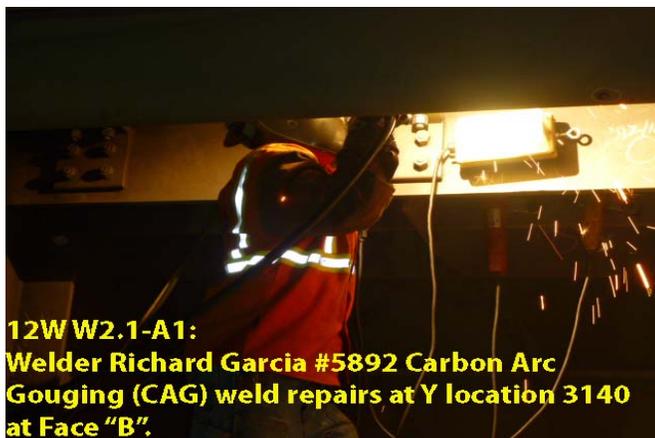
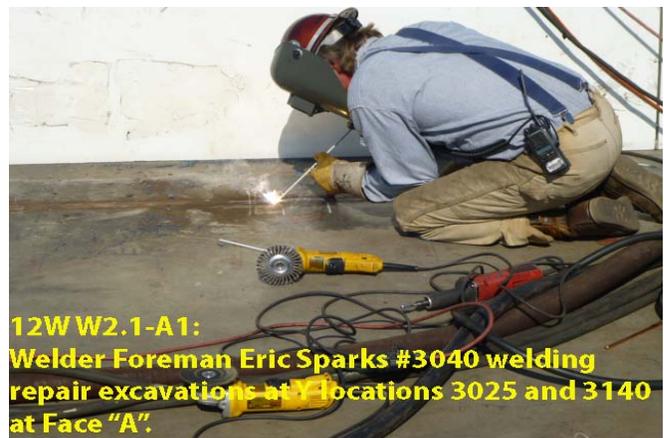
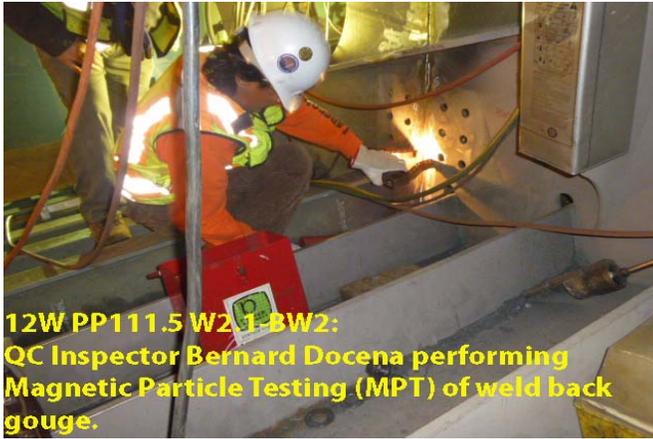
Welder Richard Garcia was observed welding on welds 12W PP111.5 W2.1-BW1, 12W PP111.5 W2.1-BW2, 12W PP111.5 W2.1-BW3 and 12W PP111.5 W2.1-PS1. Welder was observed utilizing Caltrans approved Welding Procedure Specification's (WPS) ABF-WPS-D15-3040B-3 for Flux Core Arc Welding (FCAW) and ABF-WPS-D15-1040A for Shielded Metal Arc Welding (SMAW). The welder was observed preheating the welds prior to welding. Other welding parameters observed appear to be in compliance with the WPS noted above.

Welder Richard Garcia was also observed performing Carbon Arc Gouging (CAG) and welding of repairs on weld 12W W2.1-A1 at Y locations 3029 and 3140 at Face "B". Welder was observed utilizing Caltrans approved Welding Procedure Specification's (WPS) ABF-WPS-D15-1001-R for Shielded Metal Arc Welding (SMAW) of repairs. The weld was preheated before excavations and welding. Welding parameters appear to be in order.

Welder Eric Sparks was observed performing Carbon Arc Gouging (CAG) welding of repairs on weld 12W W2.1-A1 at Y locations 3029 and 3140 at Face "A". Welder was observed utilizing Caltrans approved Welding

- Repair Excavation Y Location 3029 (60 x 20 x 10mm Deep, MPT Accept.)
- Repair Excavation Y Location 3140 (180 x 20 x 10mm Deep, MPT Accept.)

- Weld Back Gouge (1420mm, MPT Accept.)
