DEPARTMENT OF TRANSPORTATION

Quality Assurance and Source Inspection

Contract #: 04-0120F4Cty: SF/ALA Rte: 80 PM: 13.2/13.9File #: 1.28**WELDING INSPECTION REPORT****Resident Engineer:** Casey, William**Address:** 333 Burma Road**City:** Oakland, CA 94607**Report No:** WIR-028483**Date Inspected:** 22-Sep-2012**Project Name:** SAS Superstructure**OSM Arrival Time:** 700**Prime Contractor:** American Bridge/Fluor Enterprises, a JV**OSM Departure Time:** 1530**Contractor:** American Bridge/Fluor Enterprises, a JV**Location:** Job Site**CWI Name:** See below.**CWI Present:** Yes No**Inspected CWI report:** Yes No N/A**Rod Oven in Use:** Yes No N/A**Electrode to specification:** Yes No N/A**Weld Procedures Followed:** Yes No N/A**Qualified Welders:** Yes No N/A**Verified Joint Fit-up:** Yes No N/A**Approved Drawings:** Yes No N/A**Approved WPS:** Yes No N/A**Delayed / Cancelled:** Yes No N/A**Bridge No:** 34-0006**Component:** OBG**Summary of Items Observed:**

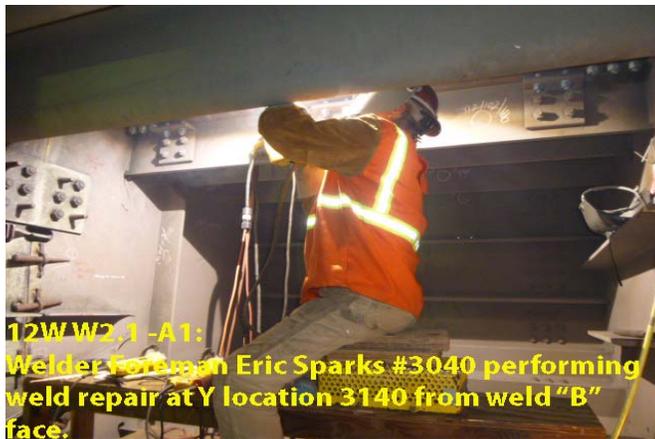
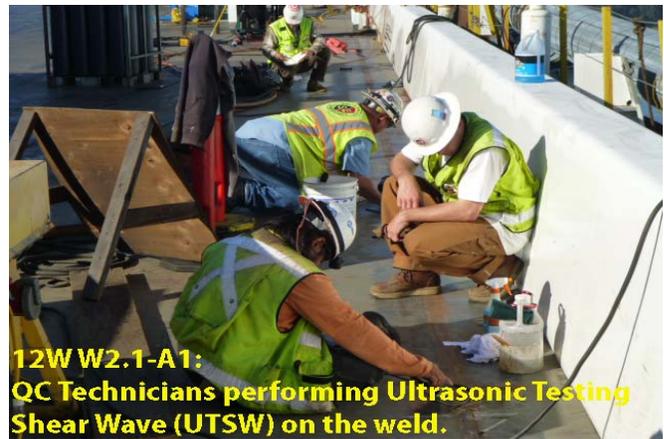
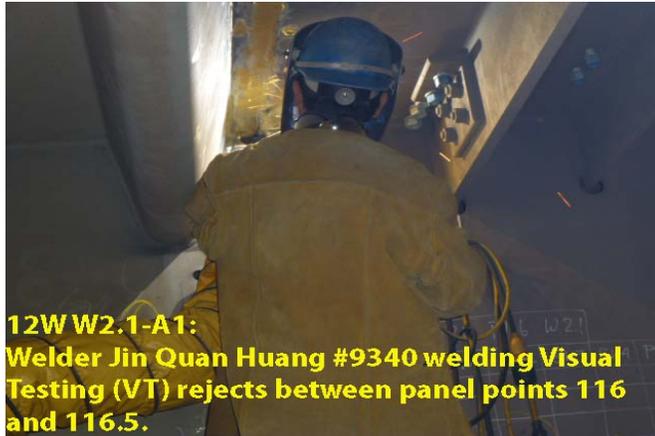
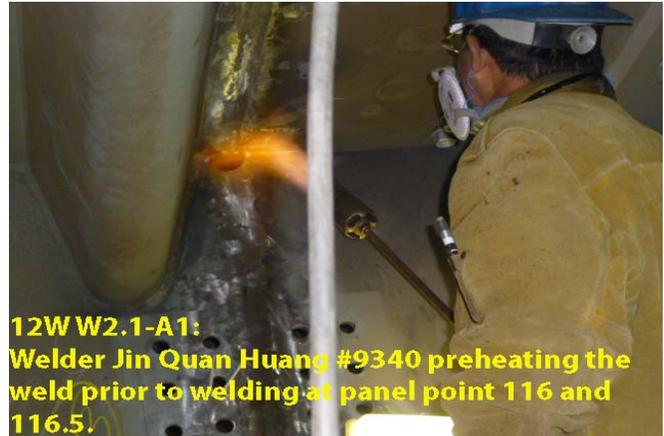
Welder Jin Quan Huang was observed grinding on welding 12W W2.1-A1 from the underside removing Visual Testing (VT) rejects between panel points 116 & 116.5, that were noted earlier when the weld was ground flush in preparation for Ultrasonic Testing Shear Wave (UTSW). The welder was observed utilizing Caltrans approved Welding Procedure Specification's (WPS) ABF-WPS-D15-1001-R and preheating the weld to 150 degrees Fahrenheit prior to welding. All other welding parameters appear to be in compliance with the WPS noted above.

Welder Guo Wu Chen was observed grinding on welding 12W W2.1-A1 from the underside removing Visual Testing (VT) rejects between panel points 116.5 & 117.5, that were noted earlier when the weld was ground flush in preparation for Ultrasonic Testing Shear Wave (UTSW). The welder was observed utilizing Caltrans approved Welding Procedure Specification's (WPS) ABF-WPS-D15-1001-R and preheating the weld to 150 degrees Fahrenheit prior to welding. All other welding parameters appear to be in compliance with the WPS noted above.

Welder Foreman Eric Sparks was observed performing carbon arc gouging (CAG) and welding repairs on weld 12W W2.1-A1 at Y location 3140. The excavation was welded this morning utilizing Caltrans approved Welding Procedure Specification's (WPS) ABF-WPS-D15-1001-R. The weld was preheated to 125 degrees Fahrenheit prior to welding. Other welding parameters observed appear to be in compliance with the WPS noted above. The repaired areas were areas rejected by Ultrasonic Testing Shear Wave (UTSW).

- Repair at Y location 3140 repair. (160 x 18 x 6 deep, MT Accept.)
