**DEPARTMENT OF TRANSPORTATION**

Contract #: 04-0120F4Cty: SF/ALA Rte: 80 PM: 13.2/13.9File #: 1.28**WELDING INSPECTION REPORT****Resident Engineer:** Casey, William**Address:** 333 Burma Road**City:** Oakland, CA 94607**Report No:** WIR-028493**Date Inspected:** 25-Sep-2012**Project Name:** SAS Superstructure**Prime Contractor:** American Bridge/Fluor Enterprises, a JV**Contractor:** American Bridge/Fluor Enterprises, a JV**OSM Arrival Time:** 730**OSM Departure Time:** 2000**Location:** S.A.S. Job site**CWI Name:** Pat Swain**CWI Present:** Yes No**Inspected CWI report:** Yes No N/A**Rod Oven in Use:** Yes No N/A**Electrode to specification:** Yes No N/A**Weld Procedures Followed:** Yes No N/A**Qualified Welders:** Yes No N/A**Verified Joint Fit-up:** Yes No N/A**Approved Drawings:** Yes No N/A**Approved WPS:** Yes No N/A**Delayed / Cancelled:** Yes No N/A**Bridge No:** 34-0006**Component:** S.A.S. Structure**Summary of Items Observed:**

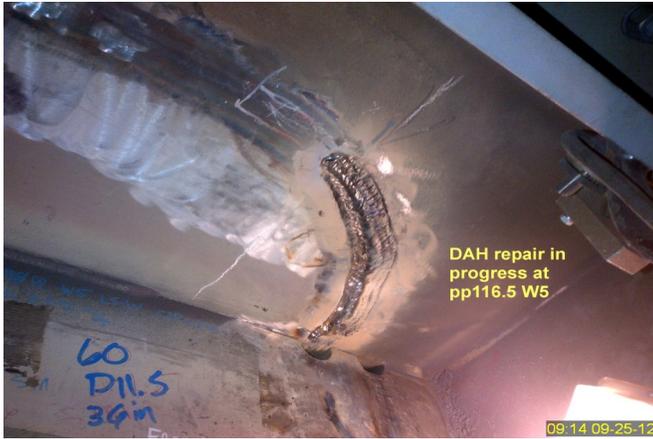
The QAI was tasked with monitoring the welding and repairs being performed by ABF welder Rick Clayborn, ID 2773. The QAI noted that repairs are in progress in the Deck Access Hole (DAH) on OBG 13W at panel point (pp) 116.5. The QAI noted that the welding is being monitored by the Quality Control Inspector (QCI) Pat Swain. The QAI noted that the Complete Joint Penetration (CJP) groove weld is being repaired from the bottom in the overhead (4G) position. The QAI also noted that this is a first time repair and the full length of the weld will be repaired using approved weld repair RWR 201208-076. The QAI noted that welding procedure specification (WPS) ABF-WPS-D15-1004-Repair is being utilized. The QAI noted that during the welding, the preheat and interpass temperatures were maintained and the welding parameters were within the ranges listed on the WPS. See the attached photo. At approximately 1130 hours, the QAI was re-assigned to review documents at pier 7.
