**DEPARTMENT OF TRANSPORTATION**

Contract #: 04-0120F4Cty: SF/ALA Rte: 80 PM: 13.2/13.9File #: 1.28**WELDING INSPECTION REPORT****Resident Engineer:** Casey, William**Address:** 333 Burma Road**City:** Oakland, CA 94607**Report No:** WIR-028523**Date Inspected:** 05-Oct-2012**Project Name:** SAS Superstructure**OSM Arrival Time:** 700**Prime Contractor:** American Bridge/Fluor Enterprises, a JV**OSM Departure Time:** 1730**Contractor:** American Bridge/Fluor Enterprises, a JV**Location:** jobsite

**Bridge No:** 34-0006**Summary of Items Observed:**

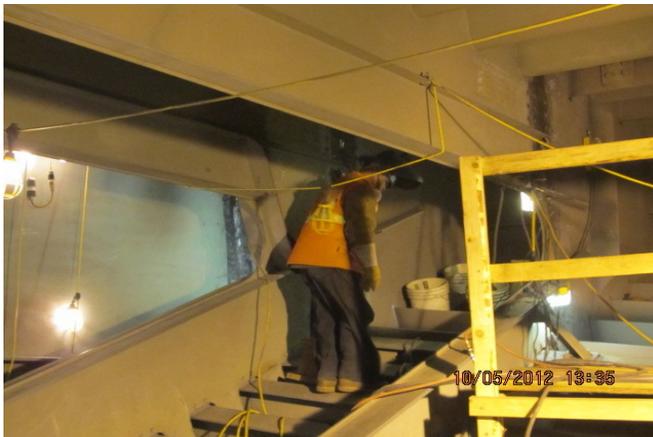
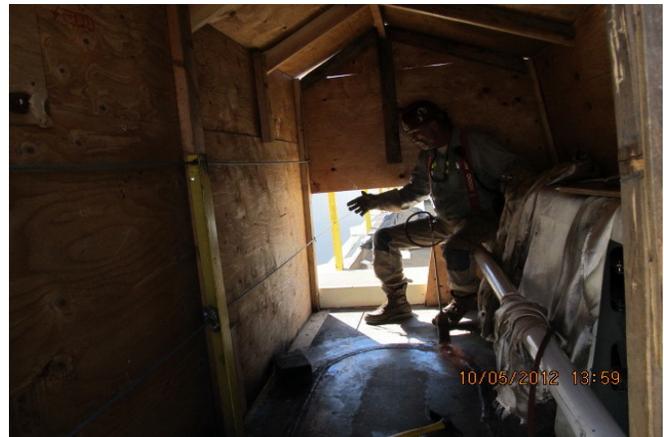
brand Tong style meter, the parameters were verified to be 122 amps. See photo attached to body of report.

The welder spent part of the shift depositing the root passes and fill passes with approximately 100% being completed at the end of the shift. QC inspector Michaels was noted to be present in order to monitor the progress and ensure the welding was within the established Welding Procedure Specification (WPS) noted as ABF-WPS-D15-1001 Rev 0 and supporting Procedure Qualification Records (PQR). Prior to and during the welding at this location the QC inspector observed the preheat temperature using a Raytek non-contact Thermometer, was sufficient and compliant to the above-mentioned WPS. Using a Tempil Stick, (temperature indicating crayon) the pre-heat was then verified by this QA inspector to be greater than 150F. Using a Fluke brand Tong style meter, the parameters were verified to be 112 amps. See photo attached to body of report.

The welder spent part of the shift depositing the root passes and fill passes with approximately 100% being completed at the end of the shift. QC inspector Michaels was noted to be present in order to monitor the progress and ensure the welding was within the established Welding Procedure Specification (WPS) noted as ABF-WPS-D15-1001 Rev 0 and supporting Procedure Qualification Records (PQR). Prior to and during the welding at this location the QC inspector observed the preheat temperature using a Raytek non-contact Thermometer, was sufficient and compliant to the above-mentioned WPS. Using a Tempil Stick, (temperature indicating crayon) the pre-heat was then verified by this QA inspector to be greater than 150F. Using a Fluke brand Tong style meter, the parameters were verified to be 134 amps. See photo attached to body of report.

The welder spent the entirety of the shift depositing the fill and cap passes with approximately 100% being completed at the end of the shift. QC inspector Fred Michaels was noted to be present in order to monitor the progress and ensure the welding was within the established Welding Procedure Specification (WPS) noted as ABF-WPS-D15-1004R (Rev 0) and supporting Procedure Qualification Records (PQR). Prior to initiating the welding at this location the QC inspector observed the preheat temperature and post heat temperature using a Raytek non-contact Thermometer, was sufficient and compliant to the above-mentioned WPS. Using a Tempil Stick, (temperature indicating crayon) the preheat, and post heat temperature was then verified by this QA inspector to be greater than 350F and 450F respectively. Using a Fluke brand Tong style meter, the parameters were verified to be 133 amps
