DEPARTMENT OF TRANSPORTATION

Quality Assurance and Source Inspection

Contract #: 04-0120F4Cty: SF/ALA Rte: 80 PM: 13.2/13.9File #: 1.28**WELDING INSPECTION REPORT****Resident Engineer:** Casey, William**Address:** 333 Burma Road**City:** Oakland, CA 94607**Report No:** WIR-028533**Date Inspected:** 03-Oct-2012**Project Name:** SAS Superstructure**OSM Arrival Time:** 700**Prime Contractor:** American Bridge/Fluor Enterprises, a JV**OSM Departure Time:** 1730**Contractor:** American Bridge/Fluor Enterprises, a JV**Location:** Job Site**CWI Name:** See below.**CWI Present:** Yes No**Inspected CWI report:** Yes No N/A**Rod Oven in Use:** Yes No N/A**Electrode to specification:** Yes No N/A**Weld Procedures Followed:** Yes No N/A**Qualified Welders:** Yes No N/A**Verified Joint Fit-up:** Yes No N/A**Approved Drawings:** Yes No N/A**Approved WPS:** Yes No N/A**Delayed / Cancelled:** Yes No N/A**Bridge No:** 34-0006**Component:** OBG**Summary of Items Observed:**

OBG 12W

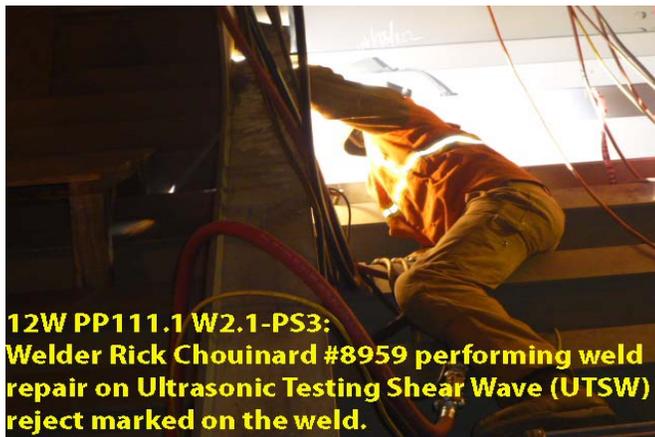
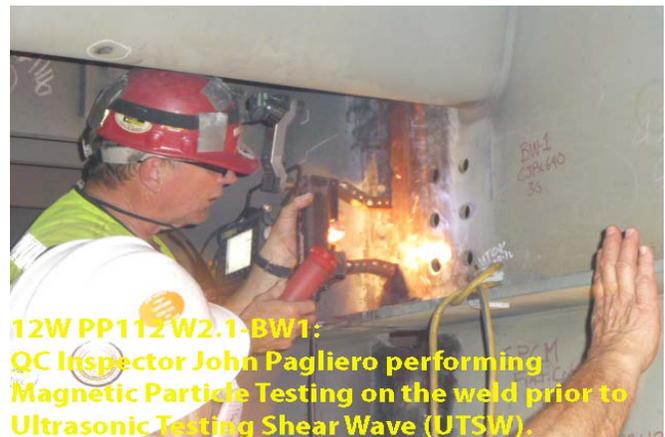
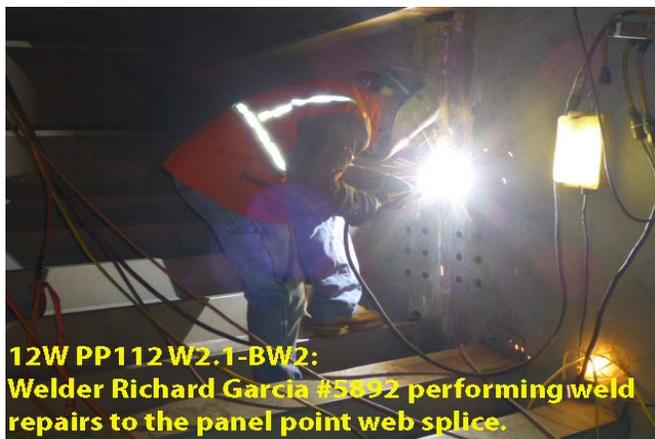
Welder Richard Garcia was observed performing weld repairs welding on weld 12W PP112 W2.1-BW2 adding weld metal to weld for an acceptable transition between unequal thickness between base metals. Welder was observed utilizing Caltrans approved Welding Procedure Specification's (WPS) ABF-WPS-D15-1000R Rev2 for Shielded Metal Arc Welding (SMAW). The welder was observed preheating the welds prior to welding. Other welding parameters as inspected by QC Inspector appear to be in compliance with the WPS noted above.

Welder Richard Chouinard was observed performing weld repairs on weld 12W PP111.5 W2.1-PS3 Carbon Arc Gouging (CAG) and welding utilizing Caltrans approved Welding Procedure Specification's (WPS) ABF-WPS-D15-1000R Rev.2 for Shielded Metal Arc Welding (SMAW). The welder was observed preheating the welds prior to welding. Other welding parameters as inspected by QC Inspector appear to be in compliance with the WPS noted above.
