DEPARTMENT OF TRANSPORTATION

Quality Assurance and Source Inspection

Contract #: 04-0120F4Cty: SF/ALA Rte: 80 PM: 13.2/13.9File #: 1.28**WELDING INSPECTION REPORT****Resident Engineer:** Casey, William**Address:** 333 Burma Road**City:** Oakland, CA 94607**Report No:** WIR-028534**Date Inspected:** 04-Oct-2012**Project Name:** SAS Superstructure**OSM Arrival Time:** 700**Prime Contractor:** American Bridge/Fluor Enterprises, a JV**OSM Departure Time:** 1730**Contractor:** American Bridge/Fluor Enterprises, a JV**Location:** Job Site**CWI Name:** See below.**CWI Present:** Yes No**Inspected CWI report:** Yes No N/A**Rod Oven in Use:** Yes No N/A**Electrode to specification:** Yes No N/A**Weld Procedures Followed:** Yes No N/A**Qualified Welders:** Yes No N/A**Verified Joint Fit-up:** Yes No N/A**Approved Drawings:** Yes No N/A**Approved WPS:** Yes No N/A**Delayed / Cancelled:** Yes No N/A**Bridge No:** 34-0006**Component:** OBG**Summary of Items Observed:**

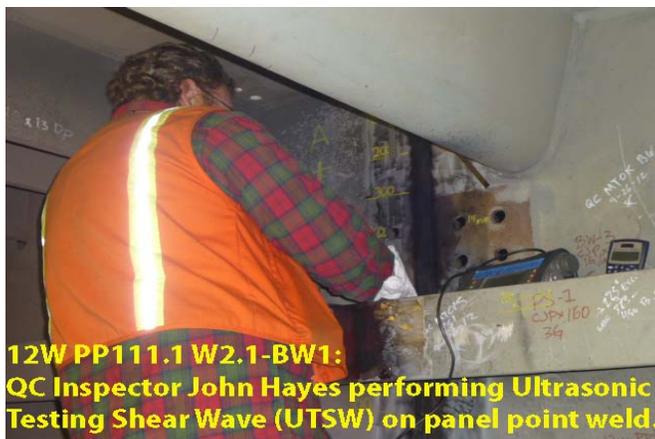
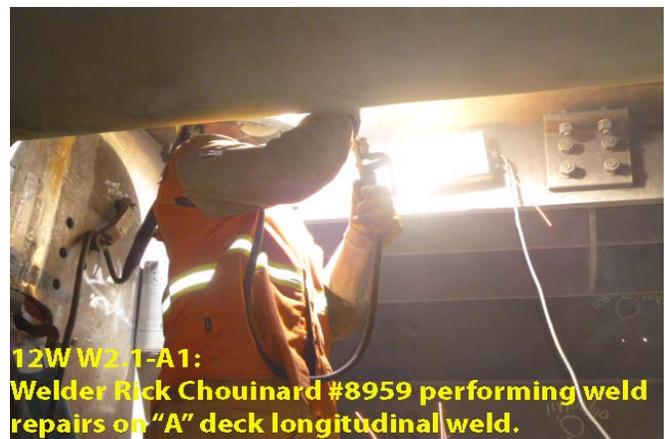
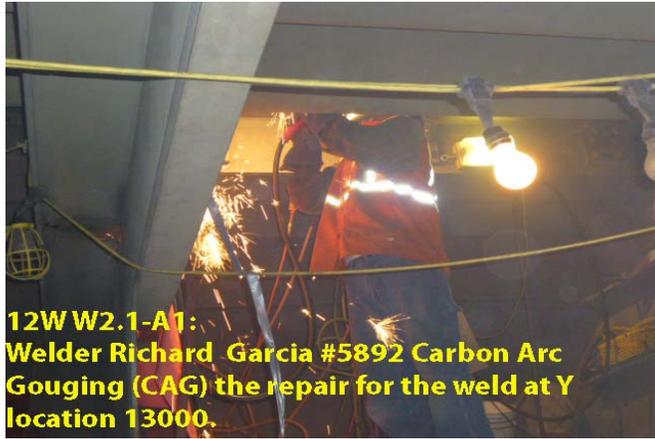
Welder Richard Garcia was observed performing weld repairs on weld 12W W2.1-A1 Carbon Arc Gouging (CAG) the weld for repairs. Welder was observed utilizing Caltrans approved Welding Procedure Specification's (WPS) ABF-WPS-D15-3000-4 for Flux Core Arc Welding (FCAW). The welder was observed preheating the welds prior to Carbon Arc Gouging and welding. Other welding parameters as inspected by QC Inspector appear to be in compliance with the WPS noted above.

Welder Richard Chouinard was observed performing weld repairs on weld 12W W2.1-A1 Carbon Arc Gouging (CAG) the weld for repairs. Welder was observed utilizing Caltrans approved Welding Procedure Specification's (WPS) ABF-WPS-D15-1000R Rev.2 for Shielded Metal Arc Welding (SMAW). The welder was observed preheating the welds prior to Carbon Arc Gouging and welding. Other welding parameters as inspected by QC Inspector appear to be in compliance with the WPS noted above.

Welder Chris Bruce was observed performing weld repairs by grinding and welding on welds 12W PP116.5 W2.1-PS4 and 12W PP116 W2.1-BW2. Welds were rejected by both Visual Testing (VT) and Ultrasonic Testing Shear Wave (UTSW). The welder was observed doing repairs utilizing Caltrans approved Welding Procedure Specification's (WPS) ABF-WPS-D15-1000R-Rev.2 for Shielded Metal Arc Welding (SMAW). He was observed preheating the welds to 150 degrees Fahrenheit prior to welding. Other welding parameters observed appear to be in compliance with the WPS noted above.
