Contract #: 04-0120F4Cty: SF/ALA Rte: 80 PM: 13.2/13.9File #: 1.28**WELDING INSPECTION REPORT**

Report No: WIR-028625
Date Inspected: 18-Oct-2012

Project Name: SAS Superstructure
Prime Contractor: American Bridge/Fluor Enterprises, a JV
Contractor: American Bridge/Fluor Enterprises, a JV

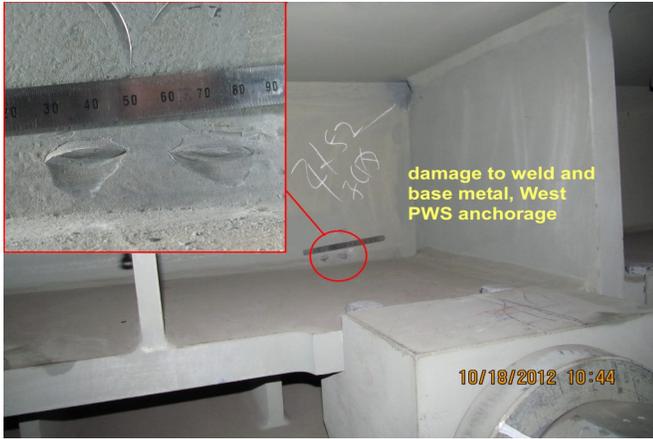
The QAI made observations of the Parallel Wire Strand (PWS) Anchorages, East bound and West bound. The QAI noted that at each PWS there appears to be damage to the base metal and at several locations there is visible damage to the adjacent welds. Photos were taken to relay to the Assistant Structural Materials Representative (ASMR) Parinaz Aghili. The QAI noted that there will need to be additional surveying of the area and will continue this work during the next shift. See the attached photo.
