Contract #: 04-0120F4Cty: SF/ALA Rte: 80 PM: 13.2/13.9File #: 1.28**WELDING INSPECTION REPORT**

Report No: WIR-028658
Date Inspected: 25-Oct-2012

Project Name: SAS Superstructure **OSM Arrival Time:** 700
Prime Contractor: American Bridge/Fluor Enterprises, a JV **OSM Departure Time:** 1730
Contractor: American Bridge/Fluor Enterprises, a JV **Location:** Job Site

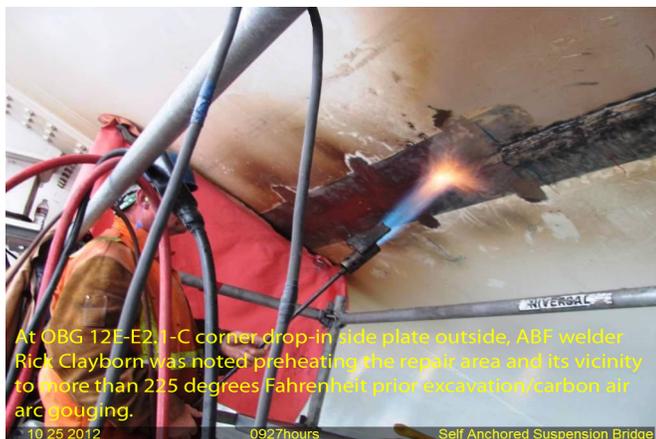
10 25 2012 0927hours Self Anchored Suspension Bridge

At OBG 12E-E2.1-C corner drop-in side plate outside, ABF welder Rick Clayborn was noted preheating the repair area and its vicinity to more than 225 degrees Fahrenheit prior excavation/carbon arc gouging.

At OBG 12E-E2.1-C corner drop-in side plate outside, QA randomly observed ABF/JV qualified welders continuing to perform CJP groove welding repair at various Y locations. The repair welding is being performed per Caltrans approved Request for Weld Repair (RWR) #201210-013. The welders were observed manually welding in the 4G (overhead) position utilizing Shielded Metal Arc Welding (SMAW) with 4.0mm diameter E7018H4R electrode implementing Caltrans welding procedure ABF-WPS-D15-1004 Repair. The second time repair excavations were preheated to more than 225 degree Fahrenheit using Miller Proheat 35 Induction Heating System/propylene gas torch prior excavation. During the shift, ABF QC Fred Michels was noted monitoring the welders with measured working current of 165 to 170 amperes on the 4.0mm E7018H4R electrode and adjusted preheat temperature of 325°F during welding. During the shift where welder has completed the welding repair as mentioned below, ABF personnel have performed the Post Weld Heat Treatment (PWHT) of 450°F and held it for one (1) hour after welding as required. After the completion of the bake out of the just concluded repair, the welder will move to another location of the same side plate and perform the same task implementing the same WPS. Listed below were excavated and welded during the shift.

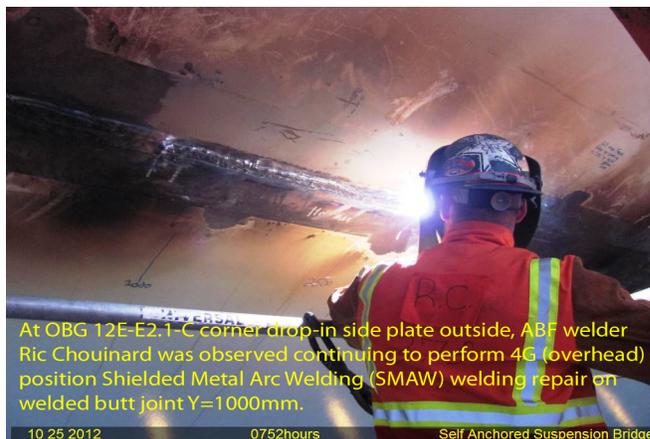
10 25 2012 0752hours Self Anchored Suspension Bridge

At OBG 12E-E2.1-C corner drop-in side plate outside, ABF welder Ric Chouinard was observed continuing to perform 4G (overhead) position Shielded Metal Arc Welding (SMAW) welding repair on welded butt joint Y=1000mm.

Welder	Y-location	Length	Width	Depth	Remarks
1. Ric Chouinard	Y=1000mm	900mm	60mm	10mm	R2-completed.
2. Ric Chouinard	Y=1900	1000	60	10	R2-in progress.
3. Mike Jimenez	Y=6650	950	60	10	R2-completed.
4. Mike Jimenez	Y=5600	1000	60	10	R2-in progress.
5. Richard Garcia	Y=14500	1000	60	10	R2-completed.
6. Richard Garcia	Y=9600	1000	60	10	R2-in progress.

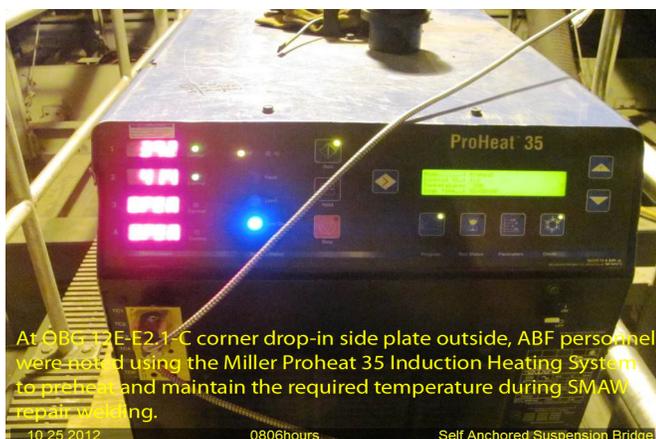
10 25 2012 0806hours Self Anchored Suspension Bridge

At OBG 12E-E2.1-C corner drop-in side plate outside, ABF personnel were noted using the Miller Proheat 35 Induction Heating System to preheat and maintain the required temperature during SMAW repair welding.

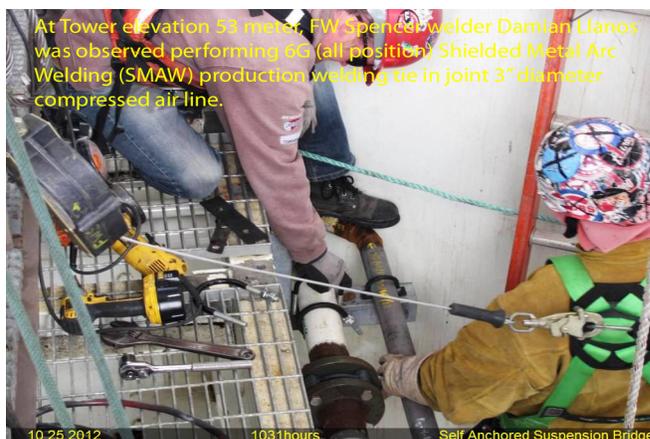
10 25 2012 1031hours Self Anchored Suspension Bridge

At Tower elevation #3 meter, FW Spender welder Damian Llanos was observed performing 6G (all position) Shielded Metal Arc Welding (SMAW) production welding tie in joint 3" diameter compressed air-line.

At Tower location elevation 53 meter, this QA randomly observed FW Spencer qualified welder Damian Llanos continuing to perform Complete Joint Penetration (CJP) 6G (all position) Shielded Metal Arc Welding (SMAW) welding root pass to cover pass on 3" domestic utility water line field splice butt joints. The welder was noted welding the butt joints on one 3" diameter 45 degree elbow to 3" diameter pipe line tie-in. The welder was noted welding the root pass with 3/32" diameter E6010 electrode and followed by fill pass to cover pass using 3/32" diameter E7018H4R electrode implementing Caltrans procedure FW Spencer WPS 1-12-1. The welder was noted preheating and removing the moisture of the joint using a portable propane gas torch prior welding. During welding, ABF QC Barry Drake was noted monitoring the parameters of the welder. At the end of the FW Spencer shift, CJP welding on one (1) 3" diameter domestic utility water line tie-in was completed.
