Contract #: 04-0120F4Cty: SF/ALA Rte: 80 PM: 13.2/13.9File #: 1.28**WELDING INSPECTION REPORT**

Report No: WIR-028693
Date Inspected: 26-Oct-2012

Project Name: SAS Superstructure
Prime Contractor: American Bridge/Fluor Enterprises, a JV
Contractor: American Bridge/Fluor Enterprises, a JV

Ultrasonic Testing of ESW

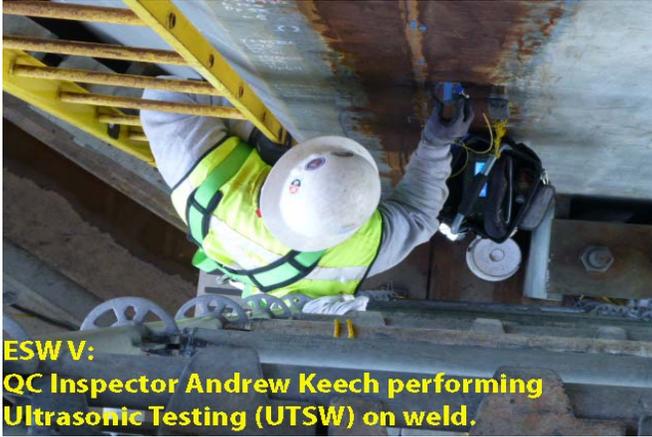
This QA witnessed QC Inspector Andrew Keech perform Ultrasonic Testing (UT) of Tower Electroslag Complete Joint Penetration (CJP) shear plate welds designated as "ESW V" and "ESW T" on face B. The QC Inspector was testing various Y locations where indications were previously recorded in order to ascertain an appropriate indication to use as a model for the development of a technique to determine indication height. The welds were tested in accordance with supplemental procedure SE-UT-D1.5-CT-108-ESW-R5. An indication was inspected on weld T and after close scrutiny of the weld, height evaluation with current techniques are inconclusive with further evaluations required. All indications inspected were recorded previously. This QA observed Mr. Keech calibrate his scope and perform testing on this date.
