Contract #: 04-0120F4Cty: SF/ALA Rte: 80 PM: 13.2/13.9File #: 1.28**WELDING INSPECTION REPORT**

Report No: WIR-028790
Date Inspected: 28-Nov-2012

Project Name: SAS Superstructure
Prime Contractor: American Bridge/Fluor Enterprises, a JV
Contractor: American Bridge/Fluor Enterprises, a JV

| Bridge No: | 34-0006 | Component: | SAS OBG | |

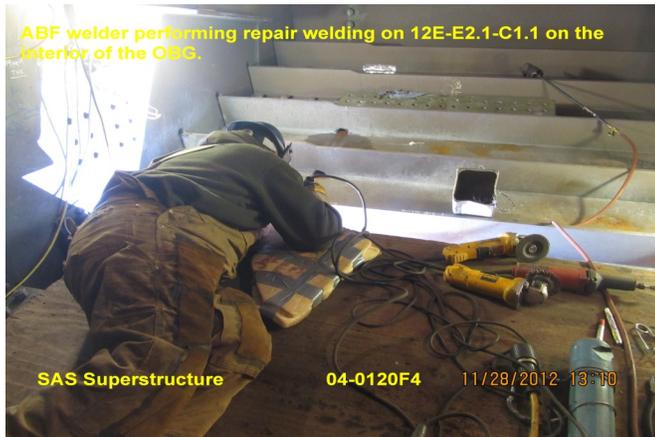
ABF welder Mike Jimenez #4671 was observed performing ongoing weld repairs on weld 12E-E2.1-C1.1 at y=17, 940mm. The dimensions of the excavation were noted as 75L/20W/6D. At y=18,780mm; the dimensions of the excavation were noted as 70L/20W/10D. At y=18,800mm; the dimensions of the excavation were noted as 110L/25W/11D. The welder was observed utilizing WPS ABF-WPS-D15-1004-Repair-Revision 0 for SMAW. The welder was observed preheating the welds prior to Carbon Arc Gouging and welding. Other welding parameters as inspected by the QC Inspector appeared to be in compliance with the WPS noted above. RWR-201210-016 was referenced during this weld repair.
