Contract #: 04-0120F4Cty: SF/ALA Rte: 80 PM: 13.2/13.9File #: 1.28**WELDING INSPECTION REPORT****Resident Engineer:** Casey, William**Address:** 333 Burma Road**City:** Oakland, CA 94607**Report No:** WIR-028833**Date Inspected:** 06-Dec-2012**Project Name:** SAS Superstructure**OSM Arrival Time:** 700**Prime Contractor:** American Bridge/Fluor Enterprises, a JV**OSM Departure Time:** 1739**Contractor:** American Bridge/Fluor Enterprises, a JV**Location:** Job Site**CWI Name:** Jesse Cayabyab**CWI Present:** Yes No**Inspected CWI report:** Yes No N/A**Rod Oven in Use:** Yes No N/A**Electrode to specification:** Yes No N/A**Weld Procedures Followed:** Yes No N/A**Qualified Welders:** Yes No N/A**Verified Joint Fit-up:** Yes No N/A**Approved Drawings:** Yes No N/A**Approved WPS:** Yes No N/A**Delayed / Cancelled:** Yes No N/A**Bridge No:** 34-0006**Component:** SAS Tower**Summary of Items Observed:**

Caltrans Office of Structural Material (OSM) Quality Assurance Inspector (QAI) Joselito Lizardo was present at the Self Anchored Suspension (SAS) job site as requested to perform observations on the welding of components for the San Francisco Oakland Bay Bridge (SFOBB) Project.

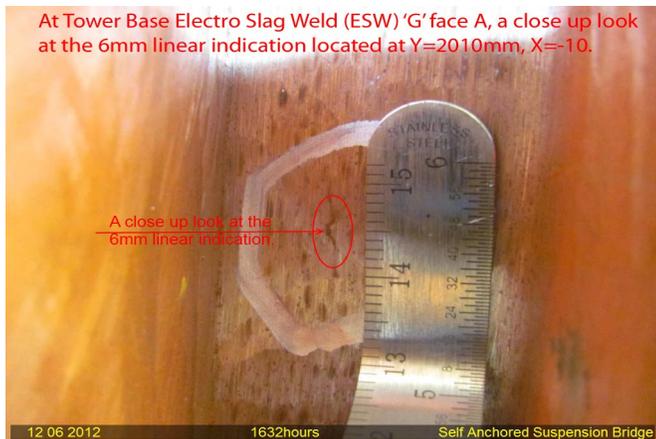
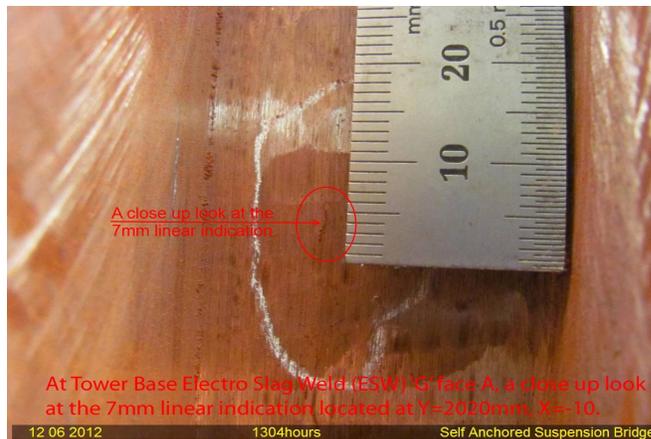
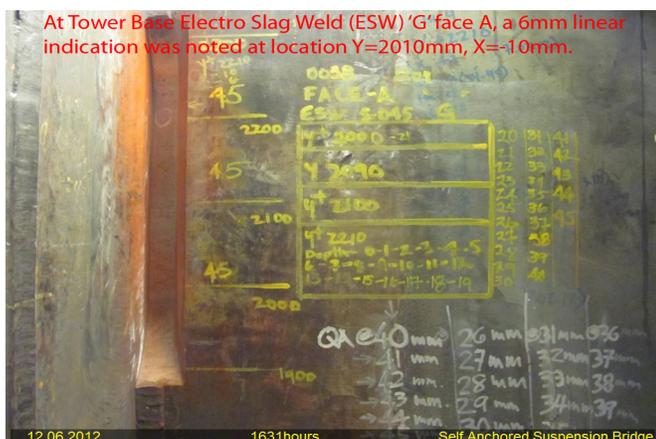
At Tower Base Electro Slag Weld (ESW) 'G' weld joint #S-045 face A, ABF personnel was observed continuing to perform exploratory excavation on welded ESW at locations Y=2000, Y=2090, Y=2100 and Y=2210mm due to UT detected defects. The ABF personnel have resumed the exploratory excavation from 41mm deep where they left off Monday. The personnel were noted using only the disc grinder in every 1mm increments of excavation. ABF QC Jesse Cayabyab was observed performing Magnetic Particle Testing (MT) on the following various depths with three (3) linear indications noted so far. This QA also performed the same test and noted same result. During the shift, the ABF personnel continued the excavation in 1mm increments using the same method of test and verification up to 45mm with three linear indications noted. The shift was completed up to this depth of excavation and ABF is waiting for further instruction if they will excavate deeper into this exploratory excavation.

1. 41mm in depth – no significant indication noted.
2. 42mm in depth – 7mm linear indication noted @y=2020mm, X=-10.
3. 43mm in depth – 6mm linear indication noted @y=2045mm, X=-10.
4. 44mm in depth – no significant indication noted.

5. 45mm in depth –6mm linear indication noted @y=2010mm, X=-10.

The exploratory excavations at this location will be continued on the following shift.
