Contract #: 04-0120F4Cty: SF/ALA Rte: 80 PM: 13.2/13.9File #: 1.28**WELDING INSPECTION REPORT**

Report No: WIR-028861
Date Inspected: 11-Dec-2012

Project Name: SAS Superstructure
Prime Contractor: American Bridge/Fluor Enterprises, a JV
Contractor: American Bridge/Fluor Enterprises, a JV

CWI Name:	As noted below	CWI Present:	Yes	No	
Inspected CWI report:	Yes No N/A	Rod Oven in Use:	Yes	No	N/A
Electrode to specification:	Yes No N/A	Weld Procedures Followed:	Yes	No	N/A
Qualified Welders:	Yes No N/A	Verified Joint Fit-up:	Yes	No	N/A
Approved Drawings:	Yes No N/A	Approved WPS:	Yes	No	N/A
		Delayed / Cancelled:	Yes	No	N/A
Bridge No:	34-0006	Component:	SAS OBG

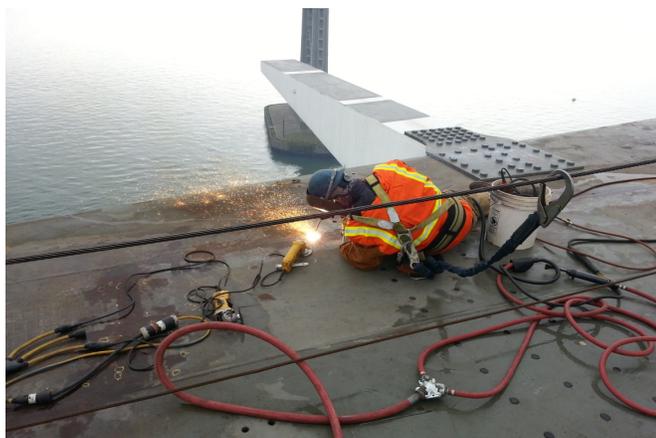
ABF welder Rick Clayborn #2773 was observed performing weld repairs on weld 13E-E2.1 at y=8440mm. The dimensions of the excavation were noted as; 80L/25W/12D. The welder was observed utilizing WPS ABF-WPS-D15-1004-Repair-Revision 0 for SMAW. The welder was observed preheating the welds prior to Carbon Arc Gouging and welding. Other welding parameters as inspected by the QC Inspector appeared to be in compliance with the WPS noted above.

This QA Inspector performed an Ultrasonic (UT) inspection on 12E-E2.1-C1.1 from 0mm to 8000mm. This QA Inspector recorded a rejectable indication at y=70mm. These welds were previously accepted by QC Ultrasonic technicians in accordance with AWS D1.5-2002, section 6, table 6.3. This QA generated a TL-6027 UT report on this date. The testing was performed in accordance with AWS.D1.5-2002 Section 6, table 6.3. RWR 201211-013 is applicable to this weld.
