Contract #: 04-0120F4Cty: SF/ALA Rte: 80 PM: 13.2/13.9File #: 1.28**WELDING INSPECTION REPORT**

Report No: WIR-029039
Date Inspected: 15-Jan-2013

Project Name: SAS Superstructure
Prime Contractor: American Bridge/Fluor Enterprises, a JV
Contractor: American Bridge/Fluor Enterprises, a JV

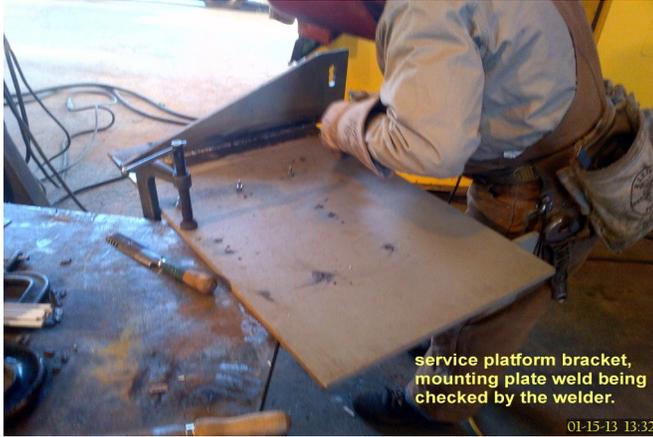
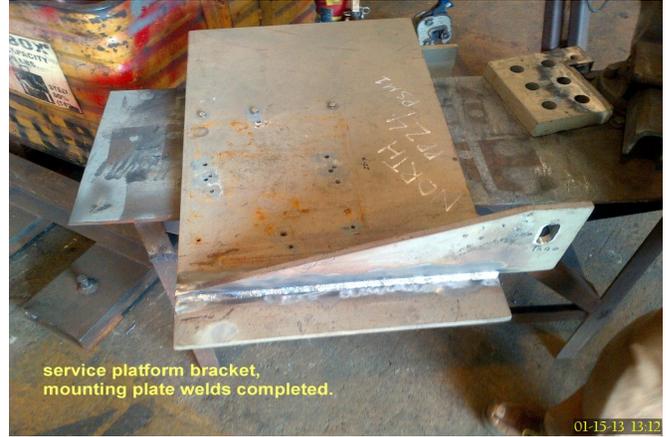
The QAI met with the Quality Control Inspector (QCI) Pat Swain. The QAI was informed that there were modifications of service platform brackets being performed at Pier 7 work area. The QAI reviewed the request for information (RFI) 3158R00. The QAI noted that 2 welded plates will be moved and re-welded. The QAI made random observations of this work in progress. The QAI noted that welder Kevin Kananen, ID 6521, is performing this work. The QAI witnessed fillet welding of the brackets and noted that the welding appeared to be conforming to the welding procedure specification (WPS) ABF-D15-F1200A. Upon completion of the welding, the QAI noted that the QCI visually inspected and conducted Magnetic Particle Testing (MT) on the welds. The QAI was informed that the welds were acceptable. The QAI conducted visual examination of the welds and noted that they appeared to be conforming to the contract requirements. The QAI was informed that the plates / parts will be primer coated at a later time. See the attached photos.
