DEPARTMENT OF TRANSPORTATION

Contract #: 04-0120F4Cty: SF/ALA Rte: 80 PM: 13.2/13.9File #: 1.28**WELDING INSPECTION REPORT****Resident Engineer:** Casey, William**Address:** 333 Burma Road**City:** Oakland, CA 94607**Report No:** WIR-029086**Date Inspected:** 04-Feb-2013**Project Name:** SAS Superstructure**OSM Arrival Time:** 700**Prime Contractor:** American Bridge/Fluor Enterprises, a JV**OSM Departure Time:** 1730**Contractor:** American Bridge/Fluor Enterprises, a JV**Location:** Job Site**CWI Name:** See below.**CWI Present:** Yes No**Inspected CWI report:** Yes No N/A**Rod Oven in Use:** Yes No N/A**Electrode to specification:** Yes No N/A**Weld Procedures Followed:** Yes No N/A**Qualified Welders:** Yes No N/A**Verified Joint Fit-up:** Yes No N/A**Approved Drawings:** Yes No N/A**Approved WPS:** Yes No N/A**Delayed / Cancelled:** Yes No N/A**Bridge No:** 34-0006**Component:** Tower**Summary of Items Observed:**

WELDING INSPECTION REPORT

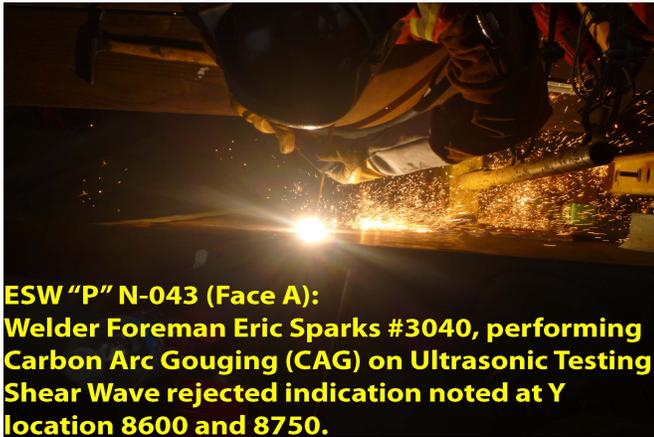
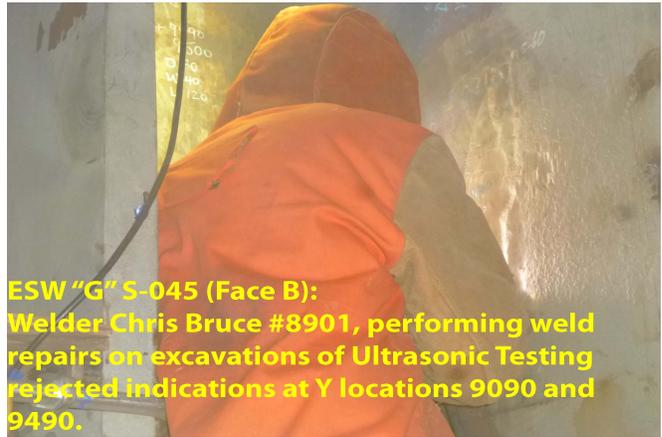
The welder was observed Carbon Arc Gouging (CAG) and performing the weld repairs on excavations on the Electroslag Weld "G" S-045 at face B. The indications were rejected with Ultrasonic Testing Shear Wave and were excavated at Y locations 9090 and 9490 as per Request for Weld Repairs or the RWR 201301-054 & 055. The welder was observed preheating the weld to 300 degrees Fahrenheit prior to welding using the Miller ProHeat 35 with heat induction blankets. The welder utilized the Welding Procedure Specification (WPS) ABF-WPS-D15-1000-Repair Rev.3 for Shield Metal Arc Welding (SMAW). The welding parameters were verified by QC Inspector William Sherwood throughout the day and they appeared to be in compliance with the WPS noted above.

The welder was observed performing the weld repair on the excavation on the Electroslag Weld "P" N-043 at face A. The indication was rejected with Ultrasonic Testing Shear Wave and was excavated at Y location 8600 as per Request for Weld Repairs or the RWR 201301-049. The welder was observed preheating the weld to 300 degrees Fahrenheit prior to welding using the Miller ProHeat 35 with heat induction blankets. The welder utilized the Welding Procedure Specification (WPS) ABF-WPS-D15-1000-Repair Rev.3 for Shield Metal Arc Welding (SMAW). The welding parameters were verified by QC Inspector William Sherwood throughout the day and they

- Y 8600 Repair Excavation 100 x 40 x 28 (MPT Accept)
